# ROLLER COMPACTED CONCRETE DAMS

Proceedings of the International Symposium held in Santander, Spain, on 2 - 4 October 1995

# **JORDÃO RIVER DERIVATION DAM - FOUNDATION CONDITIONS FOR PLACING THE RCC**

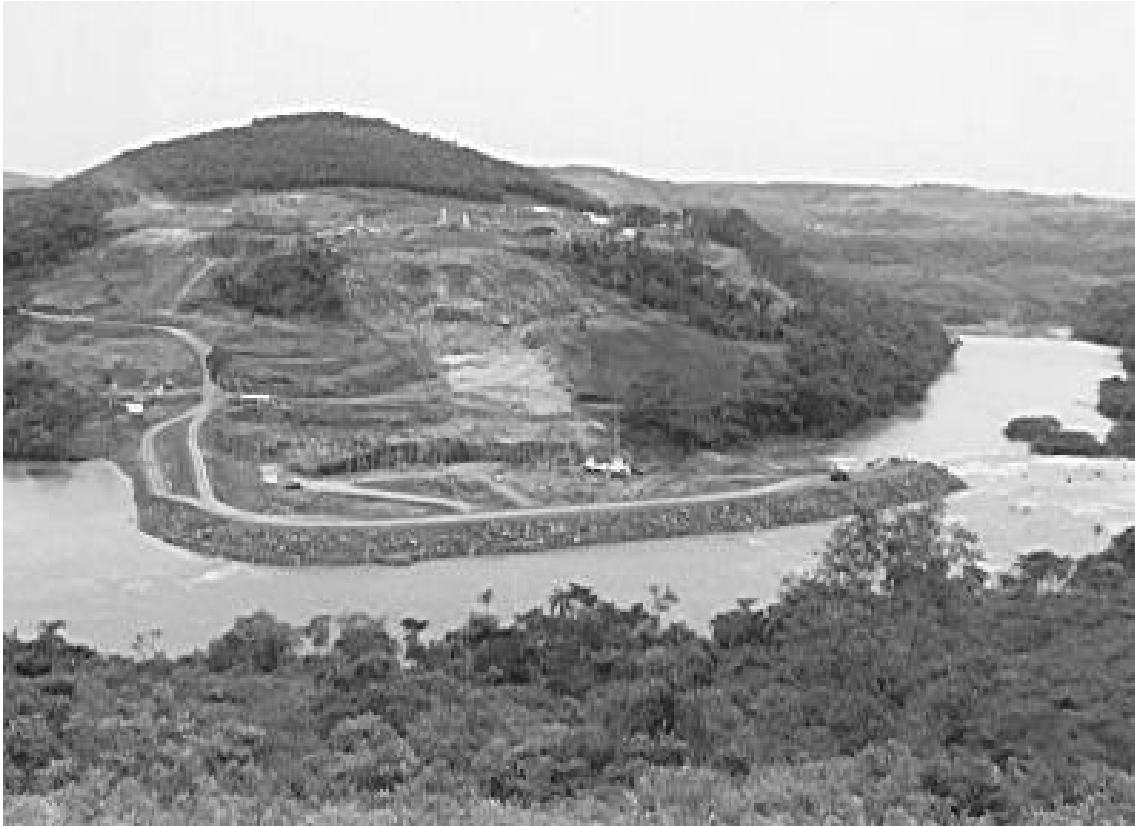
This area had a very irregular surface (see Figures 2 and 3). Loose material, fragments and rock alterations were removed and afterward, water-blast (or sand- blast) clean up under pressure to remove the whole rusted material of the rock surface.

**FIGURE 2- General view of the left margin rock surface**

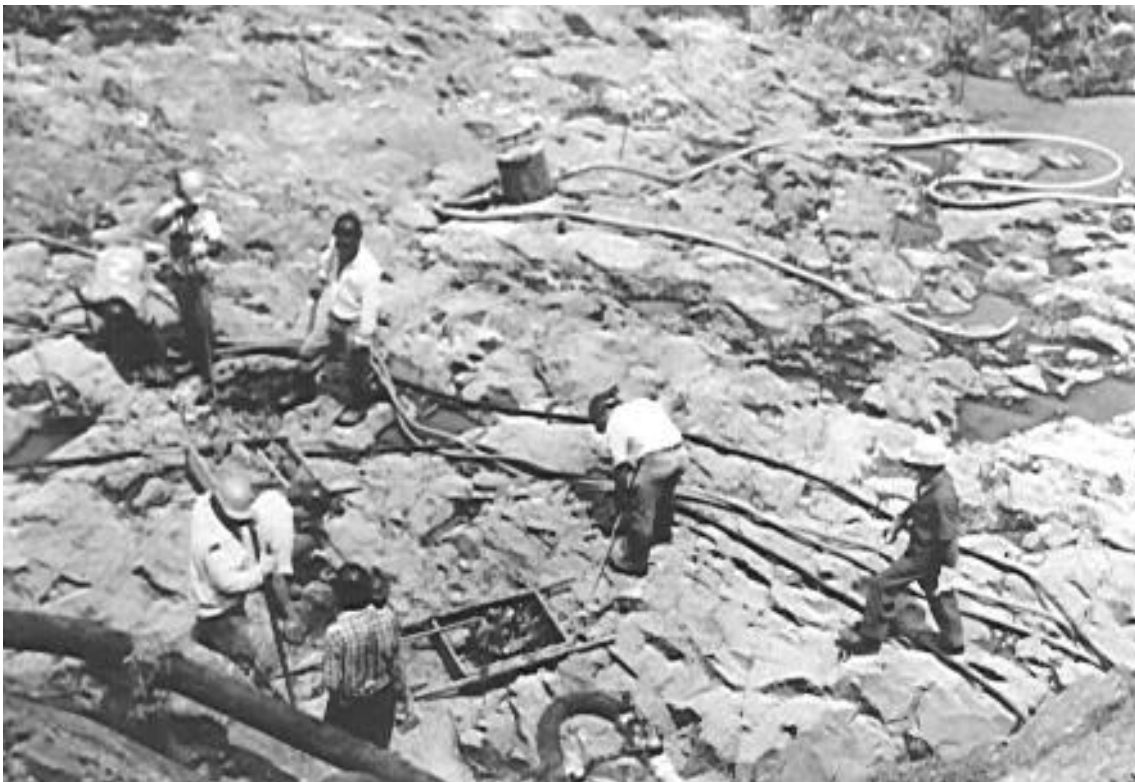
**FIGURE 3- Very Irregular surface at river bed area**

In order to meet the Project requirement that specifies a thin layer of conventional concrete to be applied in the surface contacting the rock, the surface was prepared so as to pack the existing cavities, aiming at an accessible surface to be used by the RCC application equipment.

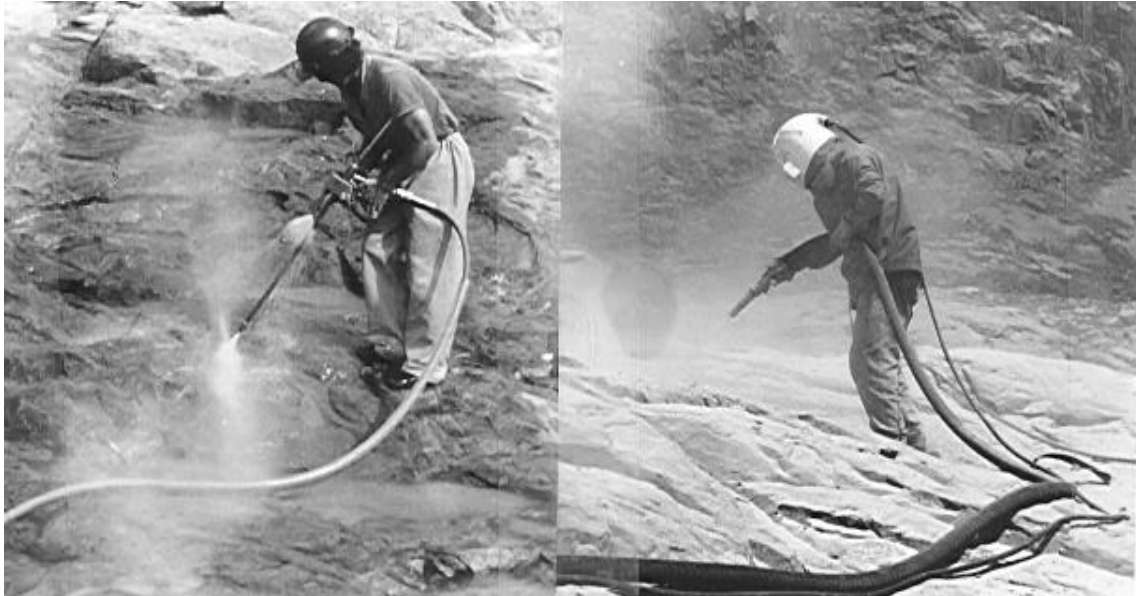
**FIGURE 4- Application of high pressure water-blast (left) or sand-blast( right) to remove the limonite ore**

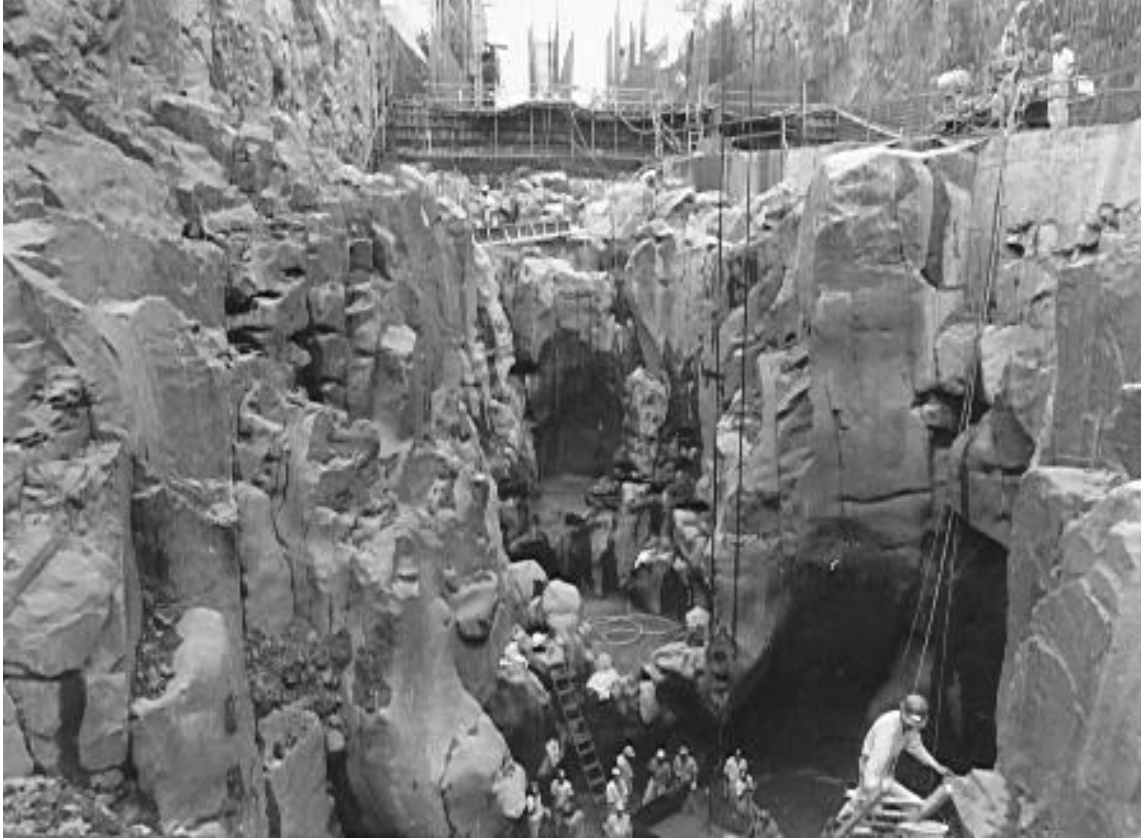
**FIGURE 6- Cavities at the foundation rock right at the downstream Sluiceway**

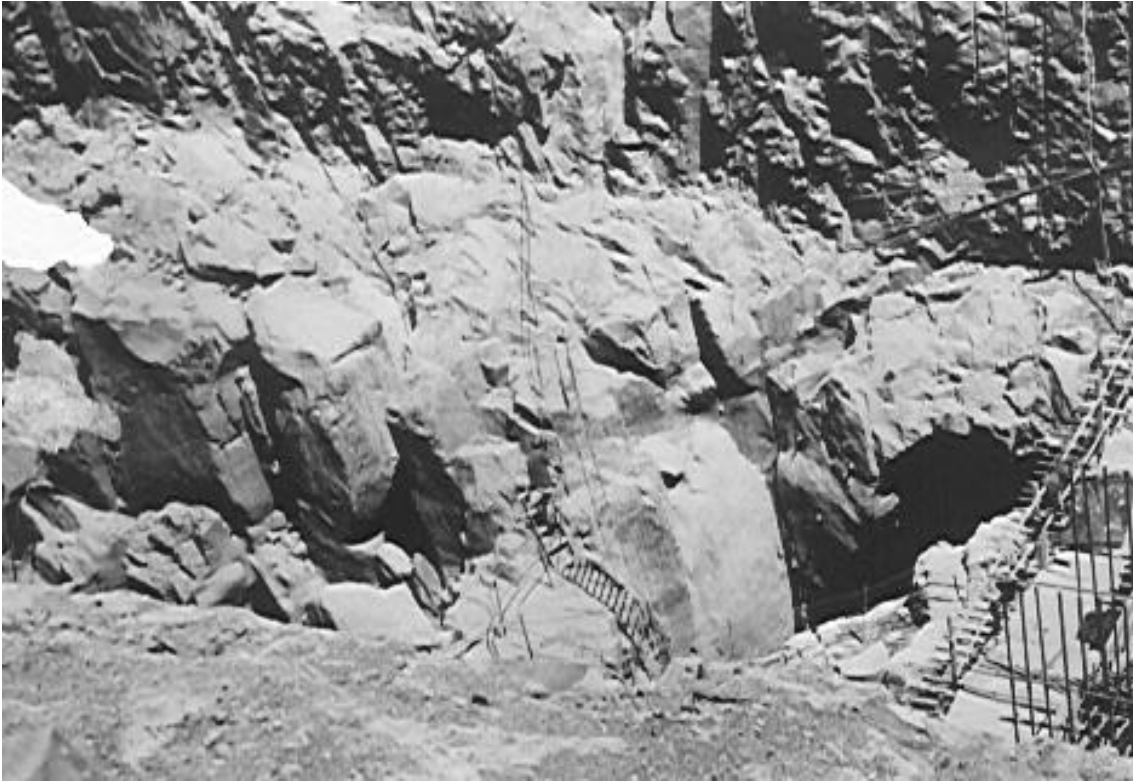
As it may be observed in Figures 7 and 8, the cavities and wells are more evident at the region where the sluiceway was originally supposed to be implemented. Although it has been planned to dislocate approximately 25 m the Dam Axis to the upstream, it has been quite evident the interferences' occurrence, mainly downstream the sluiceway .

**FIGURE 7- General view of cavities preparation downstream the Sluiceway**

To remove the loose material existing in the cavities, it was used a backhoe-excavator (See Figure 7) and a mobile crane, complemented by an intense manual work due to the size and imperfections of the job. These were:

- Removal of blocks and loose rock fragments;
- Removal of gravel, sand and slurry;
- Pressurized water-blast cleaning of the remaining rock surface;
- Concrete placement.

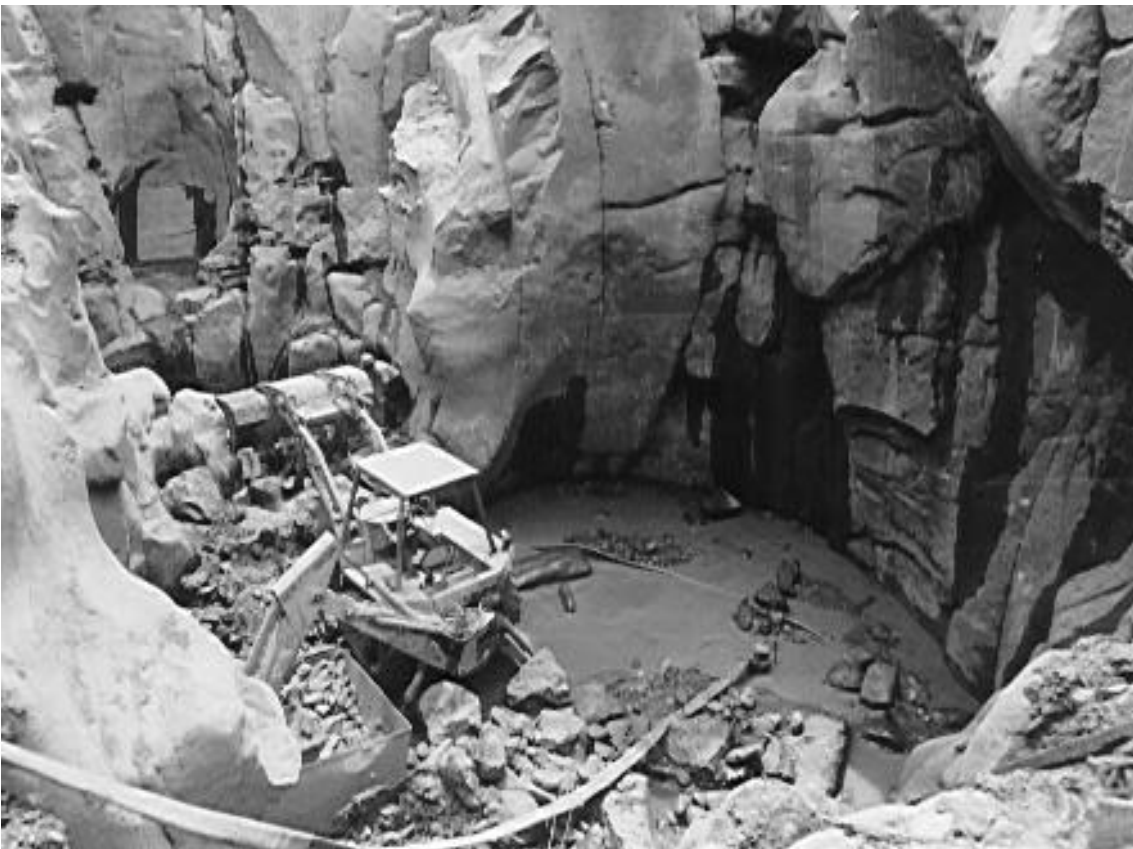
**FIGURE 8- Equipment used for cavities' cleaning**

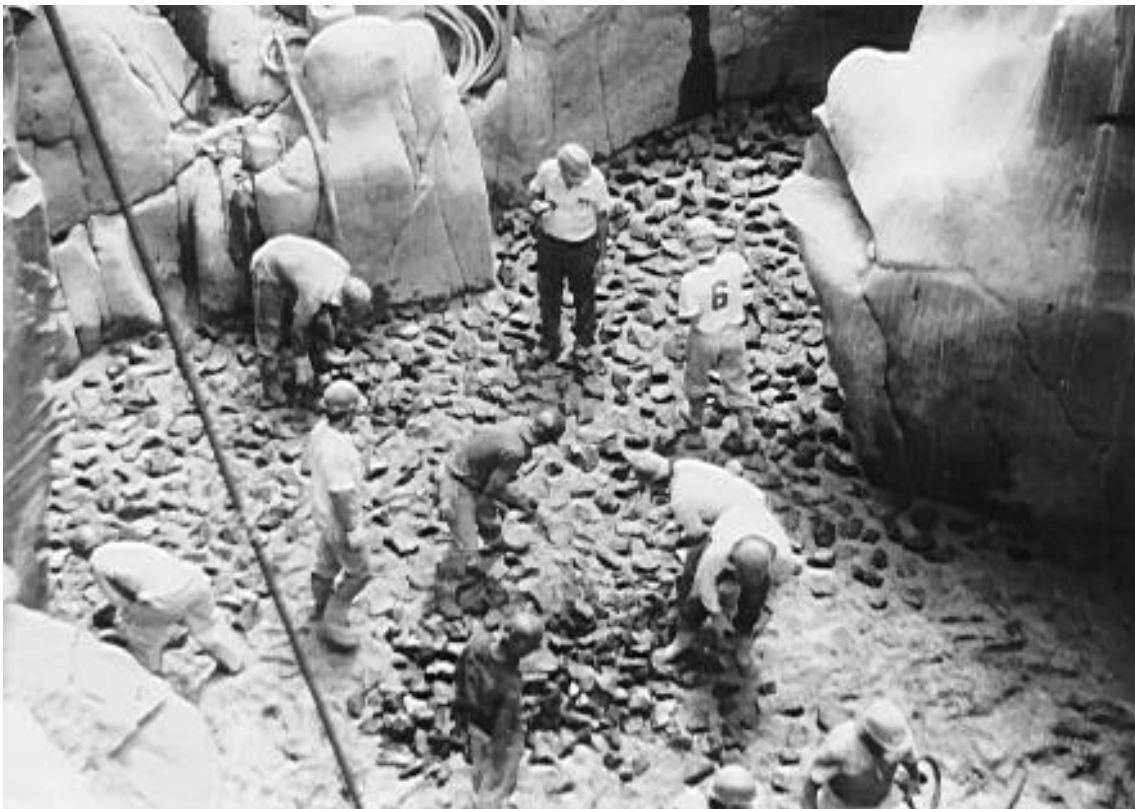
**FIGURA 9- Condition observed during the filling of the cavities near the Sluiceway**

At the time, the RCC production system was not yet implemented (final adjustments and gauging were still missing) and in order to continuously execute the concreting, cyclopean concrete was applied, with the addition of **stones** to the 12.0 Mpa concrete in the equivalent of 8% of the volume mentioned in Figure 5, thus trying to get a reduction in the thermal gradient. The following sequence was adopted:

- Placing of conventional concrete in the entire cavity area (0.15 m layers);
- Placing of the large stones ( @ 10 cm, approximately) over the concrete layer just placed;
- Placing of the subsequent conventional concrete layer.

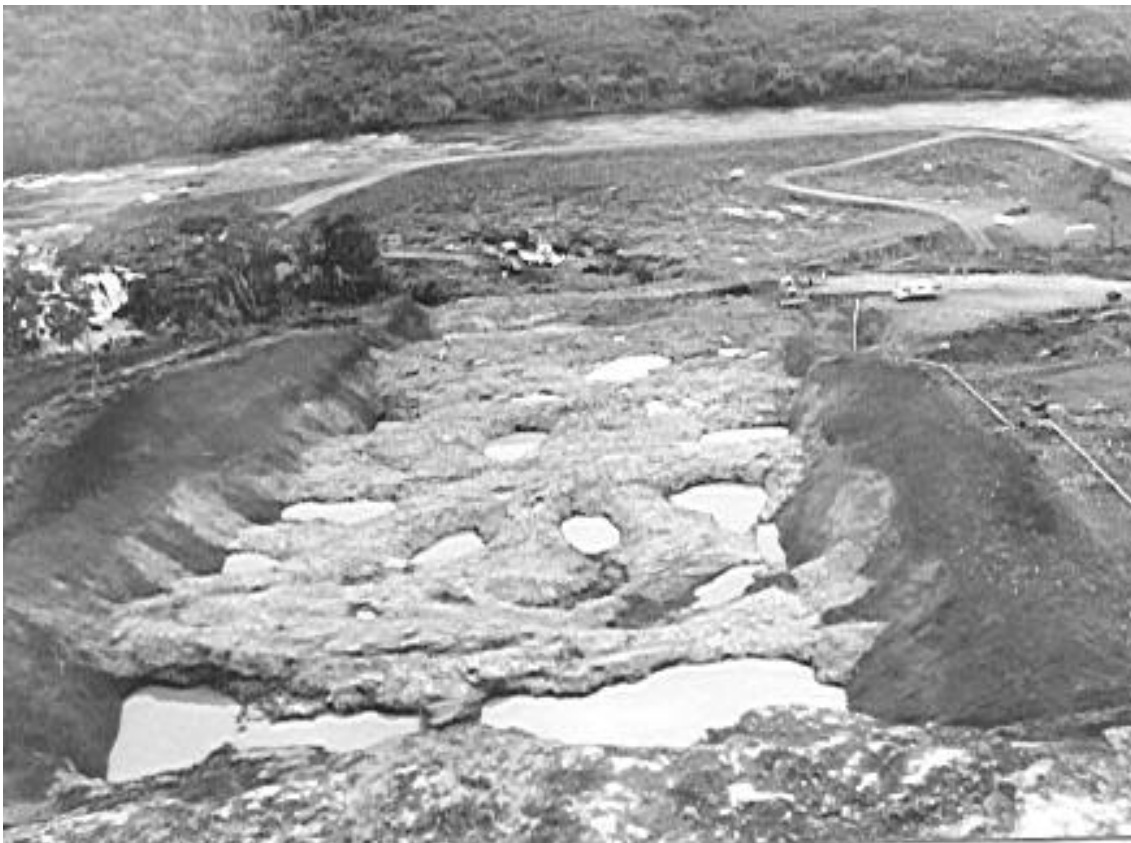
At the Left Abutment the back- filling concrete to the **shallow** cavities that were revealed after the soil excavation in the scoured area, was carried out up to levels that enabled the equipment transit for the RCC execution. The cavities were filled with 12.0 Mpa concrete (Figure 5) according to a chronological plan compatible with the RCC execution sequence.

**FIGURE 10 - View of the irregularities observed at the left abutment**

The preparation of this region was executed as already mentioned in item 4.2. Sand-blast was adopted instead of water-blast to remove the limonite layer existing on the basalt surface. The following productivity parameters were observed during these operations:
