**“CHEMICAL EXPANSION OF CONCRETE IN DAMS  
& HYDRO-ELECTRIC PROJECTS”**

**Expansion Effects of Pyrite in the Rock  
Matrix of the Rio Descoberto Dam**

# RIO DESCOBERTO DAM: WATER SUPPLY SYSTEM FOR BRASÍLIA CITY- BRAZIL- REHABILITATION AND PERFORMANCE [1; 2; 3]

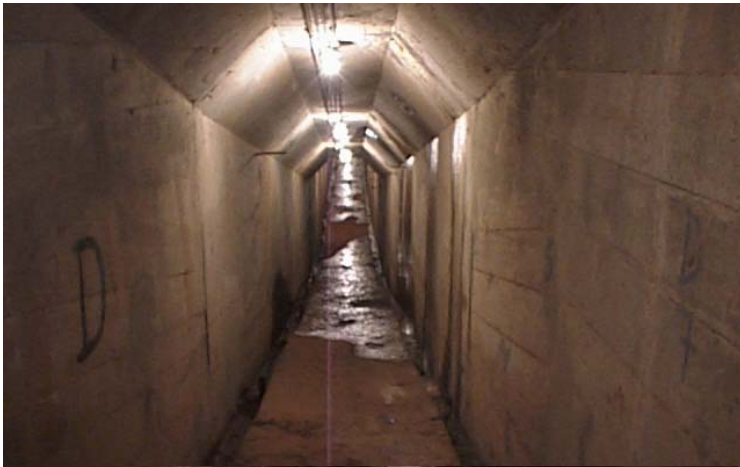
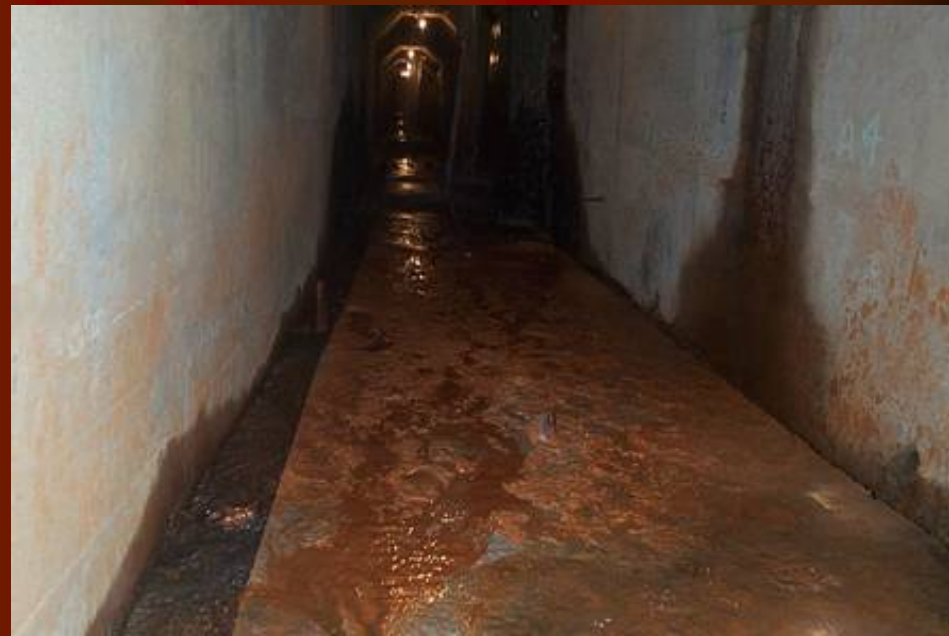
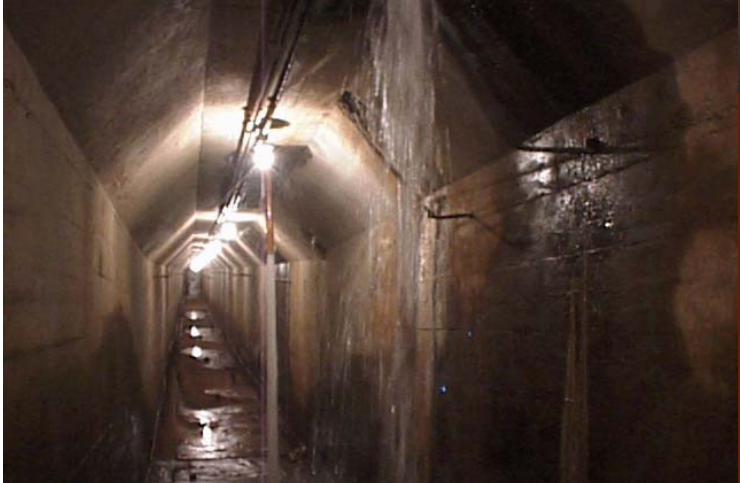
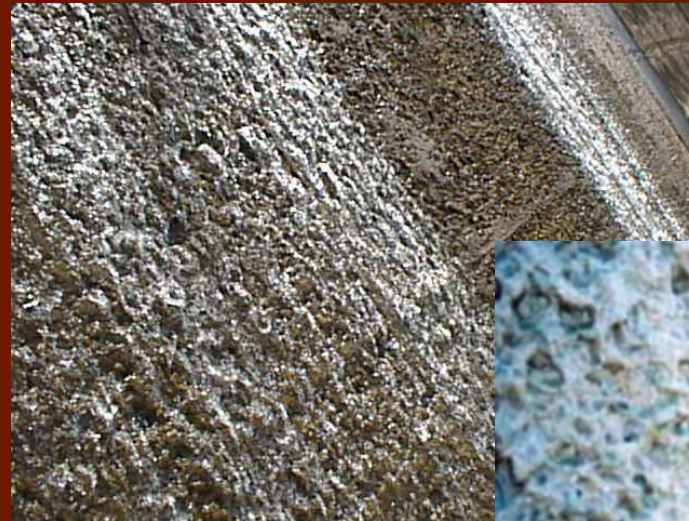
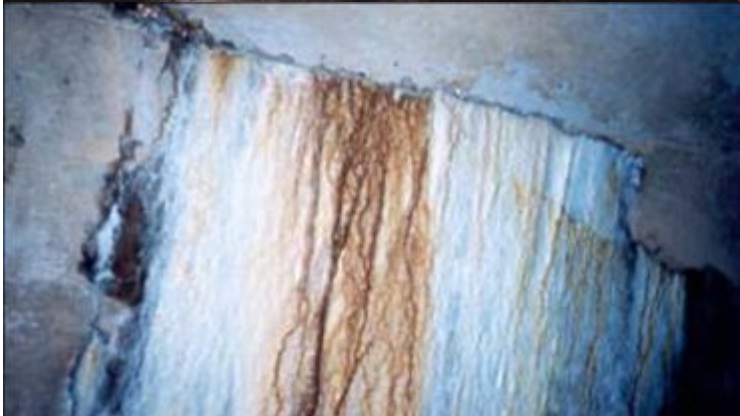
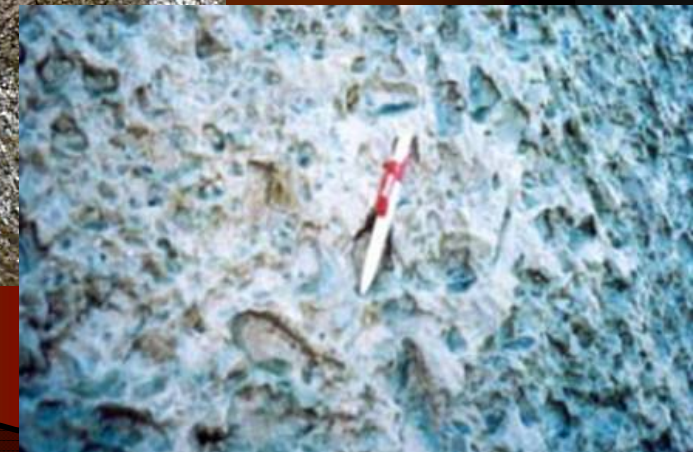
Unfortunately, just three years after the completion of these works, the dam structure was worse than it was before. Right after the completion of these works dam appearance was satisfactory, without leakages at the downstream face and only some weak moisture spots could be observed at the upstream inspection gallery's walls. The inspection gallery was satisfactory and the foundation drains of the dam were operating well.

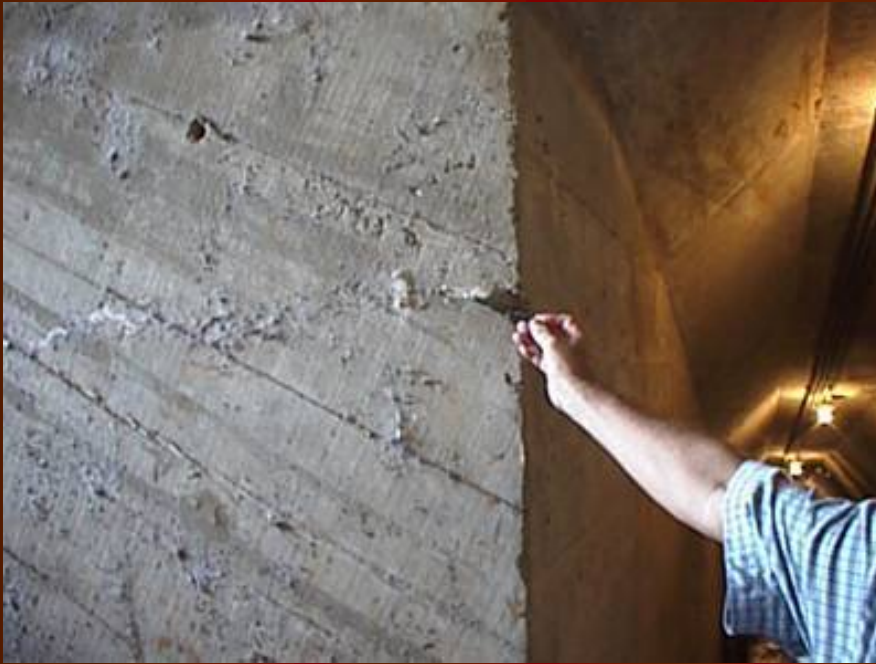
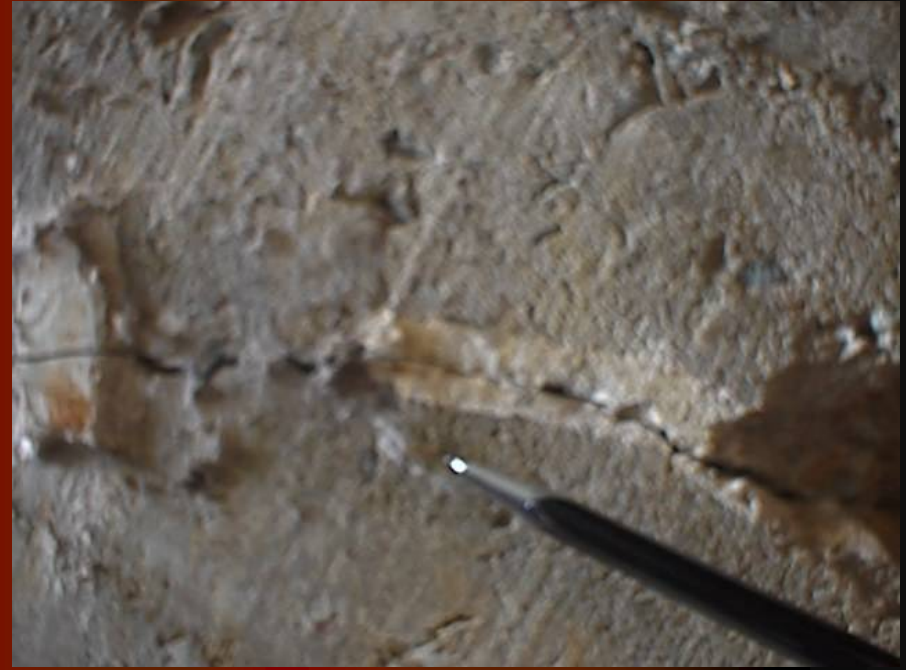
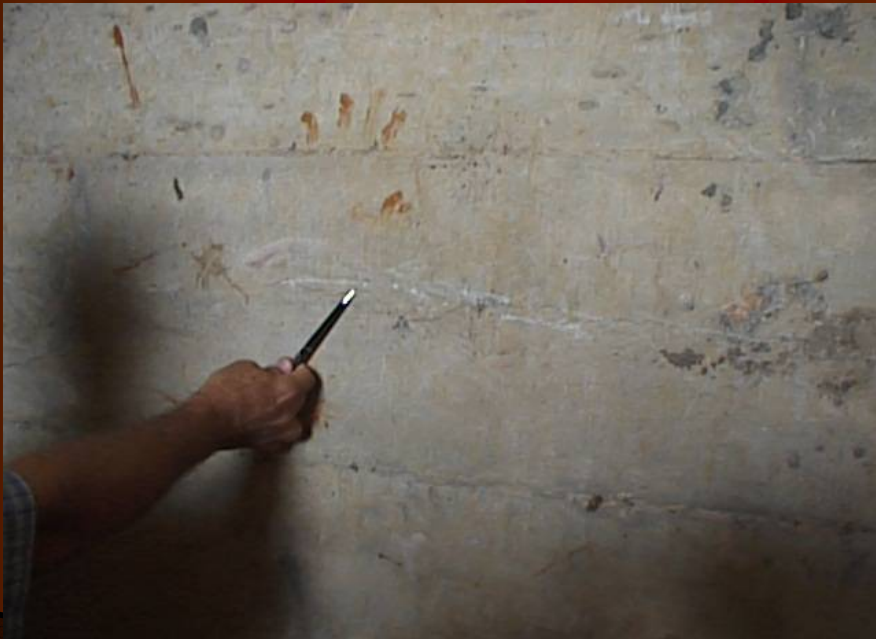
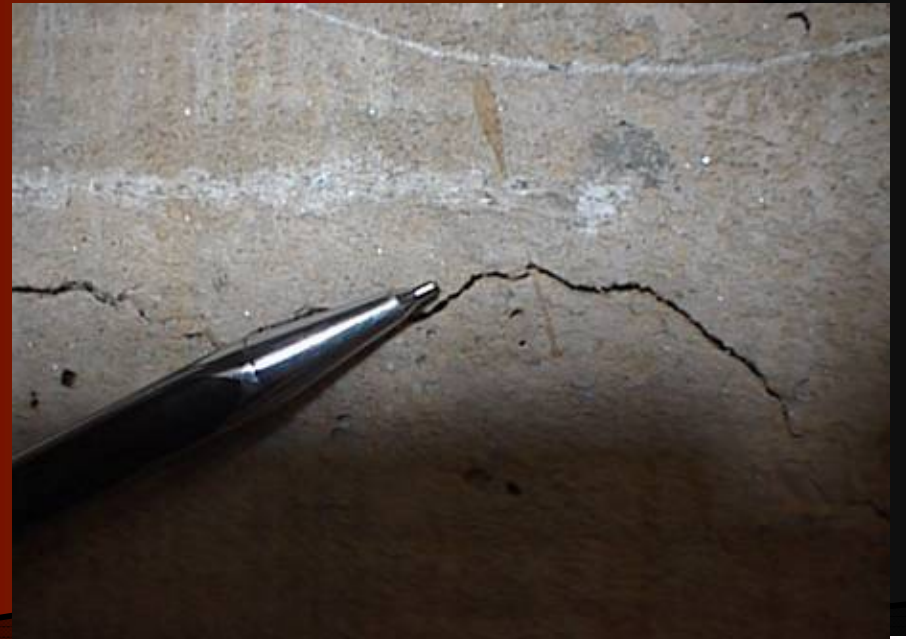
In 1993 the Descoberto Dam was presenting serious problems. Moreover than the leaching horizontal planes at the downstream “E”, “I”, “G” and “O” block’s face with significant flow, the fissure problem had also increased. At the leaching blocks, new percolating horizontal planes raised. The inspection gallery was flooded and full of carted material from the rock bottom drains.

The analyses indicated [04, 05] the presence of **pyrite** in the concrete aggregate and foundations. The combination of the presence of that mineral with the action of acidic (pure) water, was contributing to the degeneration of the concrete structure of the Descoberto Dam. The main pathologies observed were pyrite reactions [02, 04 to 10].

The adequate solution was to implant a **waterproof barrier, avoiding the contact between the reservoir water and the body of the dam.**

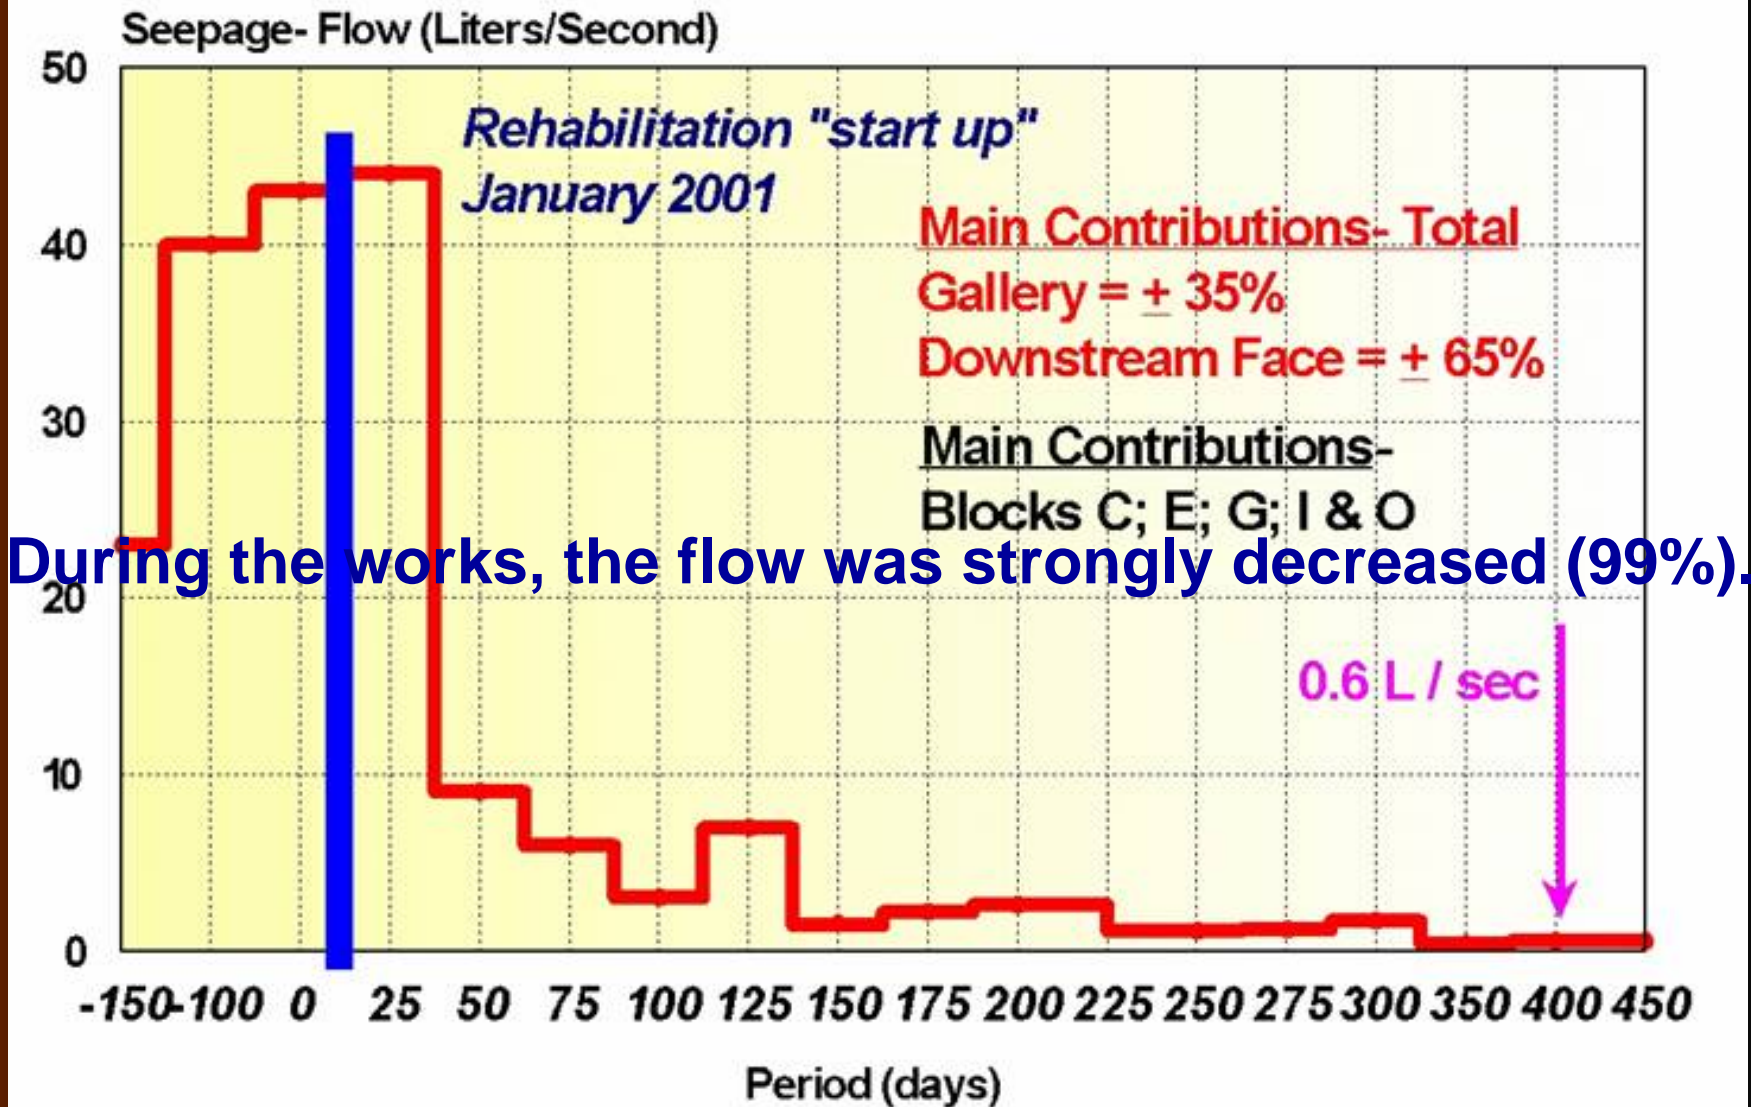
Water Seepage (liters/sec)= Gallery + Downstream Face

Since the beginning of the works, the downstream face and inspection gallery water loss flows were controlled.
