**RIO DISCOBERTO DAM:  
WATER SUPPLY SYSTEM FOR BRASÍLIA CITY-  
BRAZILREHABILITATION AND PERFORMANCE**

-----  
CONGRESS DES  
GRANDS BARRAGES  
MONTREAL, 2003  
-----

## RIO DESCOBERTO DAM: WATER SUPPLY SYSTEM FOR BRASÍLIA CITY- BRAZIL- REHABILITATION AND PERFORMANCE ( )

**Antônio Manoel SOARES      Mércio VIANA**  
Civil Engineers, CAESB- Cia. de Saneamento do Distrito Federal S/A

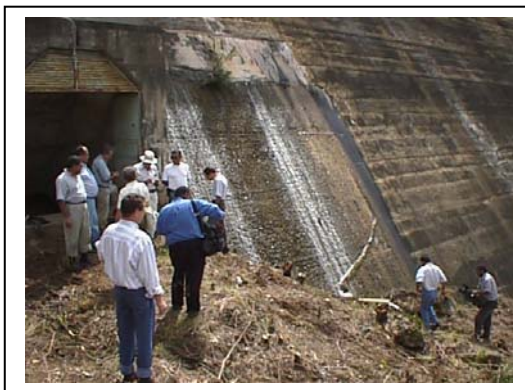
In 1993 the Descoberto Dam was presenting serious problems. Moreover than the leaching horizontal planes at the downstream "E", "I", "G" and "O" block's face with significant flow, the fissure problem had also increased. At the leaching blocks, new percolating horizontal planes raised. The inspection tunnel was flooded and full of carted material from the rock bottom drains.

**Figure 04- Downstream face of “O” concrete block showing a great leakage**

*Image 04- Parement aval, face du bloc en béton “O” montrant une grande fuite*

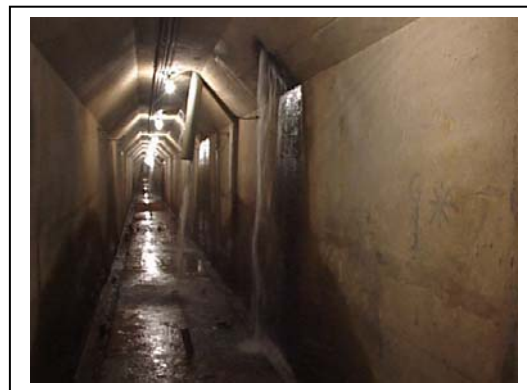
**Figure 05- Internal part of the gallery showing the water flow**

*Image 05- Côté interne de la galerie montrant le débit d'eau*

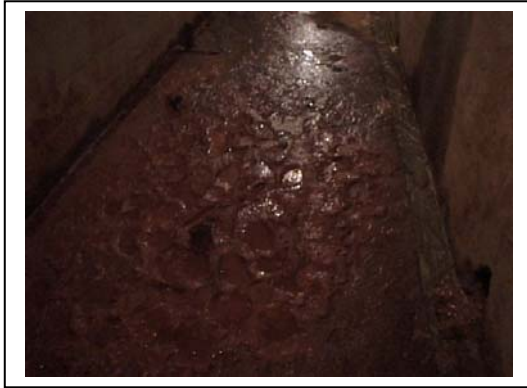
**Figure 06- Brown material in the gallery floor**

***Image 06- Matériel marron par terre dans la galerie***

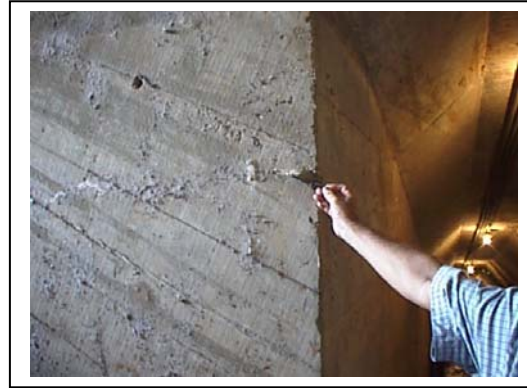
**Figure 07- Internal crack in the downstream zone of the gallery flow**

***Image 07- Fissure interne sur le parement aval du débit de la galerie***

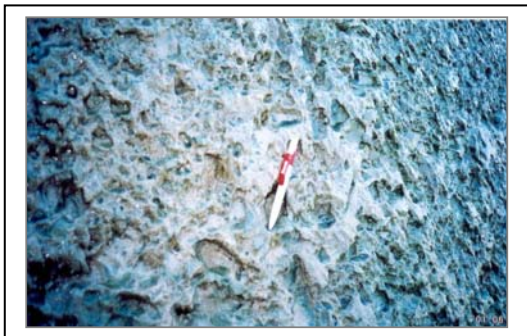
The analyses indicated <sup>[04, 05]</sup> the presence of pyrite in the concrete aggregate and foundations. The combination of the presence of that mineral with the action of acidic (pure) water, was contributing to the degeneration of the concrete structure of the Descoberto Dam. The main pathologies observed were pyrite reactions <sup>[02, 04 to 10]</sup>.

**Figure 08- Downstream face of "O" concrete block damaged by aggregate reaction**

***Image 08- Parement aval, face du bloc en béton "O" endommagé par réaction du granulat***

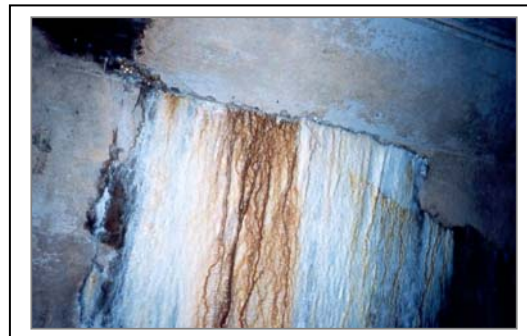
**Figure 09- Aggregate reaction at the upstream face of the gallery**

***Image 09- Réaction du granulat sur le parement amont de la galerie***

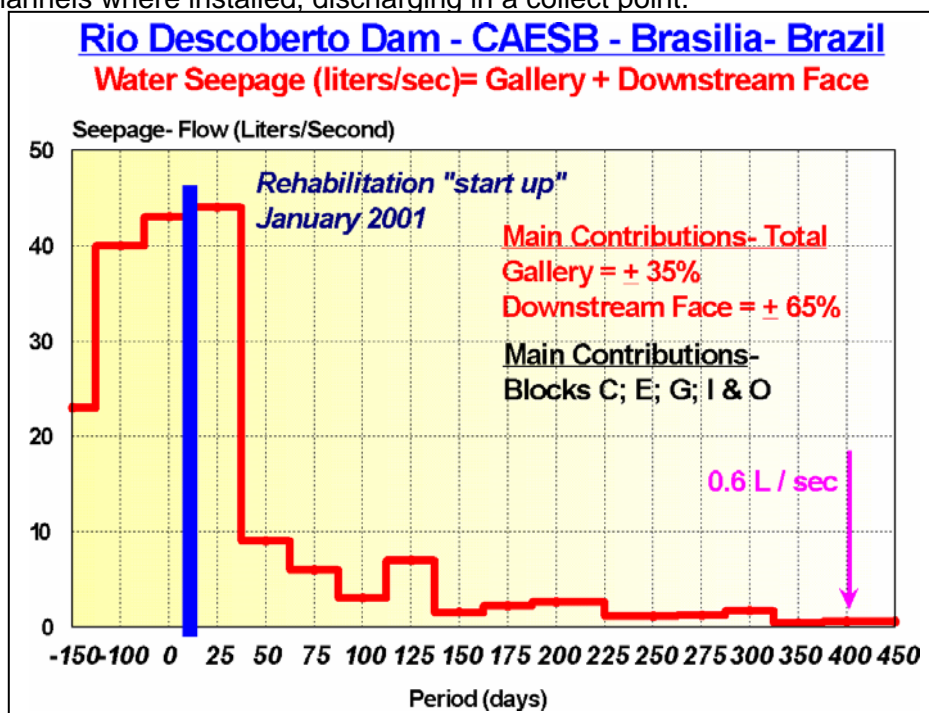
Figure 19- Water seepage control during the remedial works

At the inspection tunnel the flow measurement was made straight into the upstream pressure relief drains. The measurement was made by graduated containers and chronometers. During the job, the flow was strongly decreased (99%).

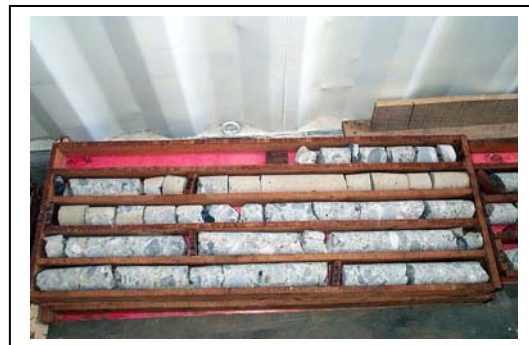
<b>Property</b>	<b>Mortar (diaphragm)</b>	<b>Interface Concrete (dam)- Mortar (diaphragm)</b>	<b>Concrete (dam)</b>
Absorption (%)	1.22		
Specific Weight (t/m <sup>3</sup> )	1.97 – 2.08		2.52
Permeability (m/s)	$10^{-11}$ – $10^{-10}$		
Compressive Strength (MPa)	12.7 – 31.1		25.7
Splitting Tensile Strength (MPa)	1.87	1.14	4.51
Direct Tensile Strength (MPa)	1.07 – 1.80		2.32
Shear Strength (MPa) under Normal Pressure: 2.0 MPa	2.77 – 5.57	2.05 – 3.77	5.03 – 5.14
Shear Strength (MPa) under Normal Pressure: 4.0 MPa	3.92 – 6.63	3.10 – 3.66	6.43 – 6.76
Shear Strength (MPa) under Normal Pressure: 6.0 MPa	5.57 – 8.38	4.50 – 6.10	12.42

**Figure 22- Drilled cores from diaphragm mortar, interface, and from the old concrete from the dam**
