# ROLLER COMPACTED CONCRETE DAMS

Proceedings of the International Symposium held in Santander, Spain, on 2 - 4 October 1995

# **JORDÃO RIVER DERIVATION DAM - FOUNDATION CONDITIONS FOR PLACING THE RCC**

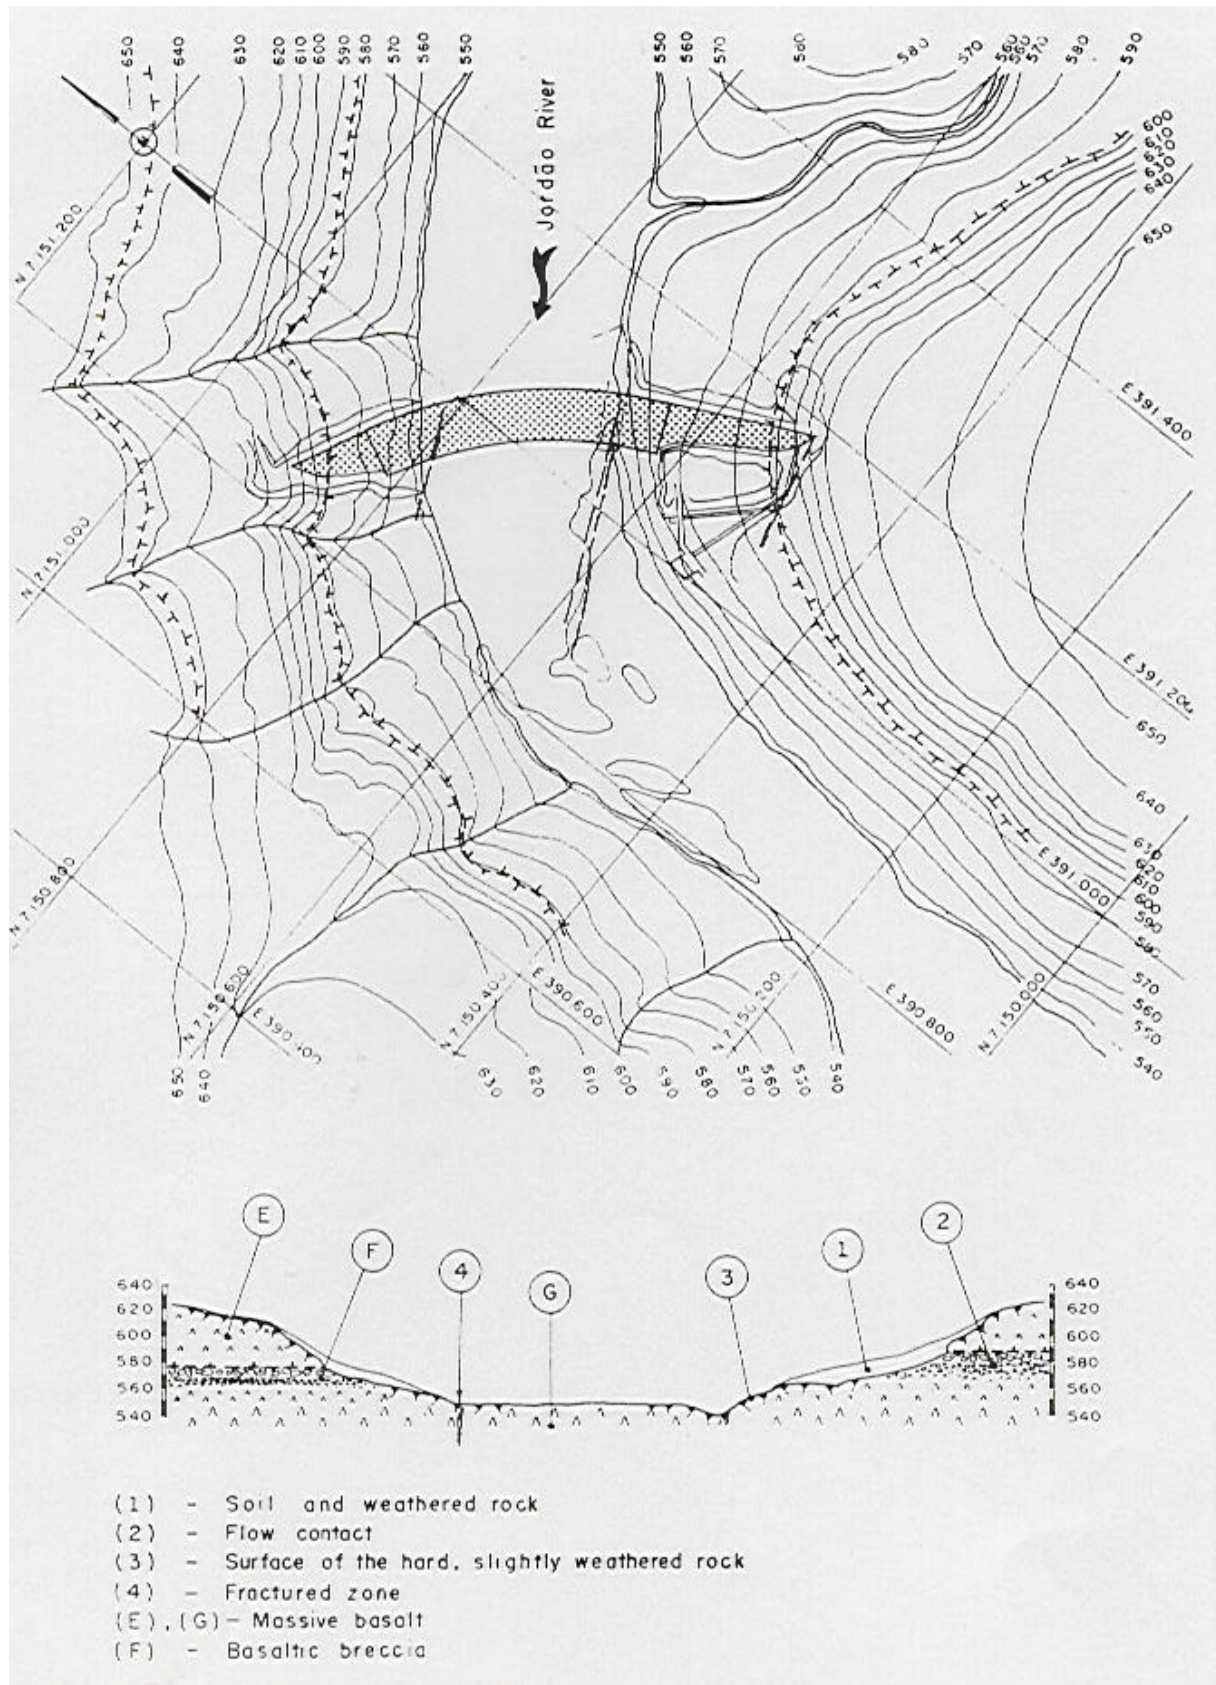
FIGURE 1 - Plan and basic geology section;

At the Dam Site, as shown in Figure 1, there is a basalt flow outburst called **GF** and identified in the region by a thickness above average and also because it can be divided into two zones, "**G**" and "**F**". The first a massive basalt of about 70-80 m and the second, an upper Basalt Breccia of about 7-20 m.

- Depressions at the Breccia zone, due to its most prominent alteration as regards the Basalt, causing cleaning difficulties;
- The abutment rock surface is made up of practically fresh material, recovered in certain zones by a yellowish limonitic layer;
- In the River bed, below the water fall, deep depressions were identified, caused by a wearing process of rock against rock forming gravel and round wells;

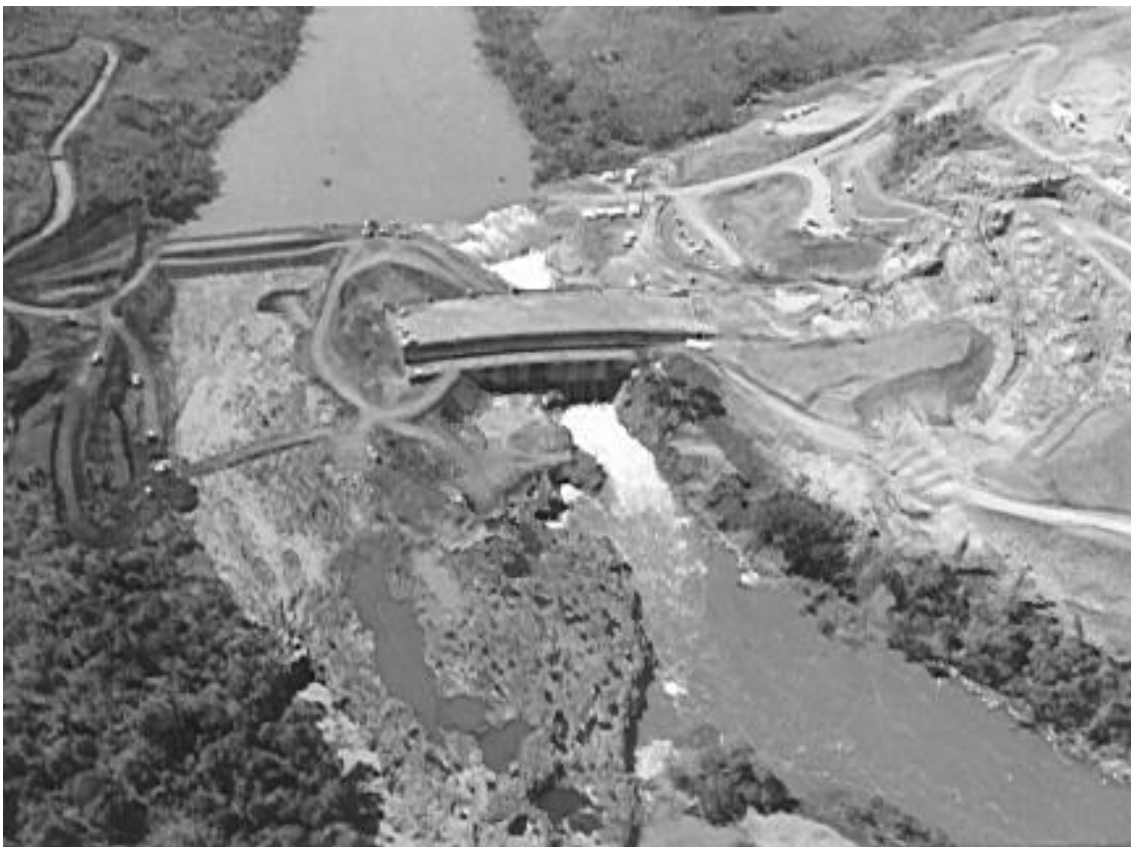
**FIGURE 11- Aerial View of Dam construction by April/1995**
