**“CHEMICAL EXPANSION OF CONCRETE IN DAMS  
& HYDRO-ELECTRIC PROJECTS”**

**Expansion Effects of Pyrite in the Rock  
Matrix of the Rio Descoberto Dam**

# RIO DESCOBERTO DAM: WATER SUPPLY SYSTEM FOR BRASÍLIA CITY- BRAZIL- REHABILITATION AND PERFORMANCE [1; 2; 3]

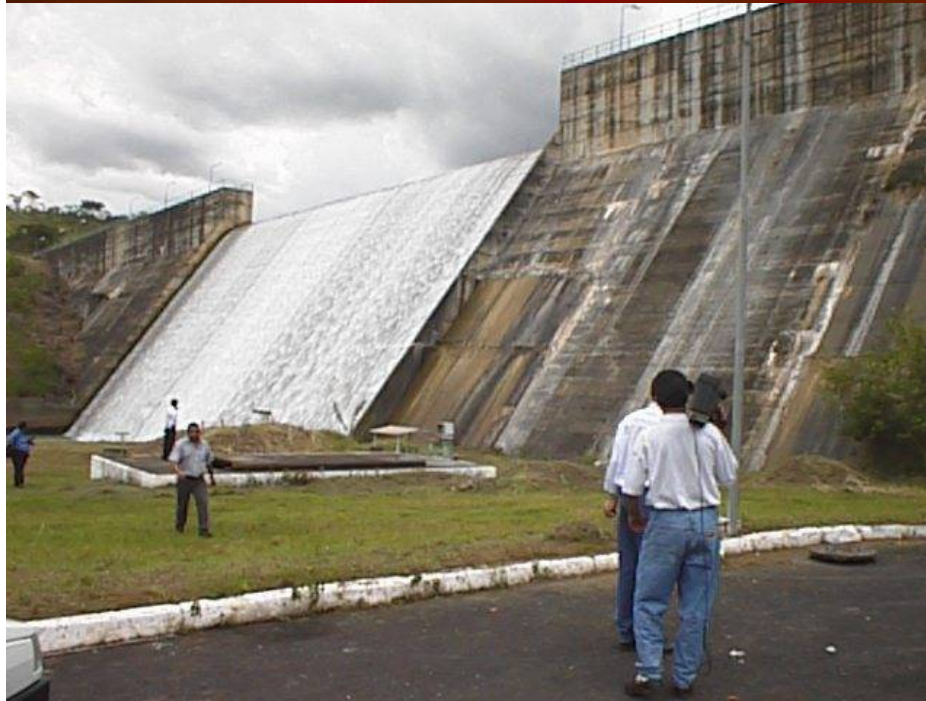
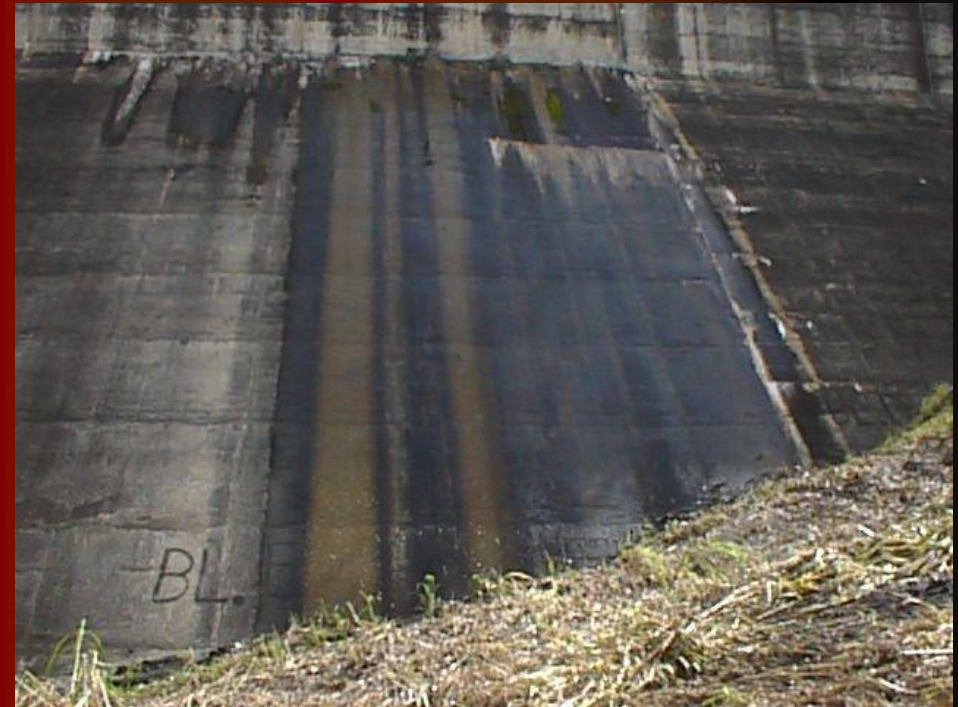
Unfortunately, just three years after the completion of these works, the dam structure was worse than it was before. Right after the completion of these works dam appearance was satisfactory, without leakages at the downstream face and only some weak moisture spots could be observed at the upstream inspection gallery's walls. The inspection gallery was satisfactory and the foundation drains of the dam were operating well.

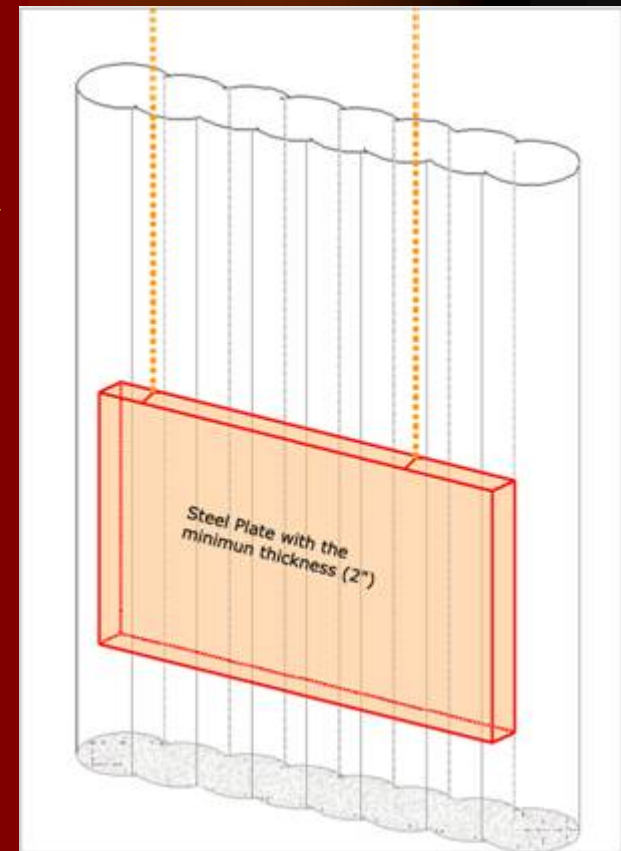
The continuity of the diaphragm panels was controlled by mechanical testing and underwater VHS video system. The mechanical test was made by letting down a steel plate with the minimum diaphragm thickness allowed. In case of persistence of doubt after the mechanical test, the VHS underwater camera was used to inspect the suspect drive. This video system was also used to check and register the contact between different drives
