**RIO DISCOBERTO DAM:  
WATER SUPPLY SYSTEM FOR BRASÍLIA CITY-  
BRAZILREHABILITATION AND PERFORMANCE**

-----  
CONGRESS DES  
GRANDS BARRAGES  
MONTREAL, 2003  
-----

## RIO DESCOBERTO DAM: WATER SUPPLY SYSTEM FOR BRASÍLIA CITY- BRAZIL- REHABILITATION AND PERFORMANCE ( )

**Antônio Manoel SOARES      Mércio VIANA**  
Civil Engineers, CAESB- Cia. de Saneamento do Distrito Federal S/A

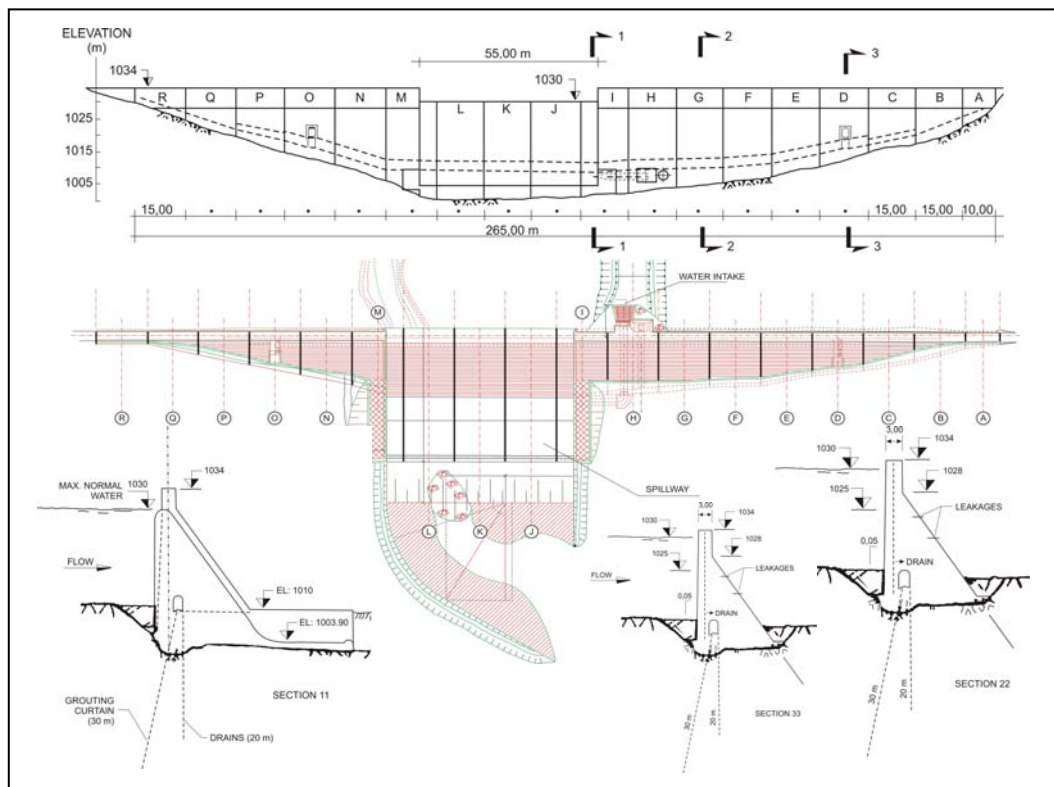
Figure 02- Dam plant, upstream view and sections  
**Image 02- Plan du barrage, vue de l'amont et sections**

Few years after filling the reservoir, leakages started to be observed at the downstream block "I" face. At the end of the 70's decade some wide fissures started to be observed too. From that time, until the performance of this project in 2000, the water leakage increased strongly, becoming into long horizontal leaching planes across the dam section.

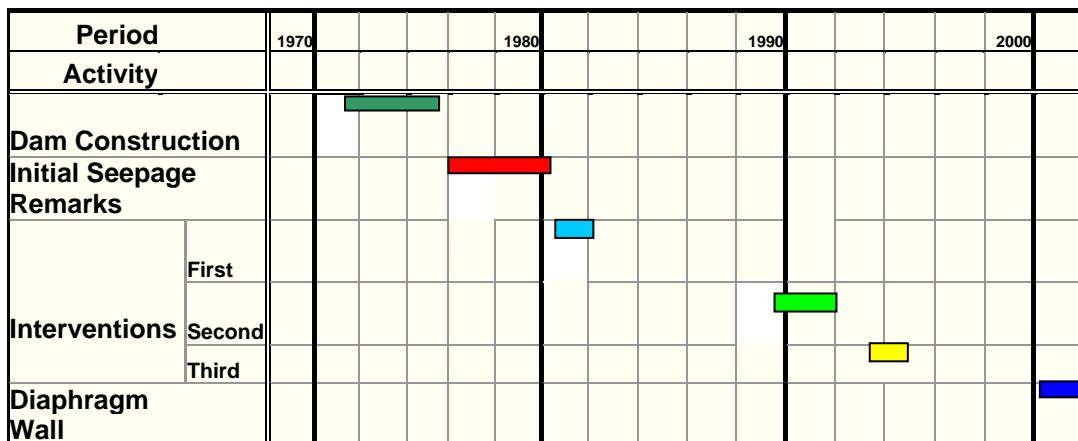
**Figure 03- Chronology of the interventions**

Since the mid 70's decade leakages were observed at the "I" block's downstream face. In 1981, as usual in leakage dam treatment method, the first

intervention was performed. The solution was based in epoxy injections applied from the downstream face

Between 1989 October and 1990 July, the second intervention was performed. The works were guided by a preliminary diagnosis report made in 1988. This report indicated concreting joints failures as the origin of the problem. These works consisted in the combination of grout injection filling at the upstream face with internal drainage holes near the downstream face.

In 1993 the Descoberto Dam was presenting serious problems. Moreover than the leaching horizontal planes at the downstream "E", "I", "G" and "O" block's face with significant flow, the fissure problem had also increased. At the leaching blocks, new percolating horizontal planes raised. The inspection tunnel was flooded and full of carted material from the rock bottom drains.

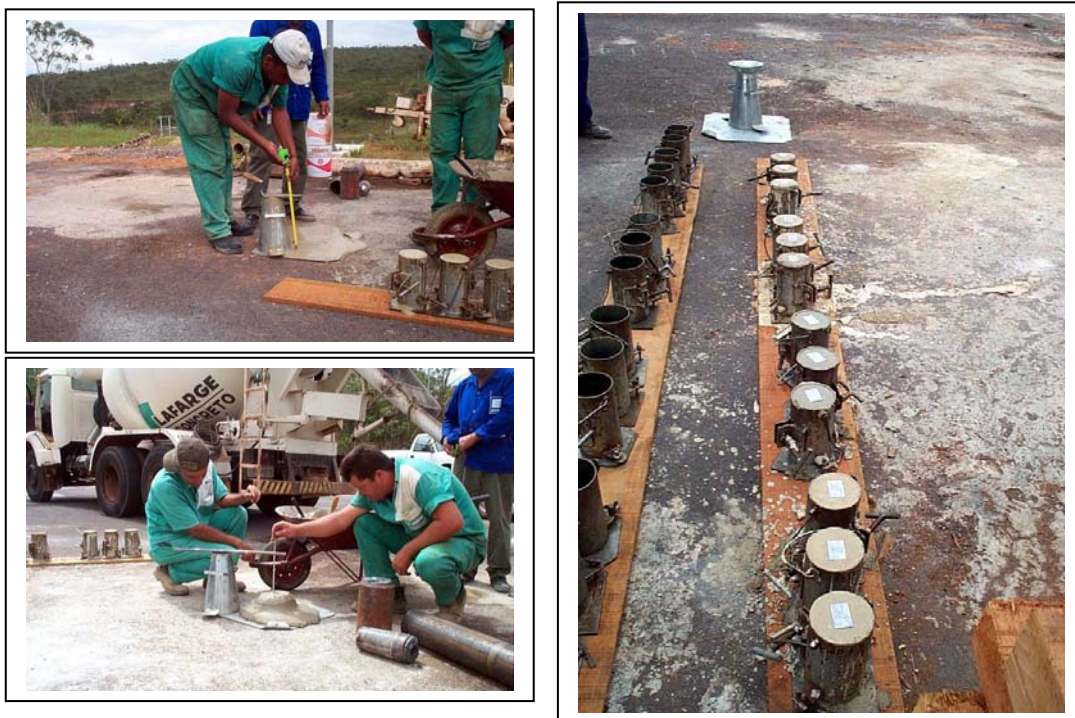
**Figures 20- Control of the mortar used**  
**Images 20- Contrôle du mortier utilisé**

Besides the initial analyses made before starting the works, during the project all the mortar applied was controlled and tested. The controls were made by casting 10 cylindrical specimens at each truck mixer (6m3 capacity). From those ten specimens, four of them were experimented at compressive tests at 4-days age, four were tested at 28-days age and the two remaining were kept tagged with all the data concerning the mortar recorded. The average compressive strength was 27 MPa; 3-days, 7-days, 28-days and 63-days age testing series have also been made.
