Structural analysis and rehabilitation  
of concrete dams and spillways

# **HISTORIC CASES ON CONCRETE DAMS REHABILITATION**

Third International  
Dam World Conference

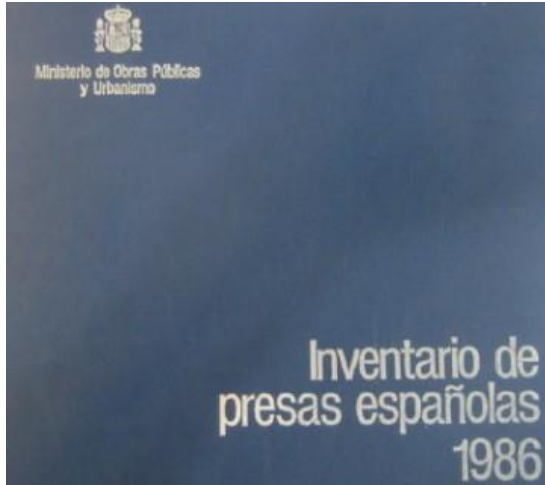
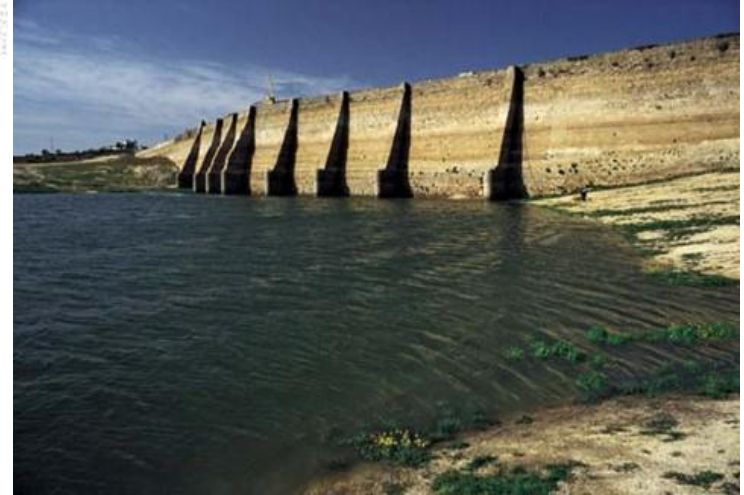
The dam of Proserpina is formed by a masonry wall (the retaining wall) to which an earth embankment is attached downstream.

The **Proserpina Dam**<sup>[01; 02]</sup> is a Roman gravity dam, dating to the 1<sup>st</sup> - 2<sup>nd</sup> centuries, located about 10 km north of Merida, (Badajoz Province-Extremadura, Spain). Is 427 m long, 12 m high and is on top 2,3 m, crest and nine buttresses on the inner side of the dam. It was built as part of the infrastructure, which supplied the city of Emerita Augusta (Mérida) with water.

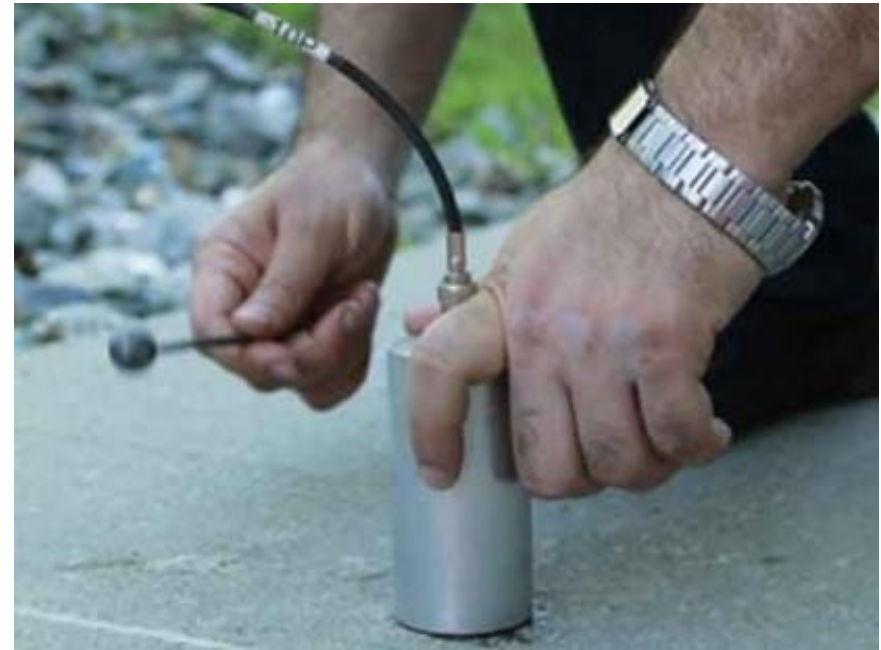
Impact-Echo can be used to investigate the condition of concrete and extent of cracking in concrete. The pulse spreads into the test object and is reflected by cracks, flaws or interfaces, and boundaries. When stress waves travel within the concrete element, a part of emitted acoustic waves by the stress pulse on the surface is reflected over the boundary layers, where different the material stiffness changes.

The data received by the transducer is normally analyzed in the frequency domain to measure the wave speed and the thickness. Impact-Echo has the advantage of requiring access to only one side of the component. The method can be used to identify freeze and thaw defects in concrete surfaces.

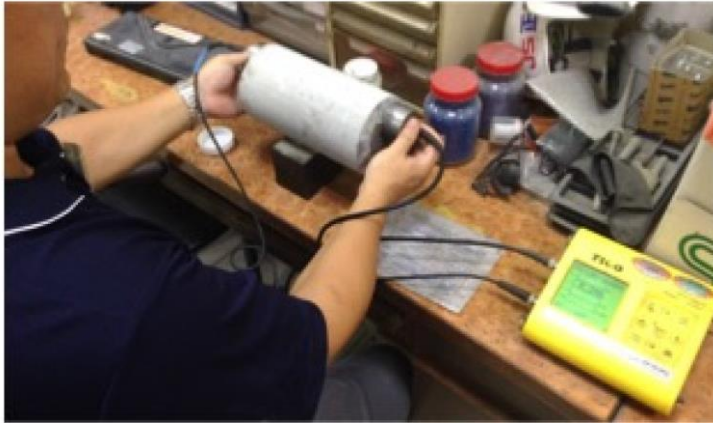
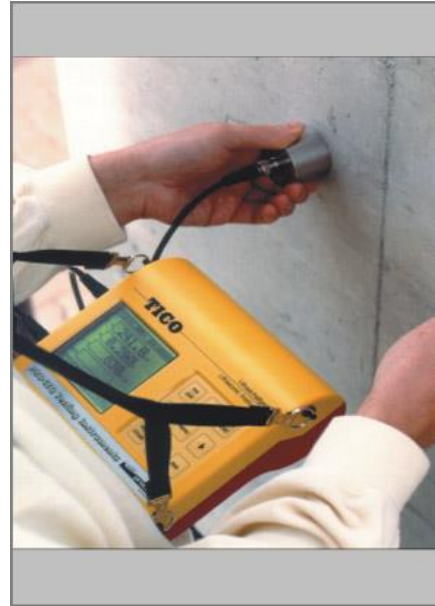
The most practical form of the **UPV** measurement in concrete structures is the seismic tomography. When access is possible, **UPV** tomography can be used to evaluate sub-surface deficiencies such as voids, and cracks.

Ultrasonic is applicable for concrete inspection allowing imaging of the internal structure of objects from concrete, reinforced concrete and stone work. The operation applies pulse-echo technique at one-side access to the object.

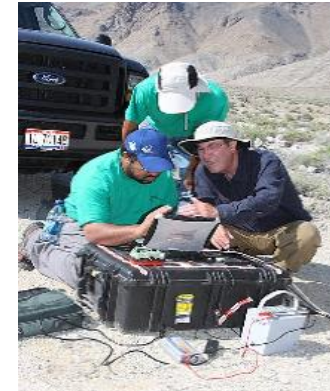
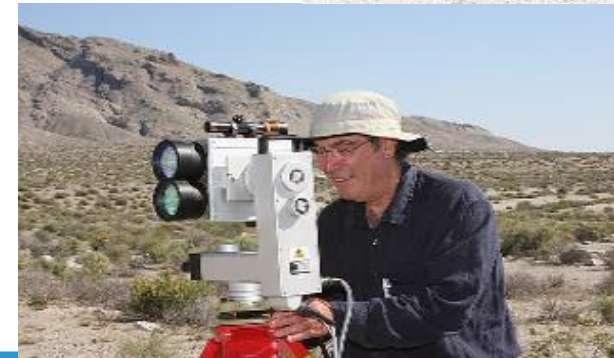
## Terrestrial Laser Scanners (TLS)

- It is similar to Sonar and Radar but uses Light (Light Detection and Ranging);
- Transmits a pulse of light and records the returned pulse of light –records time, divides by two, and multiplies by the speed of light for distance;
- Able to record thousands of points a second recording target position (X,Y,Z), intensity, and color (**RGB**);

Capable of relative positioning at mm to cm accuracy.

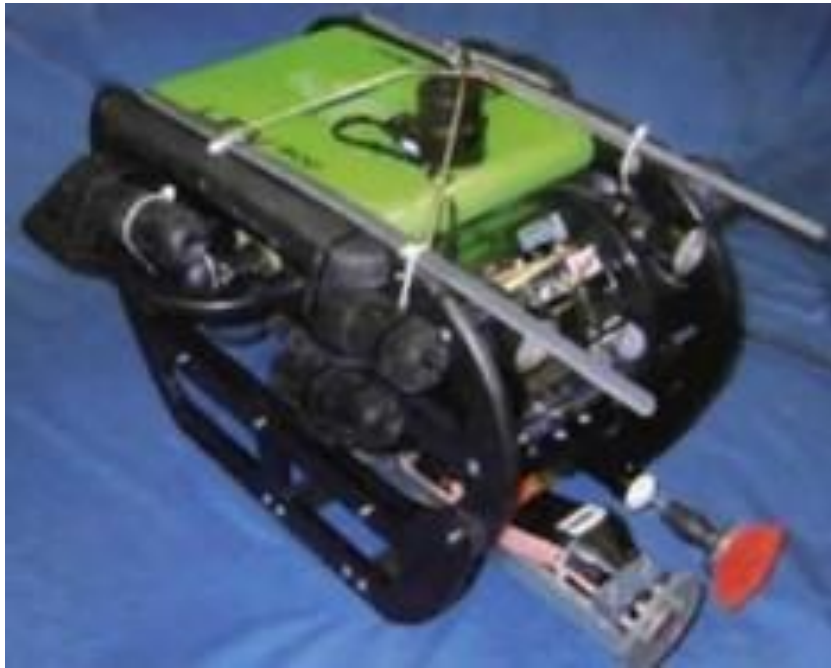
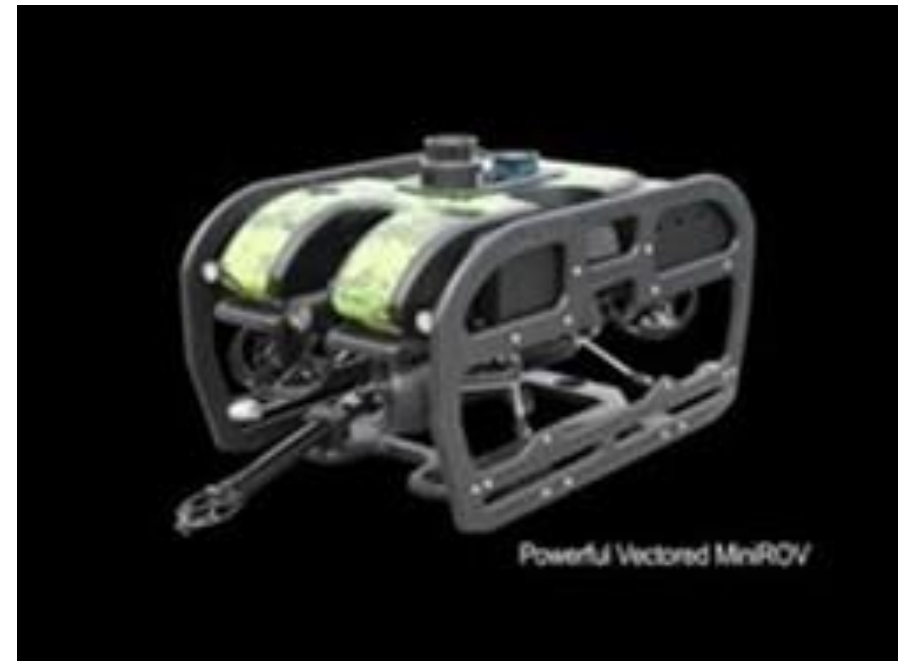
## Remotely Operated Vehicles (ROVs)

The **ROVs** are dedicated to a number of inspection projects with severely restricted access requiring a more compact and portable system. The entire system is packaged in shock mount and padded cases, which are easily transported.

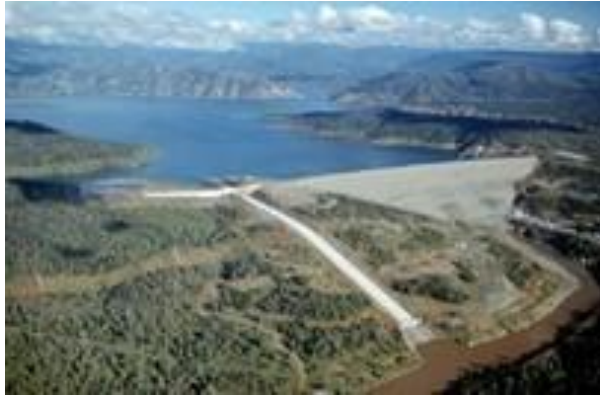
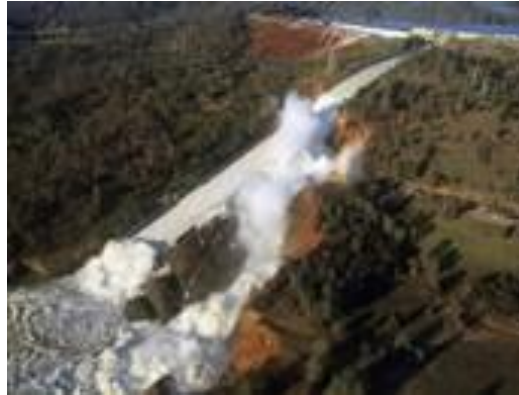
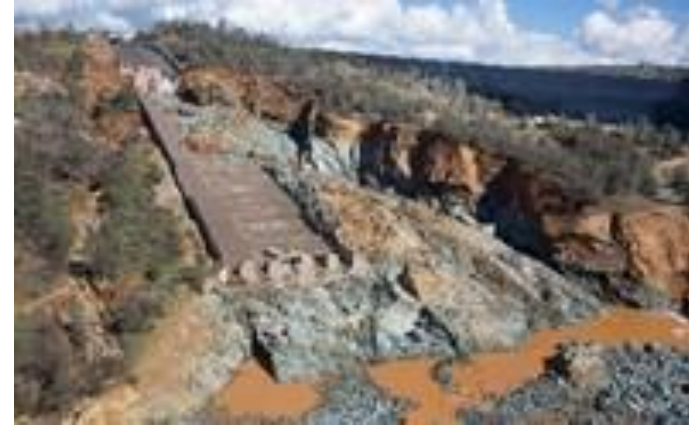
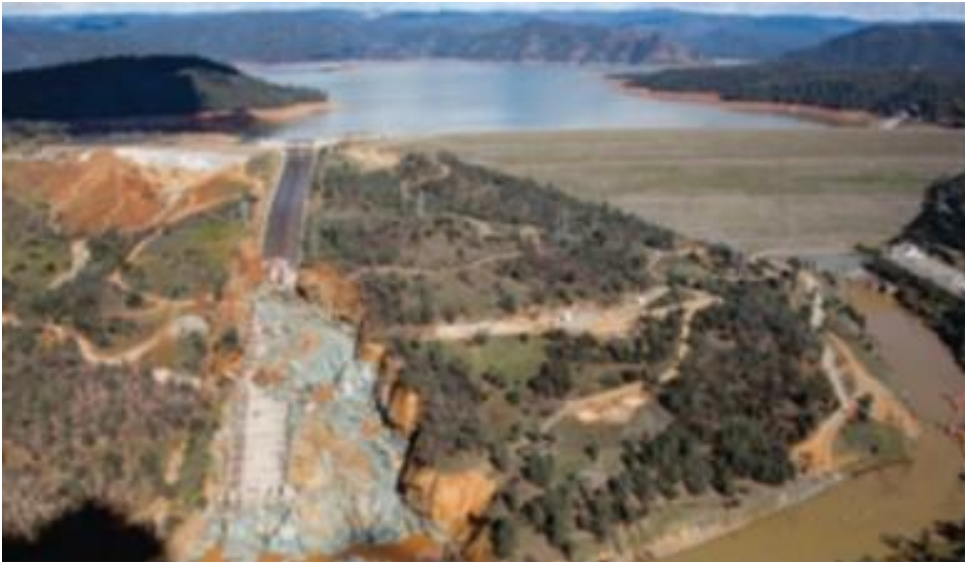
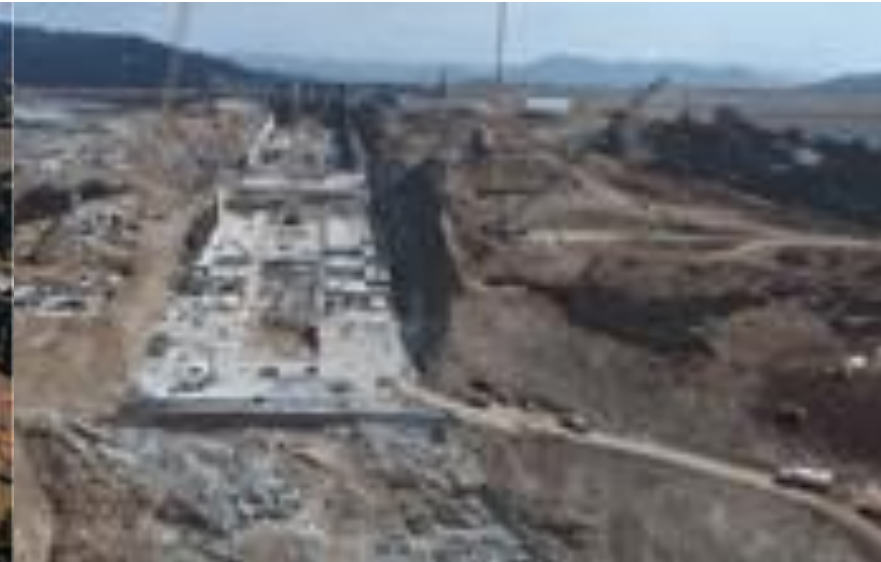
| CASE | IDENTIFICATION | COUNTRY | FINISHED | REHABILITATION<br>/ REPAIR | REFERENCES |
|---|---|---|---|---|---|
| 02 | Oroville Dam | USA | 1968 | 2017-2018 | [09]-<br><a href="https://en.wikipedia.org">https://en.wikipedia.org</a> |

There was no single root cause of the Oroville Dam spillway incident, nor was there a simple chain of events that led to the failure of the service spillway chute slab, the subsequent overtopping of the emergency spillway crest structure, and the necessity of the evacuation order. Rather, the incident was caused by a complex interaction of relatively common physical, human, organizational, and industry factors, starting with the design of the project and continuing until the incident. The physical factors can be placed into two general categories:

- Inherent vulnerabilities in the spillway designs and as-constructed conditions, and subsequent chute slab deterioration;
- Poor spillway foundation conditions in some locations.

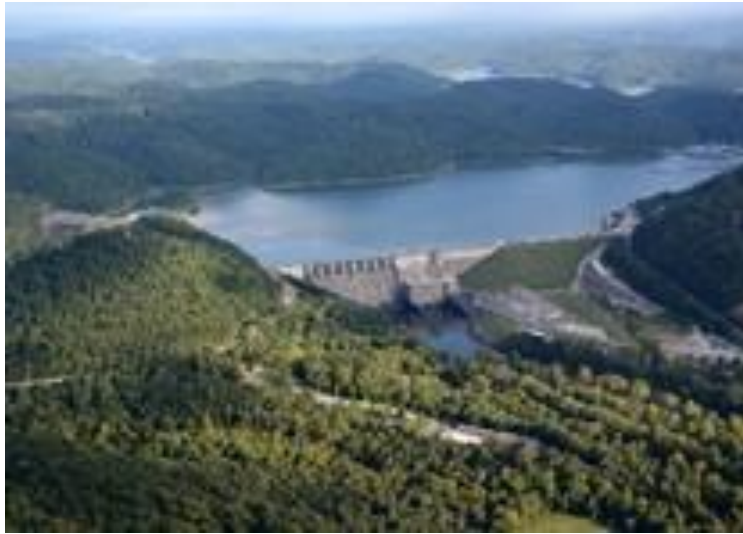
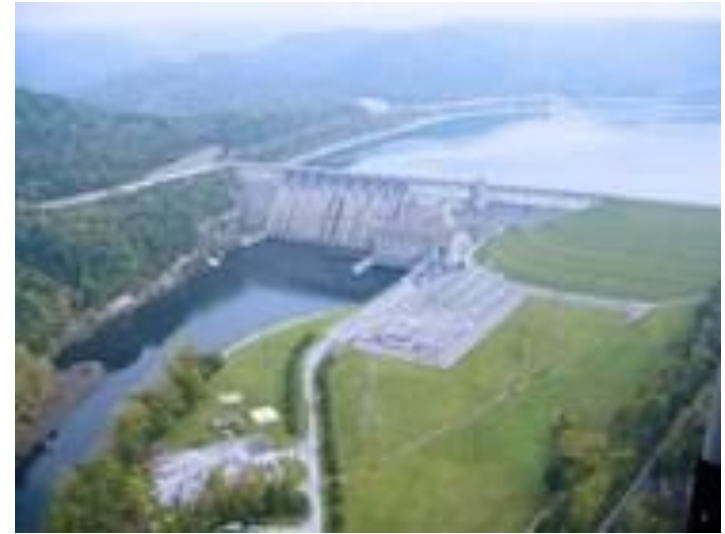
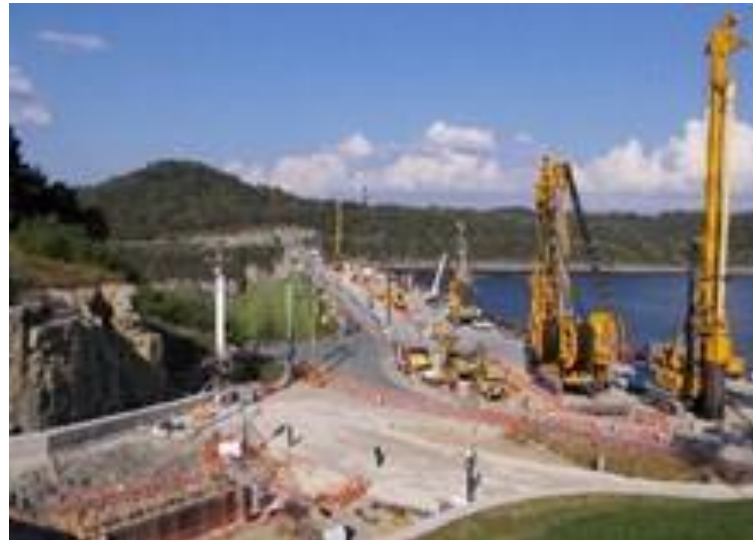
| CASE | IDENTIFICATION | COUNTRY | FINISHED | REHABILITATION/<br>REPAIR | REFERENCES |
|---|---|---|---|---|---|
| 03 | Center Hill Dam | USA | 1948 | 2008-2012 | [10; 11] |

In the late summer of 1983, cores were taken from the dam, galleries, adits, powerhouse, spillway piers, and spray walls and were sent for petrographic examination and testing. The mineralogical composition of most of the rock was calcite with some dolomite and quartz and some clays and feldspars. Some of the rock types were identified as potentially reactive. The concrete cores contained many aggregate particles with reaction rims left in relief when the more soluble carbonate particles were acid etched. The tests on the concrete cores and petrographic examinations led to the conclusion that some potentially reactive aggregates were used in the concrete. There was no proof that shortening the bridge spans and spillway gates was more than a short-term solution to operational deficiencies and that the structure might not continue to grow.

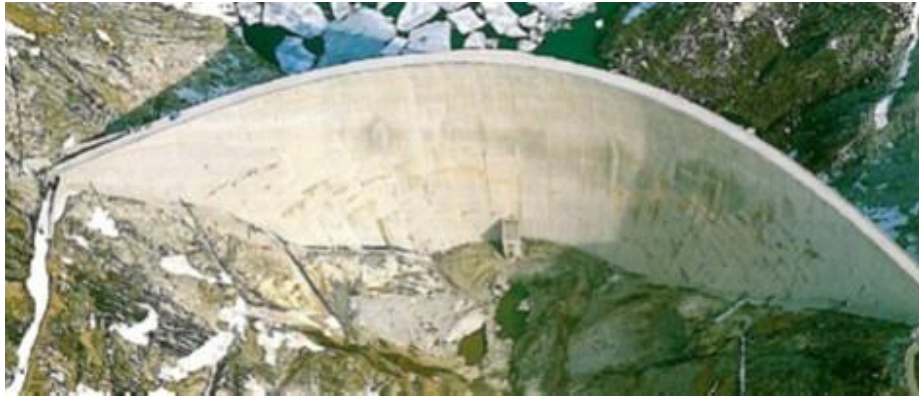
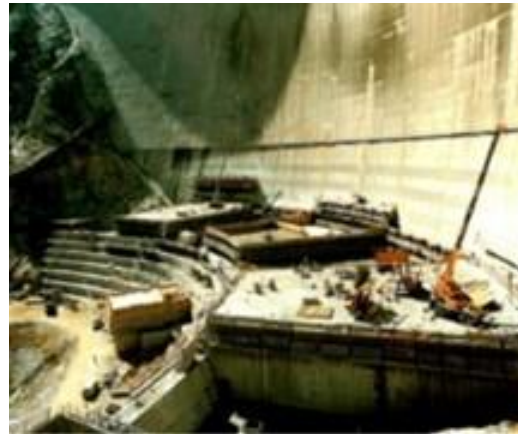
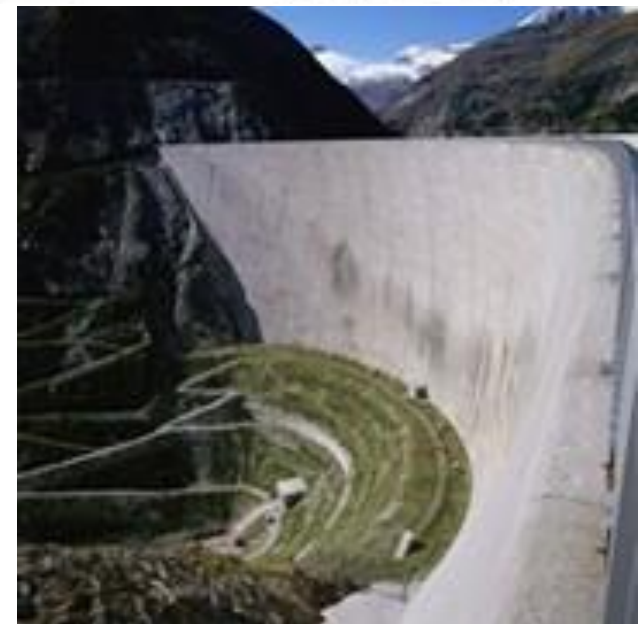
The rehabilitation work began in 1989 and was finished successfully in 1994. The adopted solution was to install a 70 m high supporting block of concrete downstream of the dam. Its function is to support the lower third of the dam, but only when the water in the reservoir exceeds a certain level. It was therefore necessary to bring the two elements together only after a certain water load had been applied. The problem was solved by installing reinforced neoprene cushions at nine levels at concrete consoles. Each cushion was connected to a double steel wedge construction that could be calibrated in height from adits below and above their horizon.

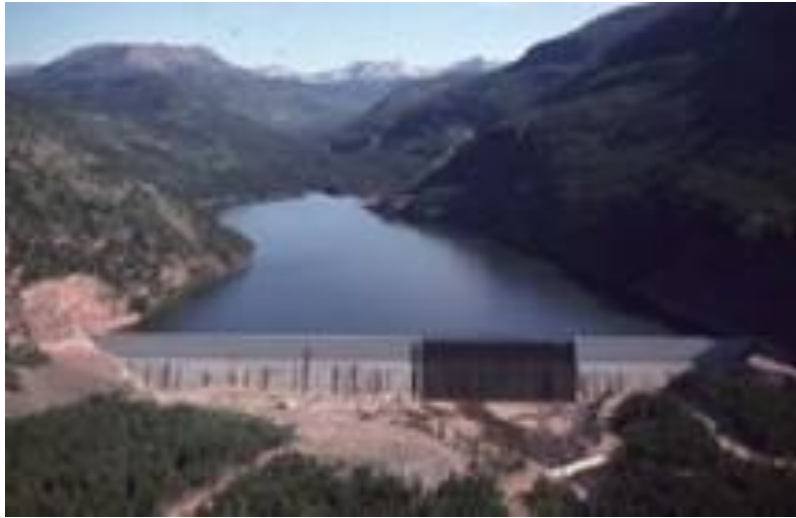
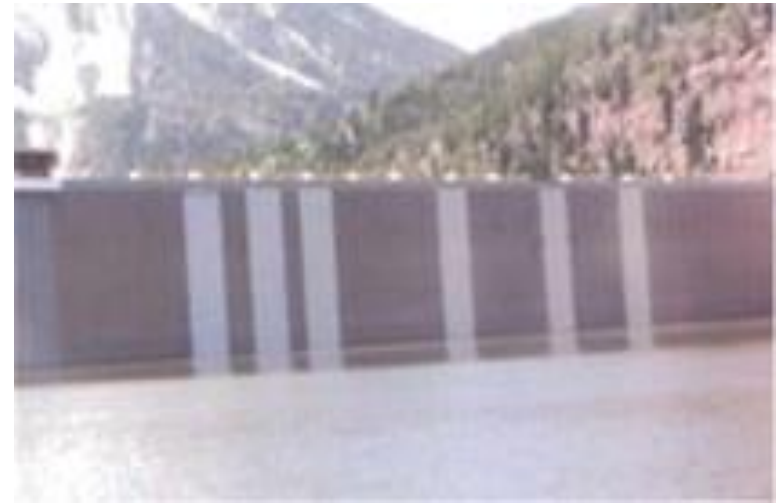
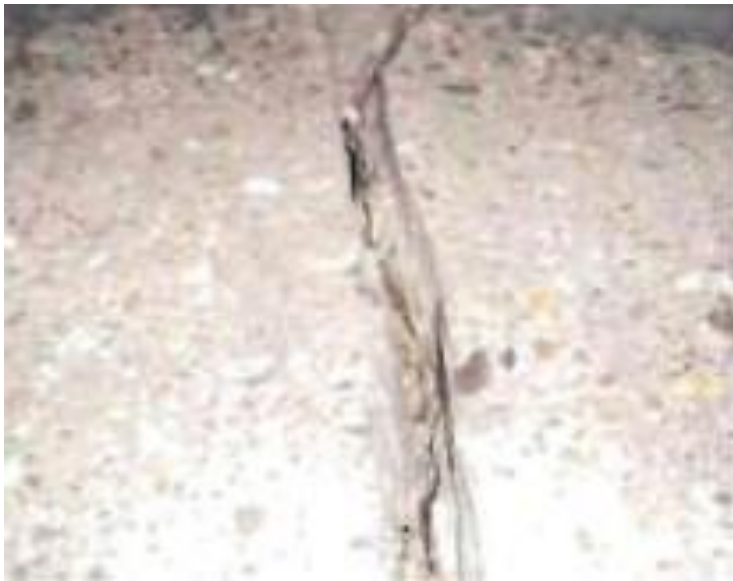
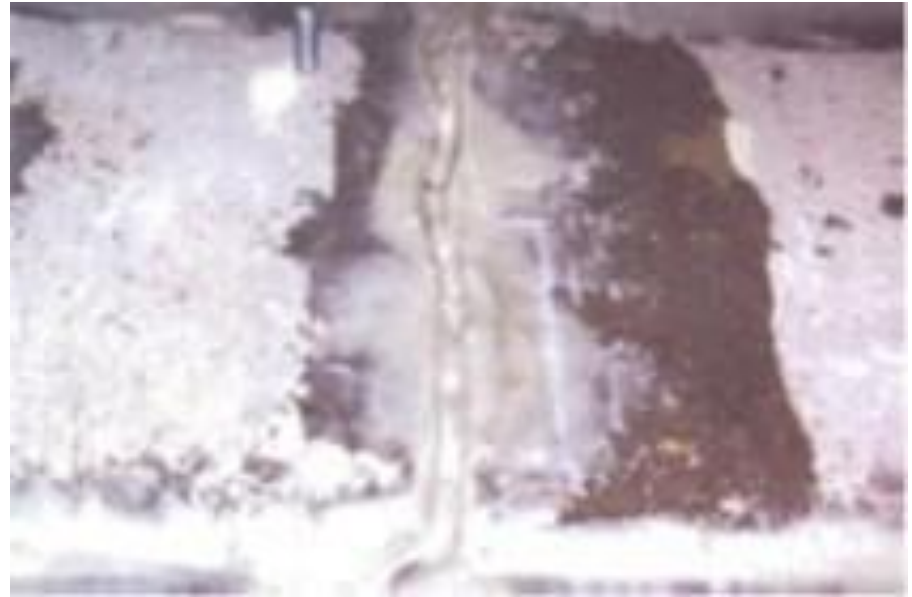
In 1988, during the first filling of the reservoir, a continuous crack was discovered in the foundation gallery.

The Bureau of Reclamation repaired this and other similar but smaller cracks at various stations. Due to the potential for crack movement with seasonal reservoir level changes, a flexible hydrophilic polyurethane resin was selected for injection into the cracks. The selected repair procedure was to inject the crack with polyurethane resin in 3 stages.

Work for the first two stages was executed from the gallery and the downstream face at elevations below the reservoir water level. When the flow of water was controlled, a urethane resin pump system was connected to the injectors, and resin was pressure injected into the crack.

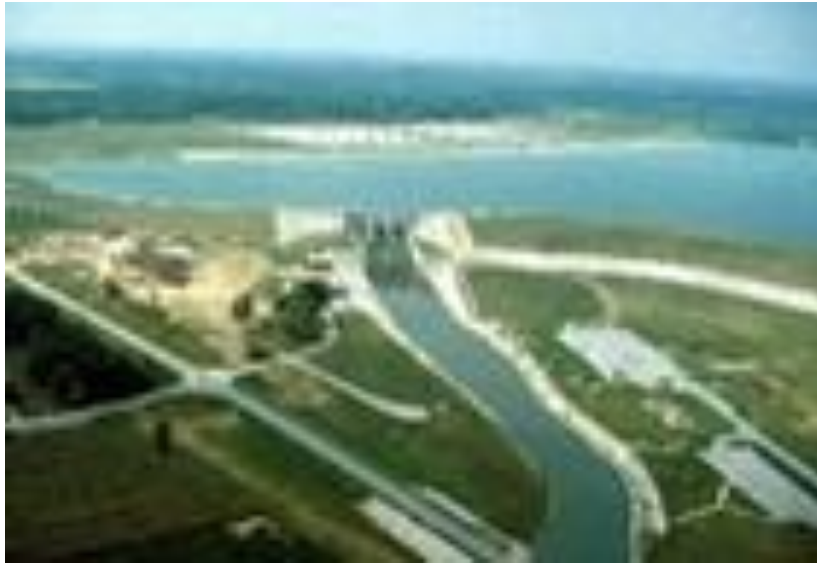
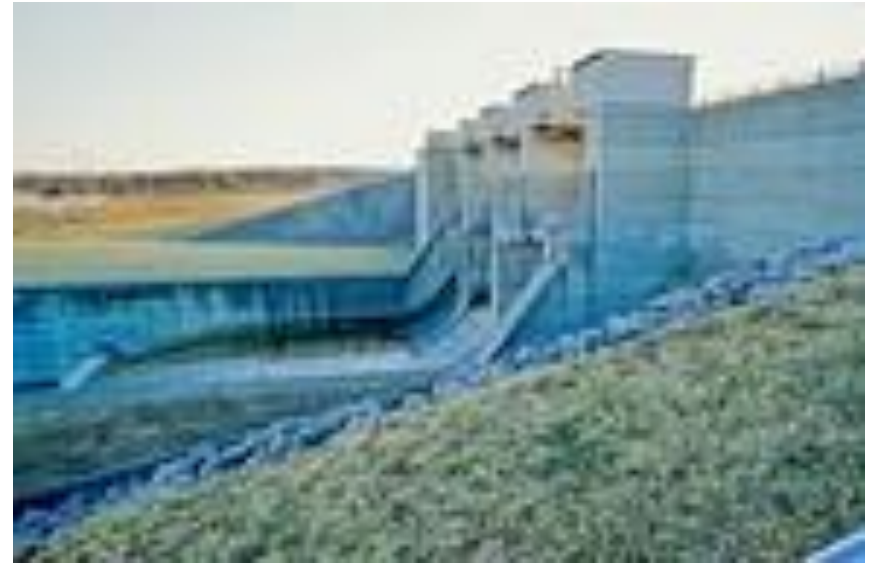
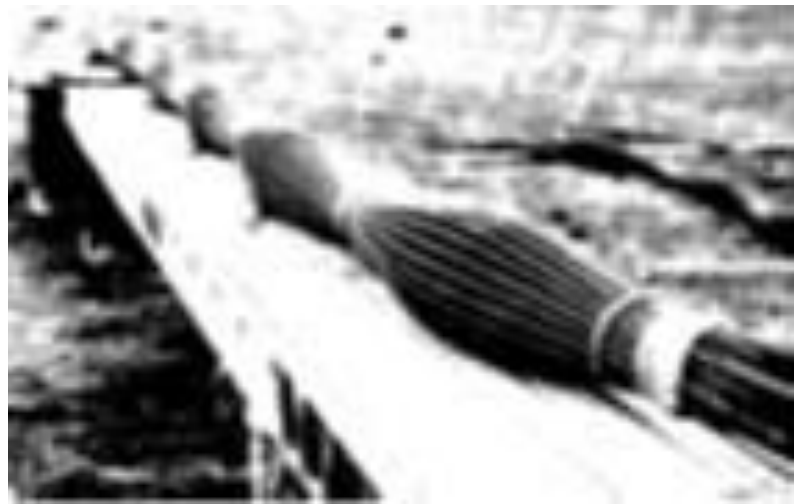
On April 24 1975, during a periodic inspection of the completed dam, the US Army Corps of Engineers expressed concern about the safety of the spillway monoliths. The rock underlying the dam is highly fractured below the base of weathering. Within this shale are several light gray, silty to clayey shale seams up to 0.30 m thick. It may be possible that the spillway monolith and its underlying bedrock could slide, opening a gap between the monolith and the rolled earth dam leading to rapid and catastrophic erosion of the dam. To prevent the concrete monolith from sliding forward, it was decided to install seven cable anchors deep into the bedrock. Each anchor consisted of bundled, high strength steel cables that were concreted into the bottom of the holes. They were then hydraulically tensioned and the holes filled with grout. Anchors were installed at a 45 degree angle to a depth of 7.9 m below the foundation of the ogees.

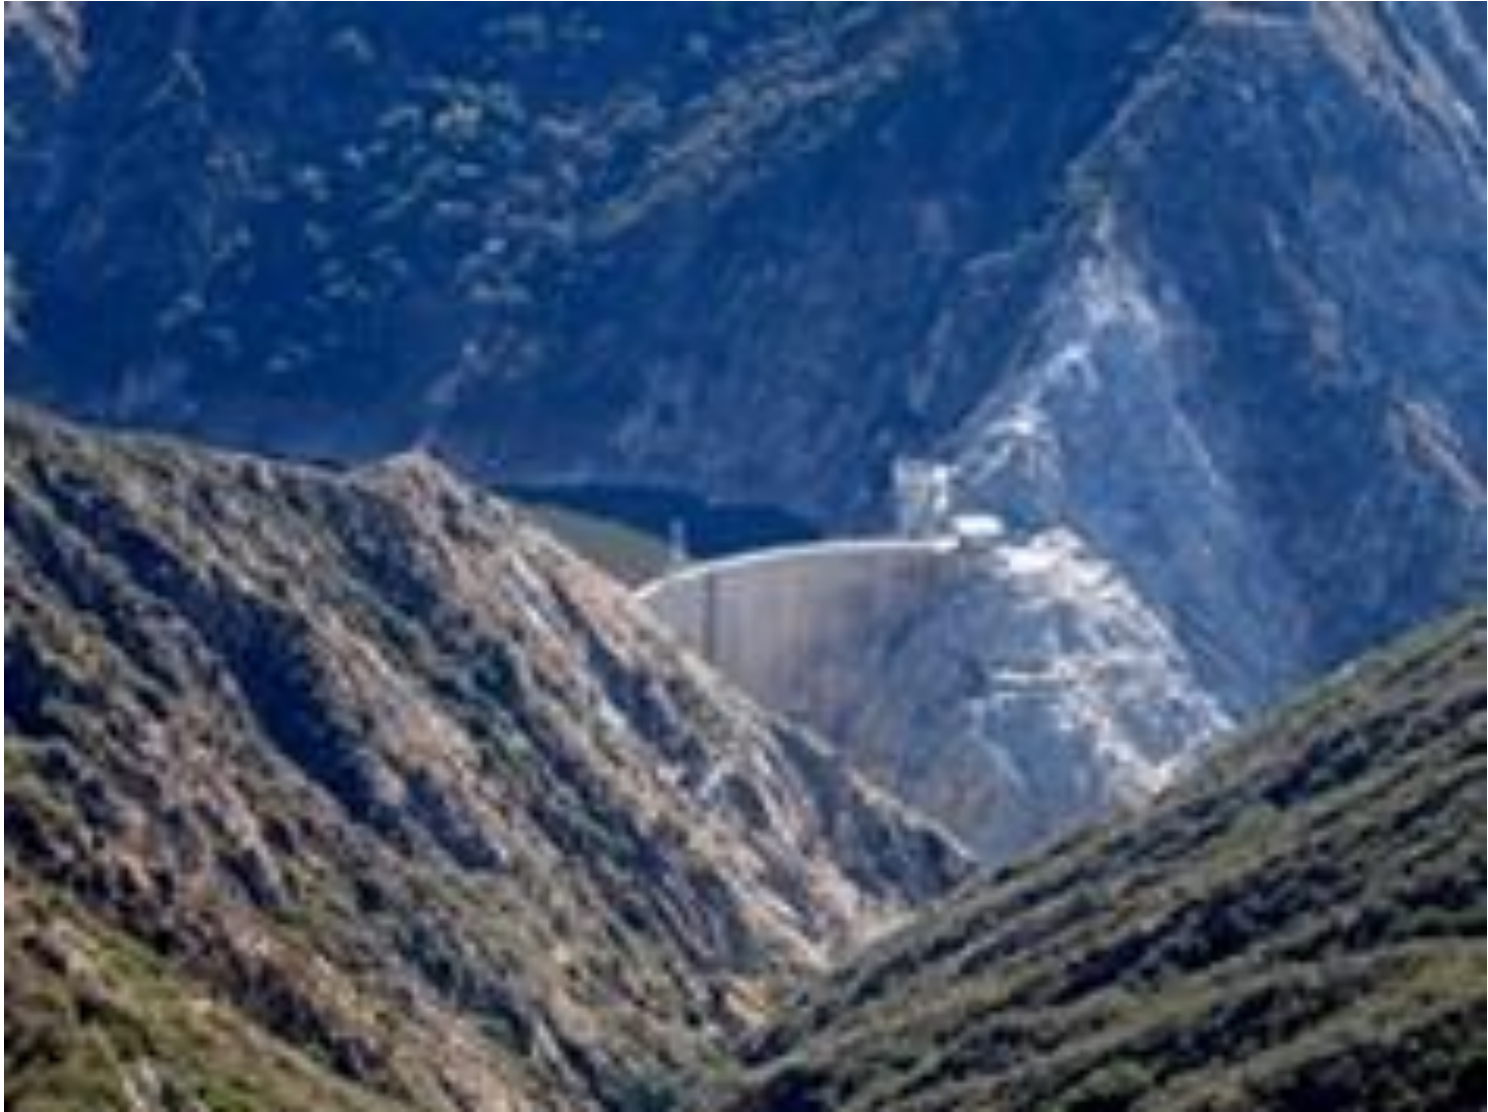
The dam was severely shaken by an earthquake of Richter magnitude 6,5. The left abutment proved to have inadequate seismic stability, and rock movement, cracking, and uplift pressures were observed. Interim rehabilitation measures included repair of sprayed concrete cover, stripping of loosened rock, installation of abutment relief drains, repair of left abutment grout curtain, consolidation grouting of upper left abutment, repair of spillway lining, and construction of an emergency outlet.

The permanent rehabilitation work included stabilization of the rock abutment with post-tensioned anchors. In addition, cracks and the open joint between the dam and thrust block were repaired by cement grouting.

The existing grout curtain in the foundation and abutment was repaired and extended. Further consolidation grouting of the foundation rock was carried out.

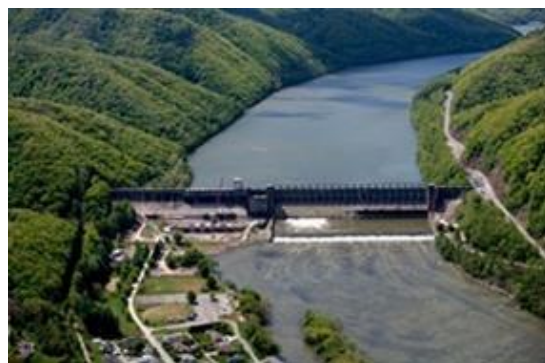
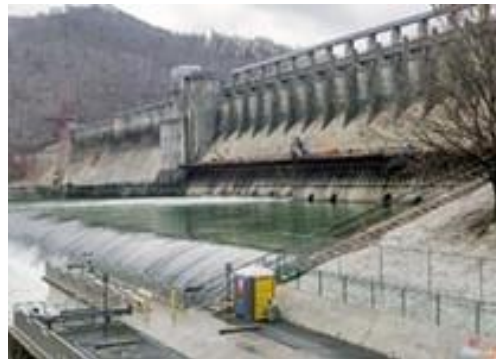
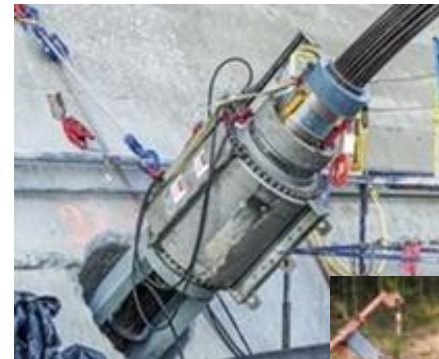
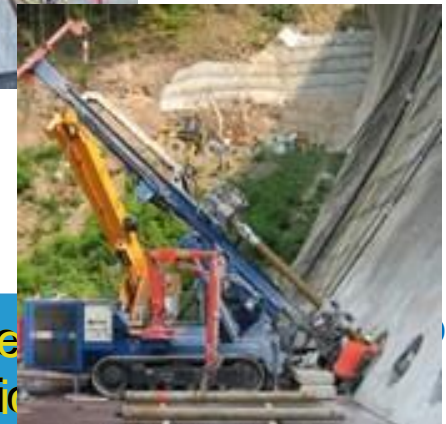
New calculations identified the possibility for dam failure due to the monoliths sliding on the bedrock. As a result, a total of 216 high-strength anchors, comprising high strength multi strands, were installed at critical monoliths to stabilize the dam.

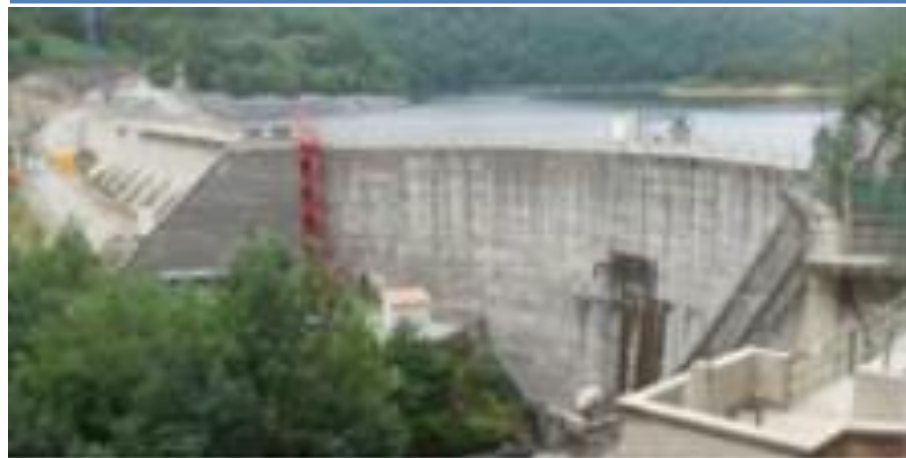
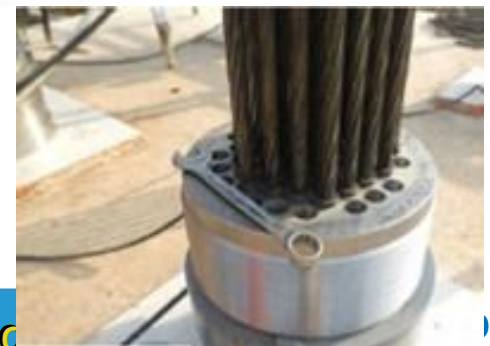
Rassisse Dam is an arch dam with an artificial abutment on the right bank, which is reinforced with two tendons each of 12 000 kN. These tendons were designed to provide additional downforce equivalent to 80 % of the weight of the abutment. The safety conditions were under control, in spite of uncertainty over the condition of the tendons, because a model analysis showed that the required pre-stressing force is smaller than that initially assessed

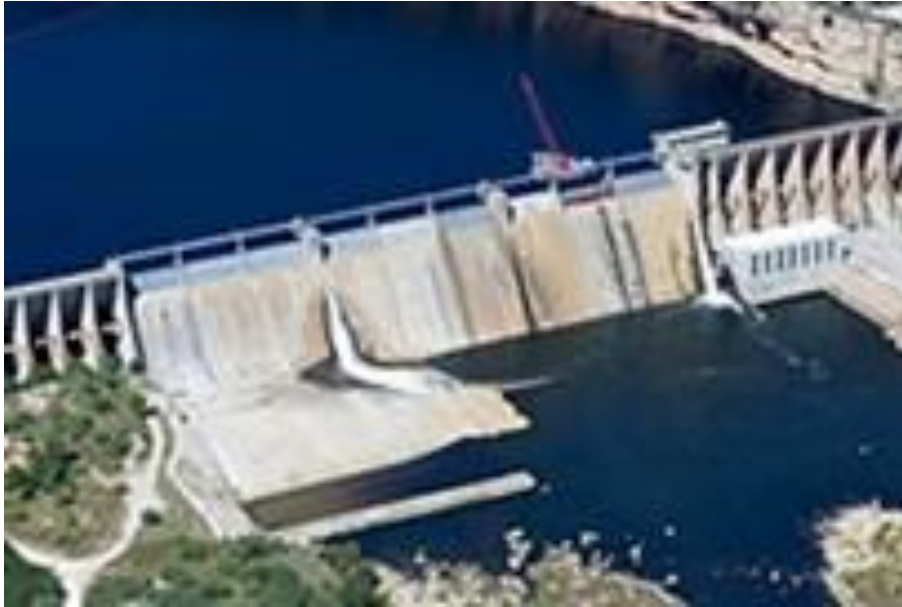
The maintenance personnel observed that cracks and spalls had developed in the heavily reinforced exterior walls of the powerhouse, also. Further investigation of the existing conditions revealed:

- That extensive corrosion of the embedded reinforcing steel was causing the thick concrete cover to shear off at the exterior face of the reinforcement;
- Delaminated concrete on the sloped top and vertical face of large encasement blocks that anchored the diameter penstock pipes that feed water from the lake to the generators' turbine wheels; and
- Spalling concrete beneath several of the large concrete struts located between the massive buttresses that support the dam's concrete slab.

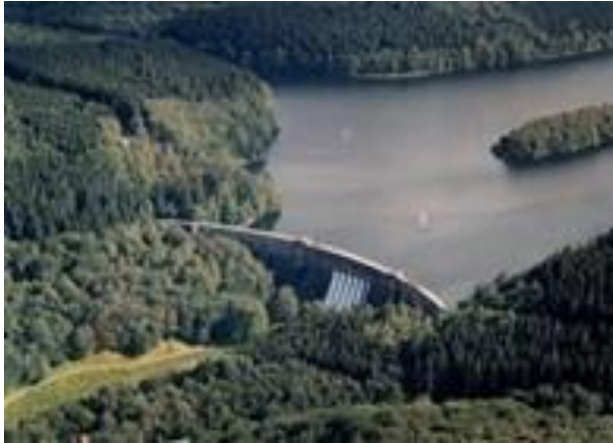
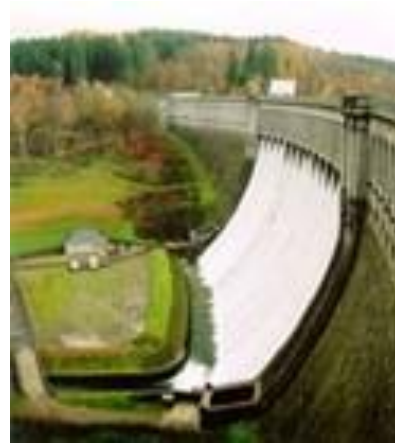
The Ennepe Dam has to be adapted to the established technical standards and safety regulations. The construction of a drainage- and inspection gallery with a Tunnel Boring Machine has been the most spectacular part of the rehabilitation work so far and has been successfully finished in August 1998.

This was considered as a difficult task for a TBM due to the curved axis of the gallery and a distance of only 3.5 m to the upstream face of the dam. In October 1997 the TBM began the driving of the access tunnel. From the tunnel, fans of drainage holes were bored within a test section.

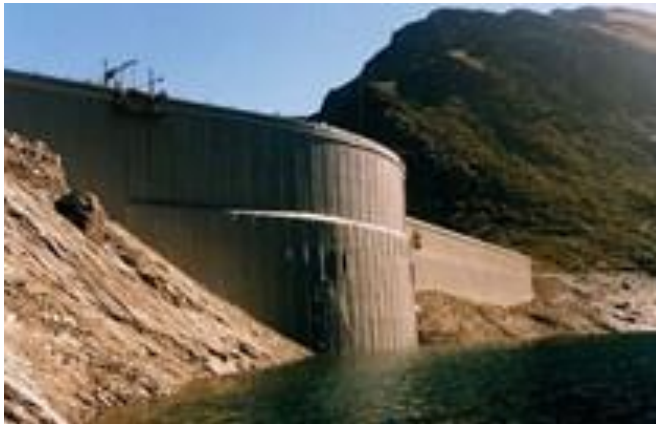
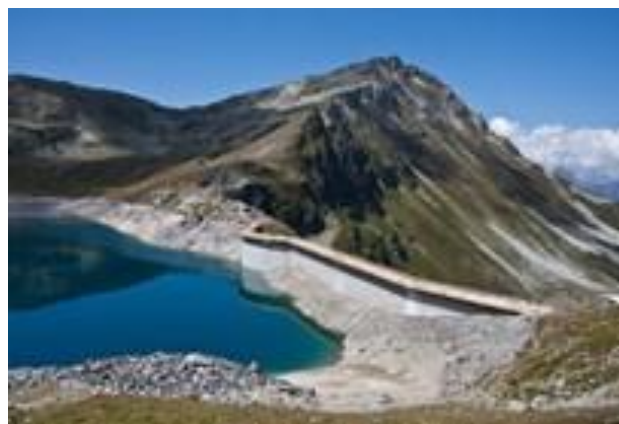
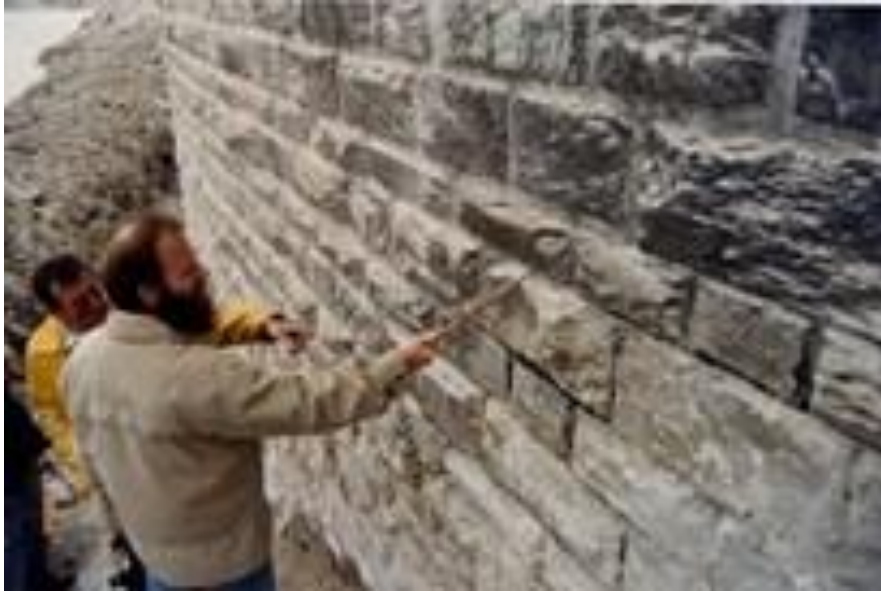
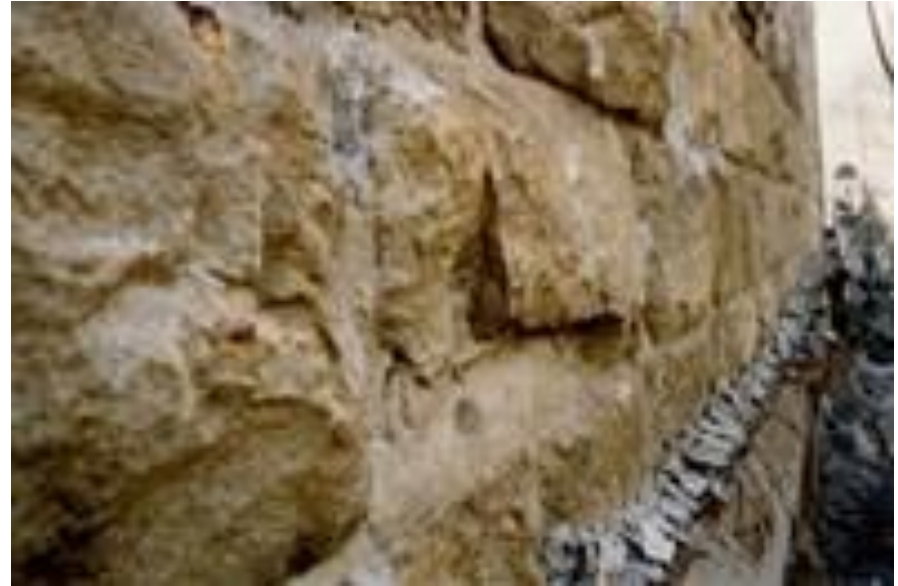
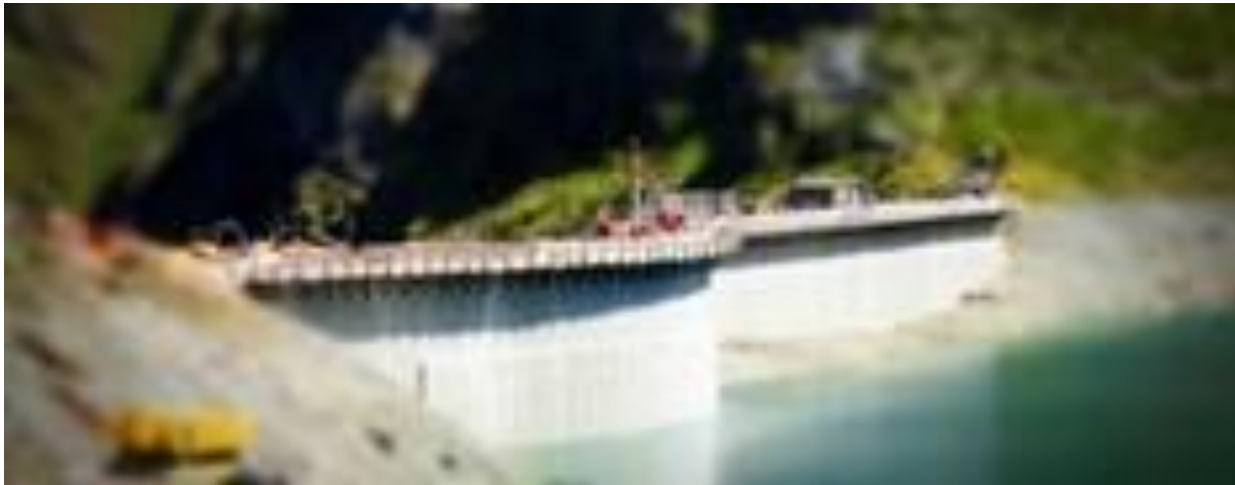
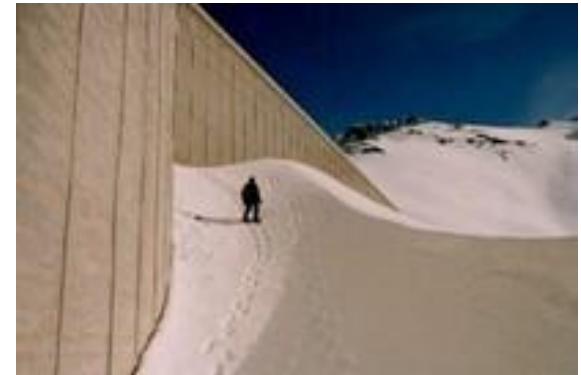
Displacements were observed that were attributed to Alkali Silica Reaction and an impermeable layer was installed on the upstream face in an attempt to reduce the seepage of water into the dam, hence to slow and ultimately to stop the expansion process. The dam is faced with rough masonry and transition layers of geosynthetic materials were used instead of more traditional methods to make good local defects and to prepare the dam surface for the application of the PVC membrane.

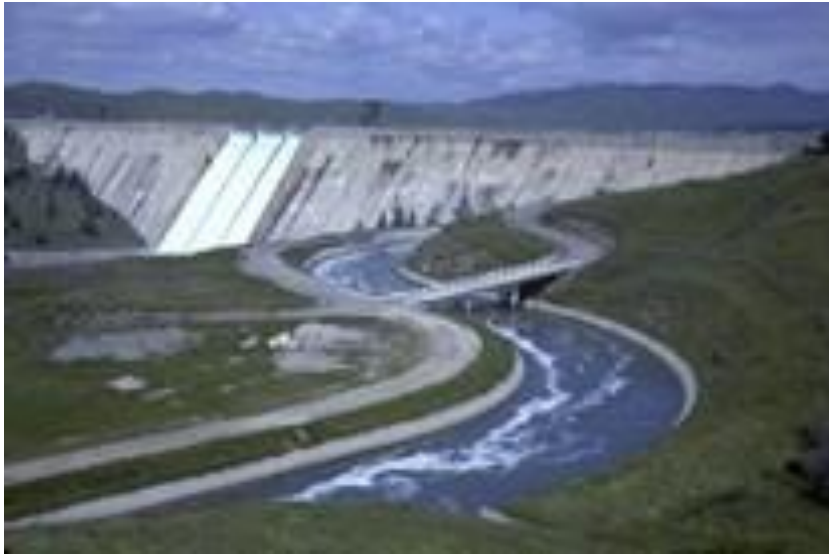
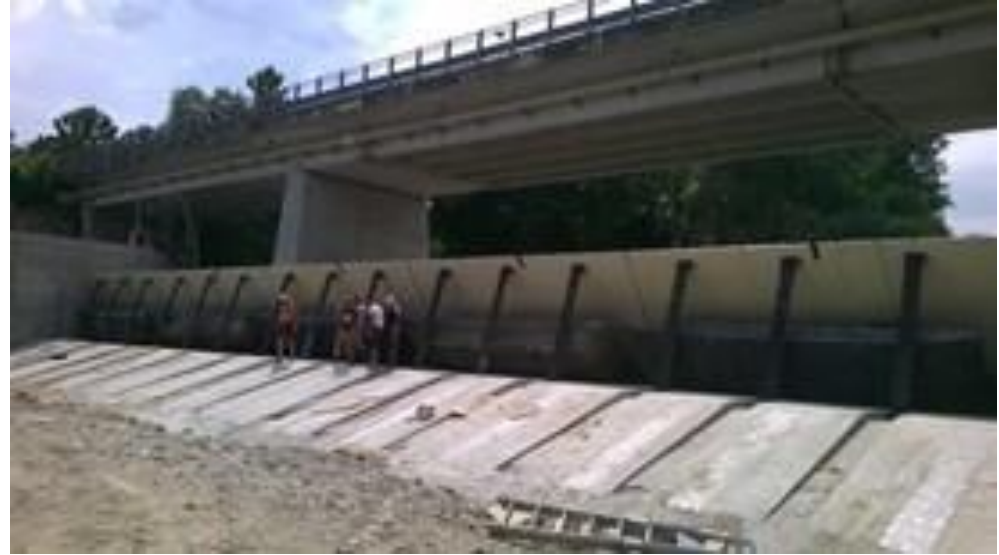
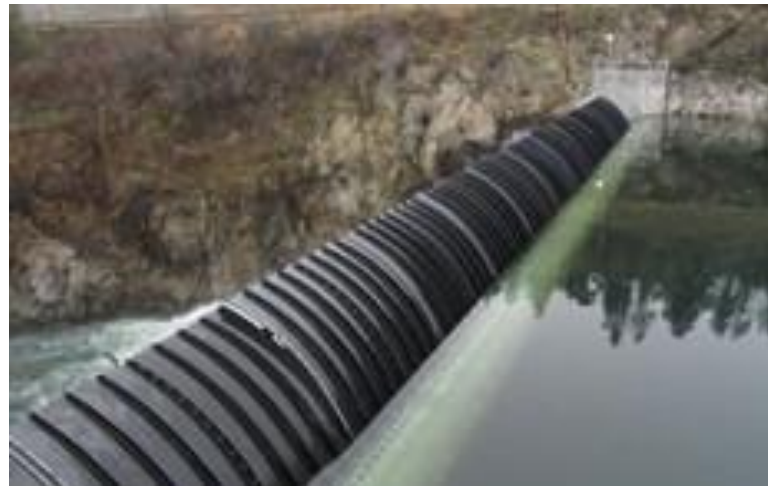
- Accurate automatic pond level control even under power failure conditions.
- Modular design that simplifies installation and maintenance.
- Unlike hydraulic spillway gates, Obermeyer gates are supported for their entire width by an inflatable air bladder, resulting in simple foundation requirements and a cost effective, efficient gate structure.
- Thin profile efficiently passes flood flows, ice and debris.
- No intermediate piers are required.
- Obermeyer Spillway gates are a great investment due to low installation cost, decreased maintenance, and increased revenue through optimized head.

These features are the result of combining rugged steel gate panels with a resilient pneumatic support system.

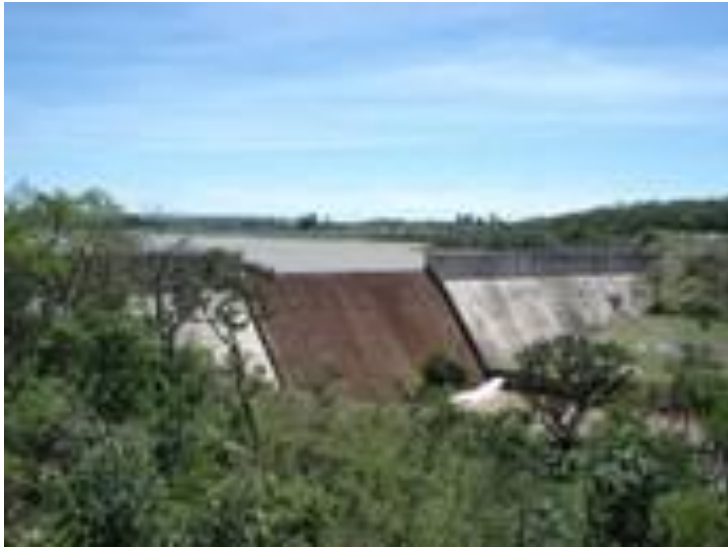
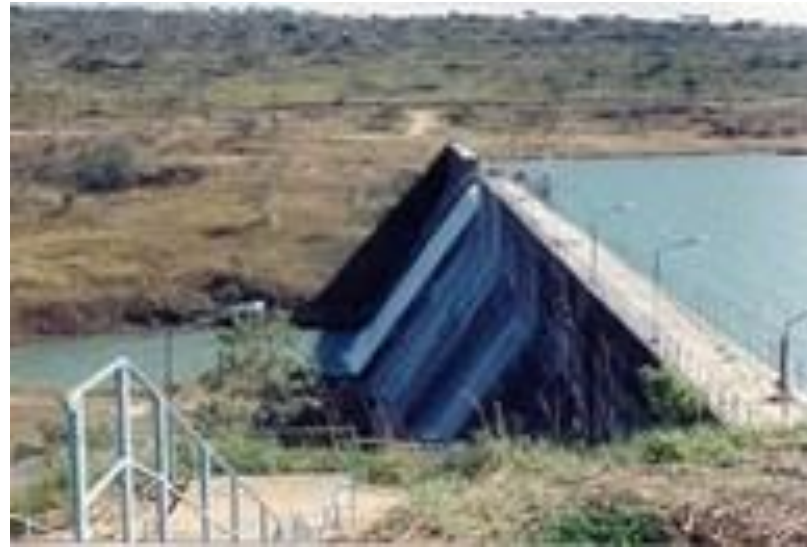
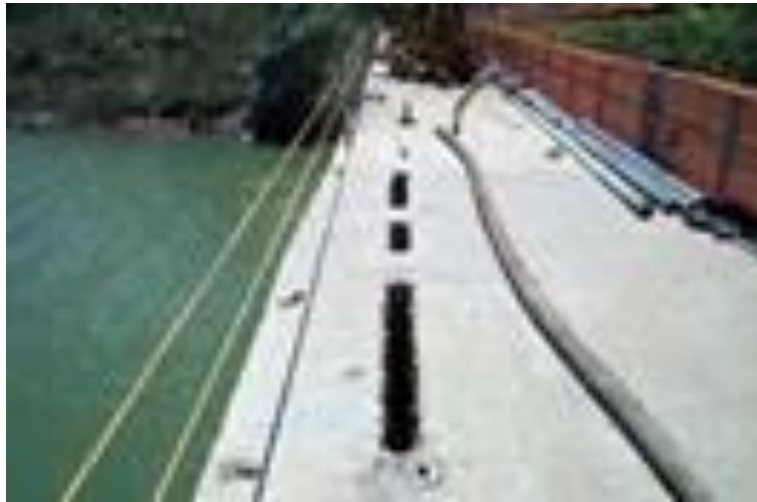
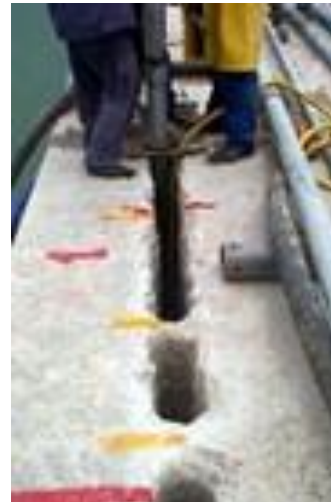
A diaphragm wall was adopted as the rehabilitation methodology. This “In the wet” technique, permitted the water supply for Brasilia (1.5 million people) to be not interrupted or affected in the course of the rehabilitation works. The reservoir’s water quality was continuously controlled during the process, and kept at the same level.

The process concept is based on the insert of a waterproof secant pile diaphragm wall inside the body of the dam, 70 cm far from the upstream face. The diaphragm is performed from the dam crest without any interference with the reservoir water, need of water level drop or intake obstruction. The secant bores are performed in sequence by drilling equipment with the use of a special guiding template.
