Structural analysis and rehabilitation  
of concrete dams and spillways

# **HISTORIC CASES ON CONCRETE DAMS REHABILITATION**

Third International  
Dam World Conference

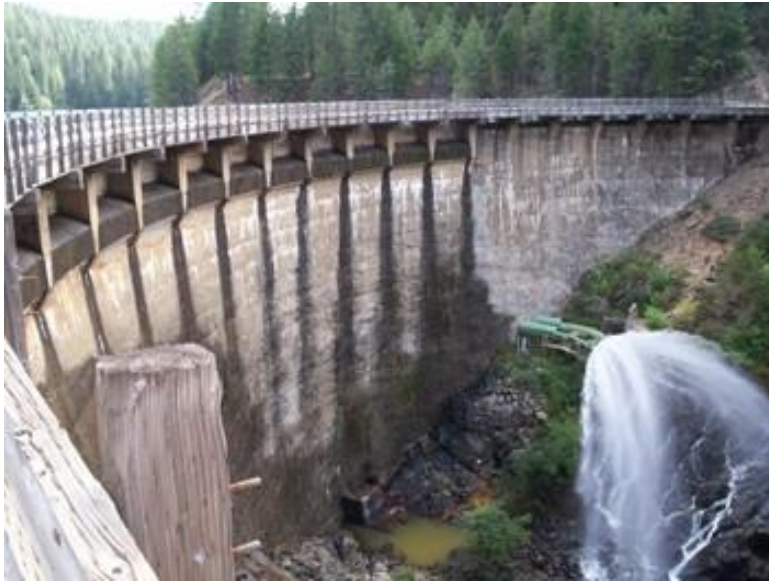
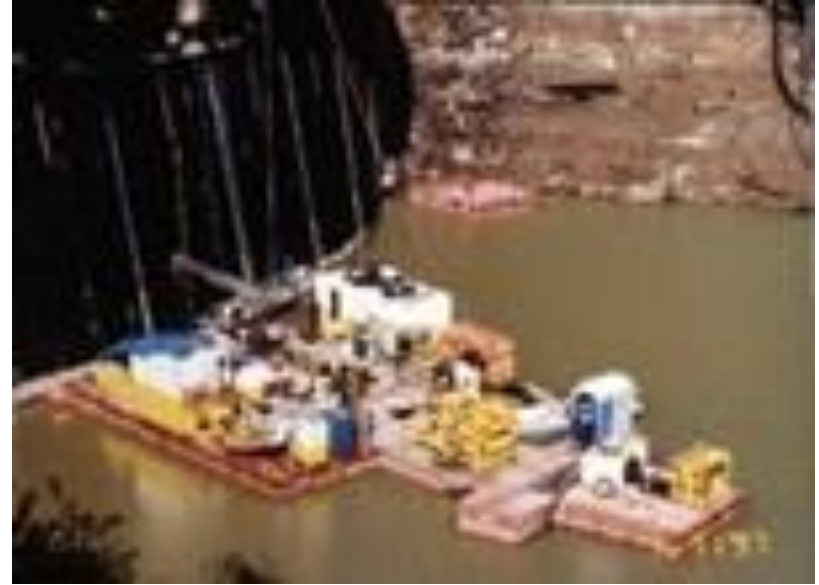
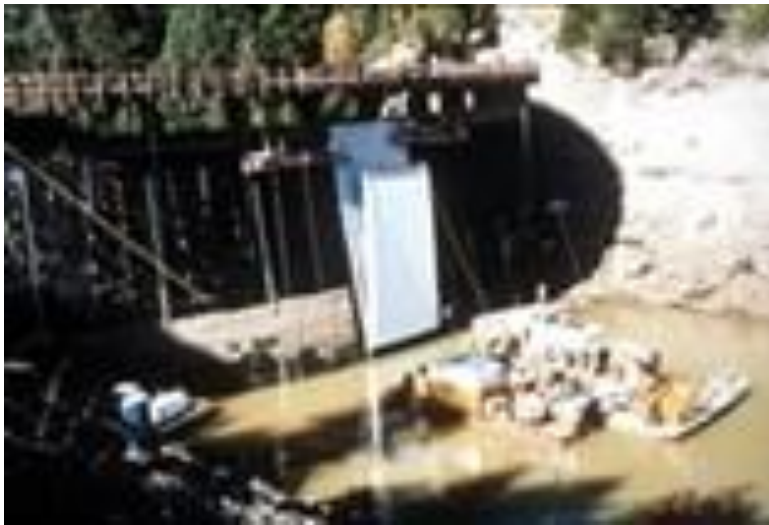
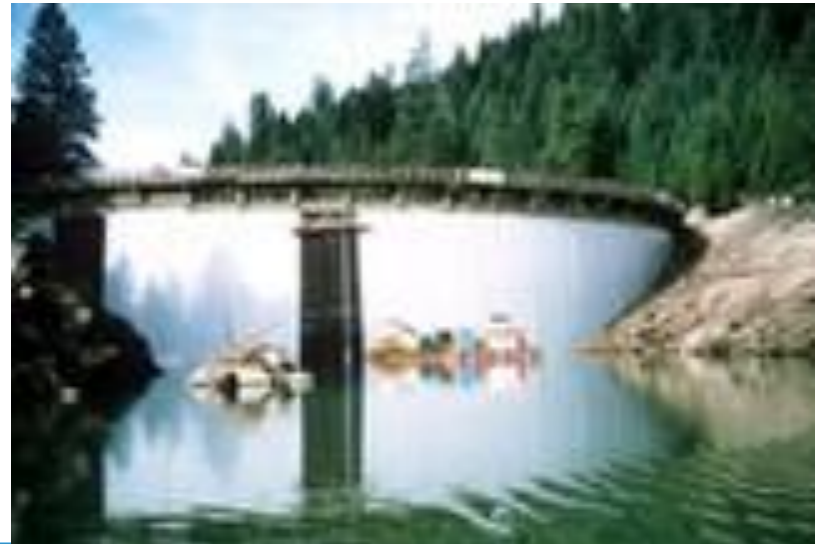
Lost Creek Dam is an arch dam whose reservoir cannot be emptied. The permeability of the concrete, and the consequent deterioration as a result of alternate freezing and thawing, resulted in progressive loss of concrete and decreasing strength of concrete at the downstream face. The stability of the dam was not an issue. The installation underwater of an upstream PVC membrane system was the preferred option.

To install internal profiles underwater, divers worked from swing platforms that were controlled from a materials barge. They used grid lines as guides to ensure the internal profiles were installed in a perfect vertical line. Gasket material was placed on the installed vertical profiles to provide a watertight seal at the membrane joints.

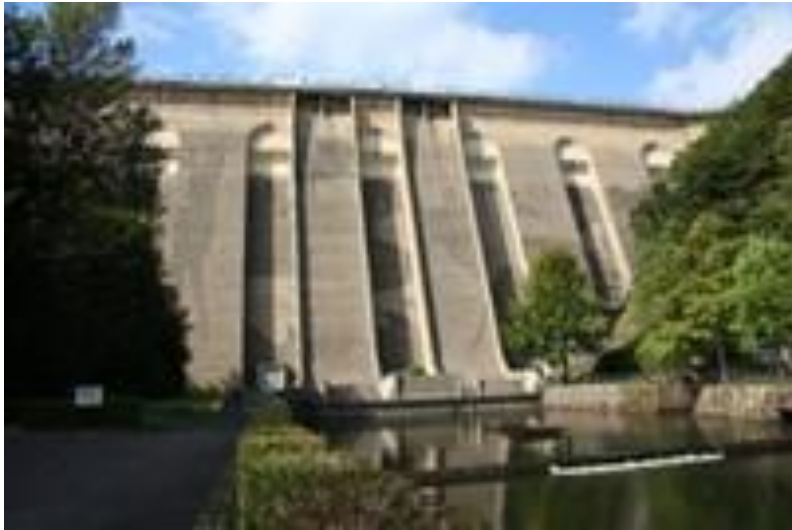
Fig. 3.3.4

Olef Dam. Typical crack pattern in the buttresses

1. Air circulation hole
2. Access hole

This Dam is an example where it was found necessary to strengthen the dam because of the combined influences of creep, shrinkage and thermal cycling. During construction shrinkage cracks appeared in the buttresses. Additional reinforced concrete support was provided on the inner side of each buttress. A concrete thermal protection wall was installed at the downstream face of the dam between the buttresses in order to reduce the magnitude of the temperature variations associated with climate and season.

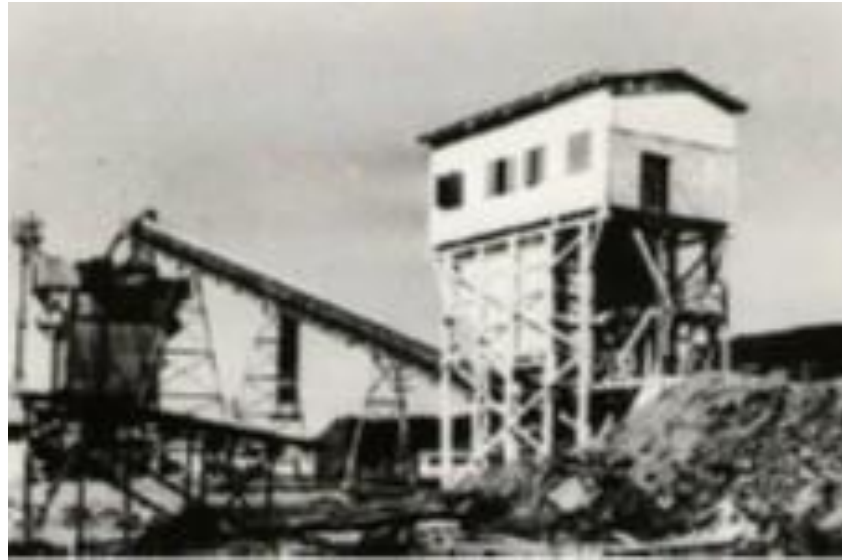
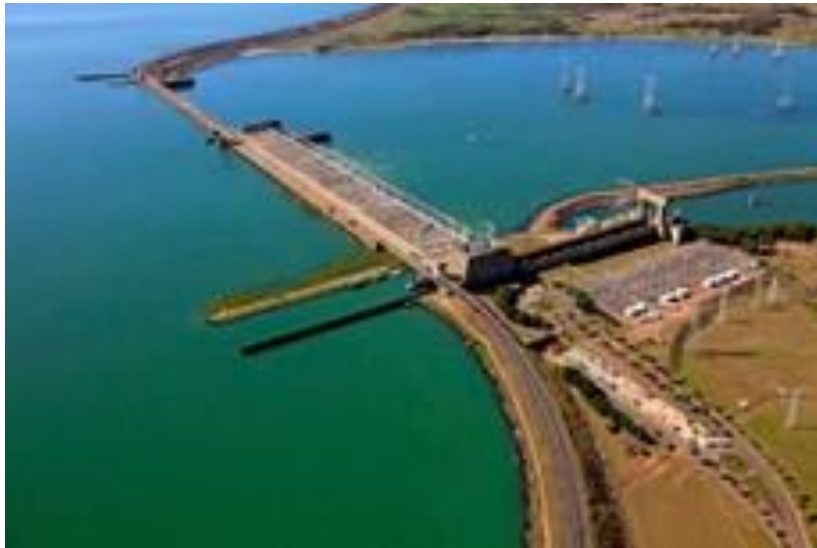
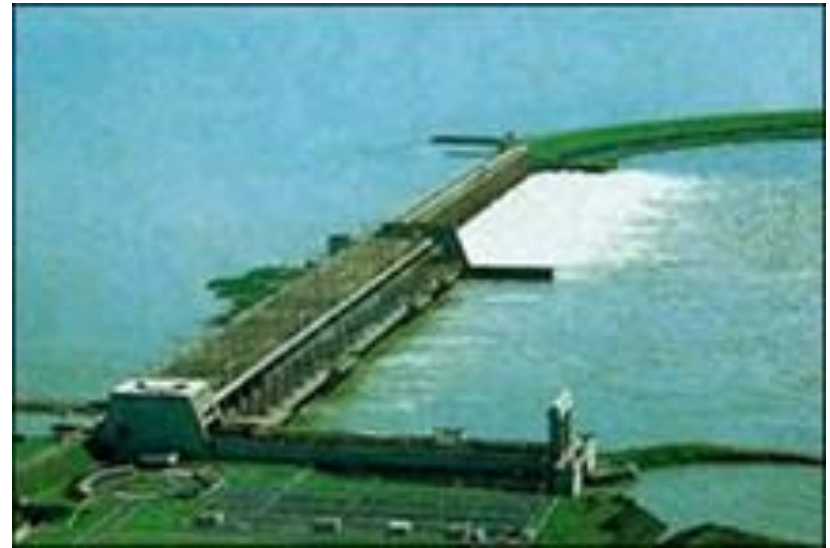
**Pre cooling:** During the construction of the dam, at the beginning of the years 60, due to the means of production and release, increase in the dimensions of the blocks and cause the appearance of cracks in the concrete. The cracks were caused by volumetric variations arising from high temperature variations, with peaks of about 60° C.

Several studies have been developed and carried out tests to control the influence of the heat of hydration of cement, in the appearance of cracks. It was established the ideal temperature of the concrete to 7° C. To that end it was necessary the adoption of pre-cooling concrete measure.

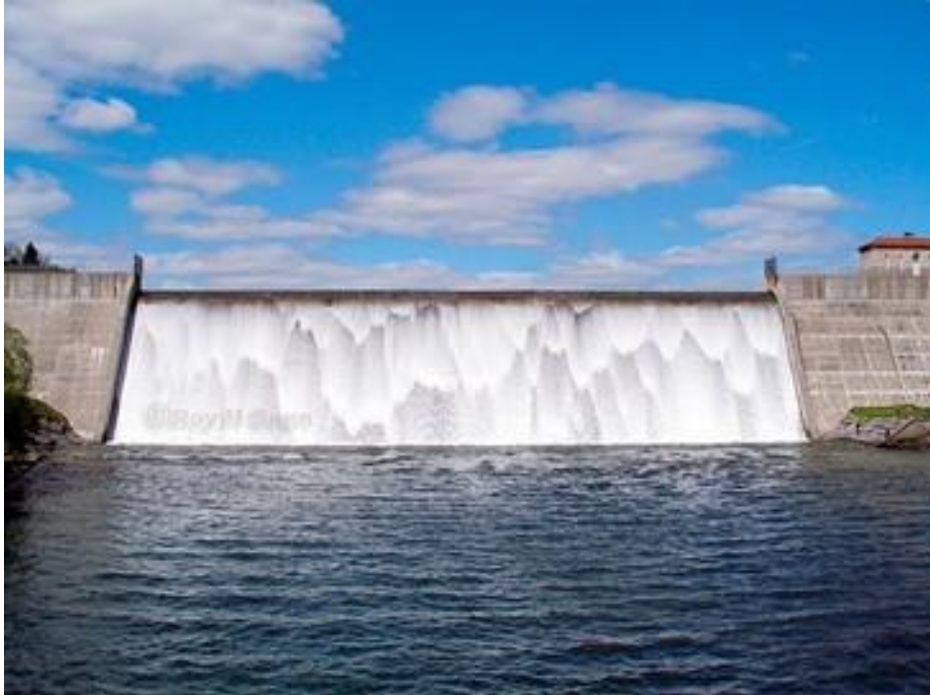
The strands were installed with double corrosion protection consisting of a plastic duct and grouting. The grouting system included simultaneous tremie-placement of grout both between the strand and casing and the casing and anchor hole. Anchor embedment depth ensured resistance of the lower anchorage to applied upward pull. In the free length of the anchor, the smooth duct and a grease and plastic coating on the strands kept the strands from bonding to the grout.

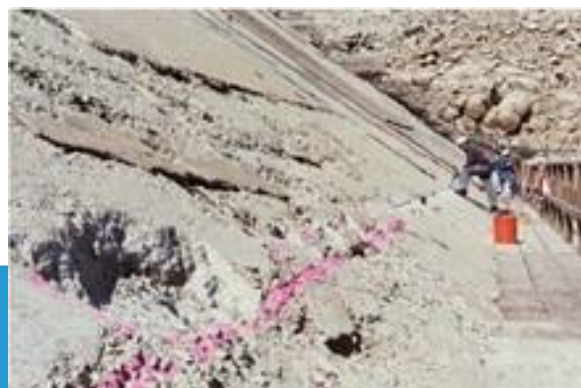
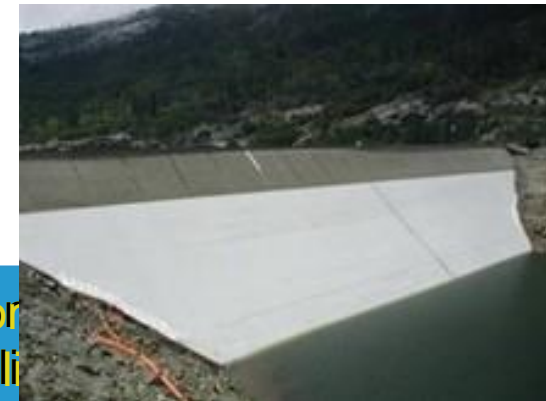
The dam (CFRD) has a history of settlement problems caused by poor consolidation of the rocks during construction. The concrete face has been cracked many times by the movement, causing leaks. The surface of the dam consists of cracks, craters and shotcrete overlays. It was decided to use a flexible geomembrane to cover the portions of the dam with the greatest leakage.

As a result PG&E and its independent board of consultants decided that installation of a flexible membrane over the existing concrete face would more satisfactorily provide the desired leakage control and accommodate any future settlement.

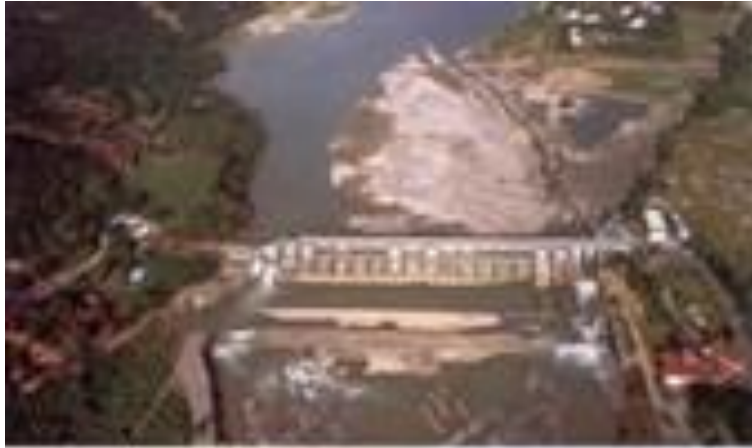
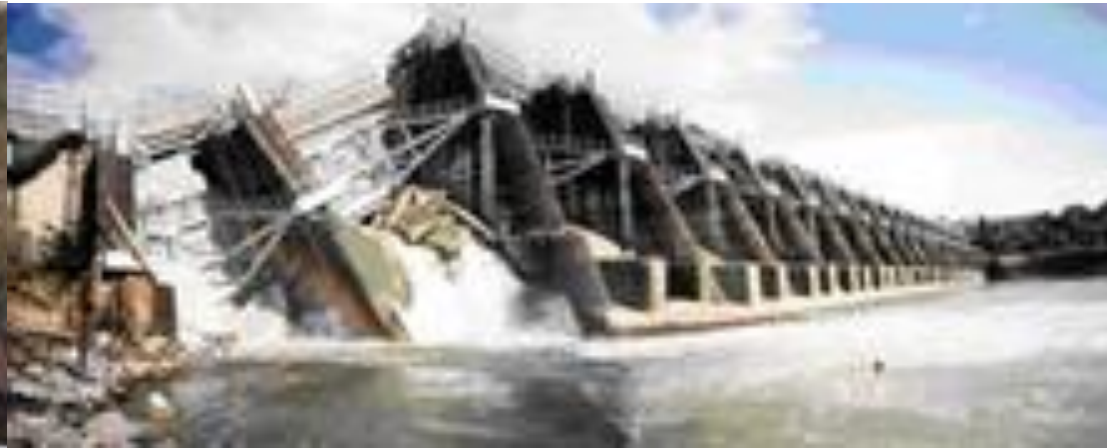
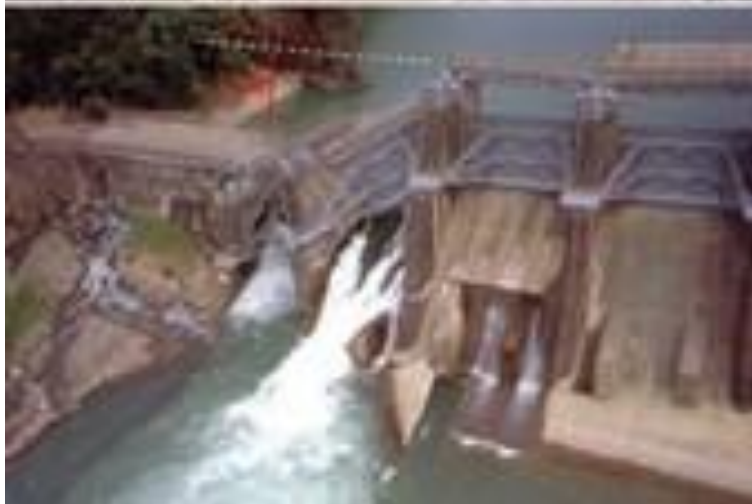
On 21, September 1999, an earthquake happened in the central region of Taiwan. Shih-Kang Dam was damaged by marvelous surface ruptures of Che-Lung-Pu fault, strong surface deformation, and great ground motion.

The Shih-Kang Dam design was based on the traditional design concept of the pseudo static earthquake acceleration. The design horizontal earthquake acceleration coefficient was  $K_h=0.15$  and the effect of the vertical motion was neglected.

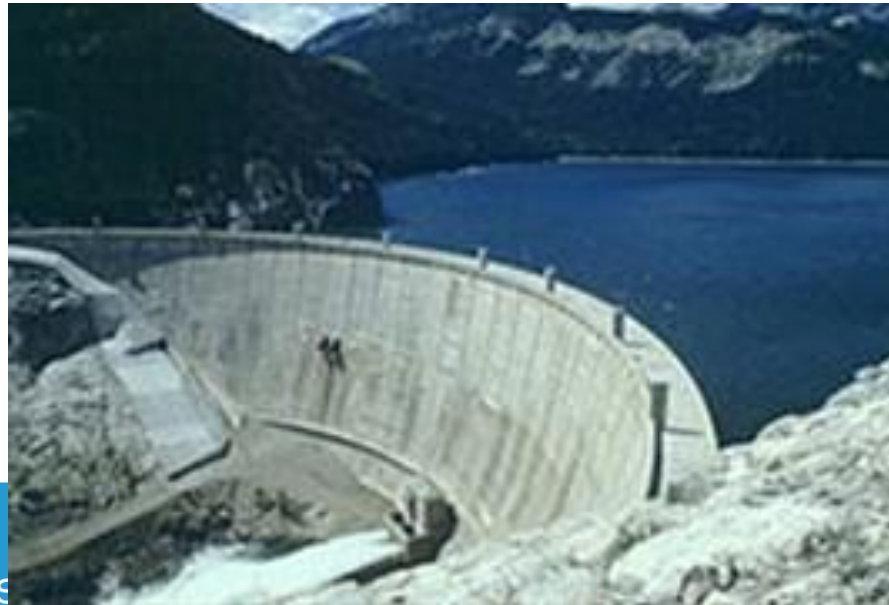
BuRec decided to rehabilitate the dam to meet a new PMF. In a new approach, piers were constructed on the crest of the dam. In the event of overtopping, the piers will divide the flow and provide aeration beneath it. The piers extend to the height of the PMF (3.7 m) and are placed at intervals of 30.5 m. The upstream pier edges project into the roadway, and the downstream edges are flush with the parapet walls. To prevent plucking erosion, rock bolts and concrete caps were installed on downstream rock abutments.

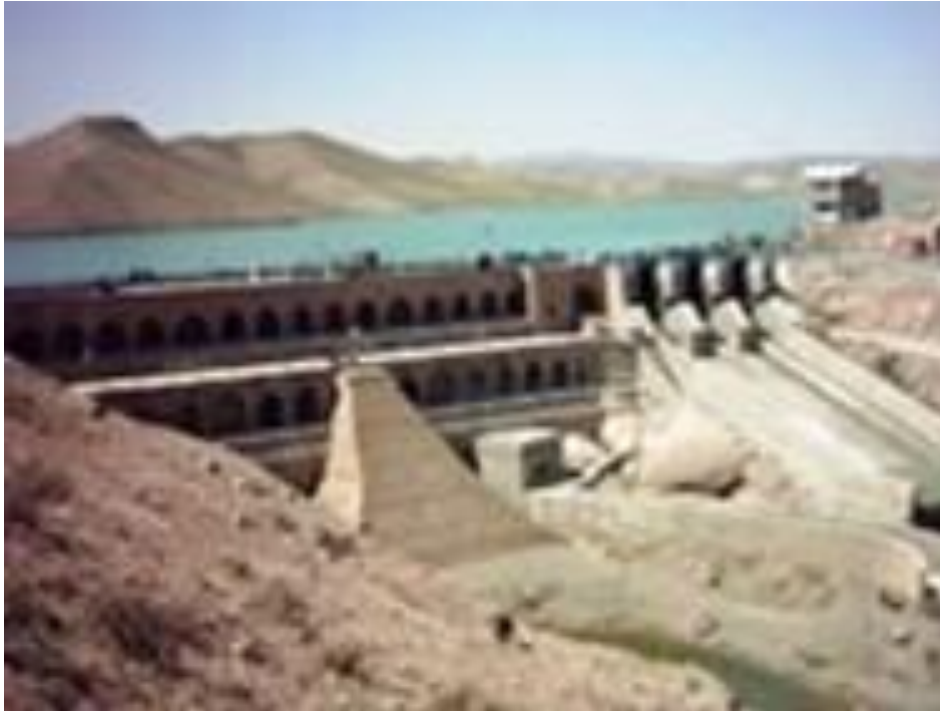
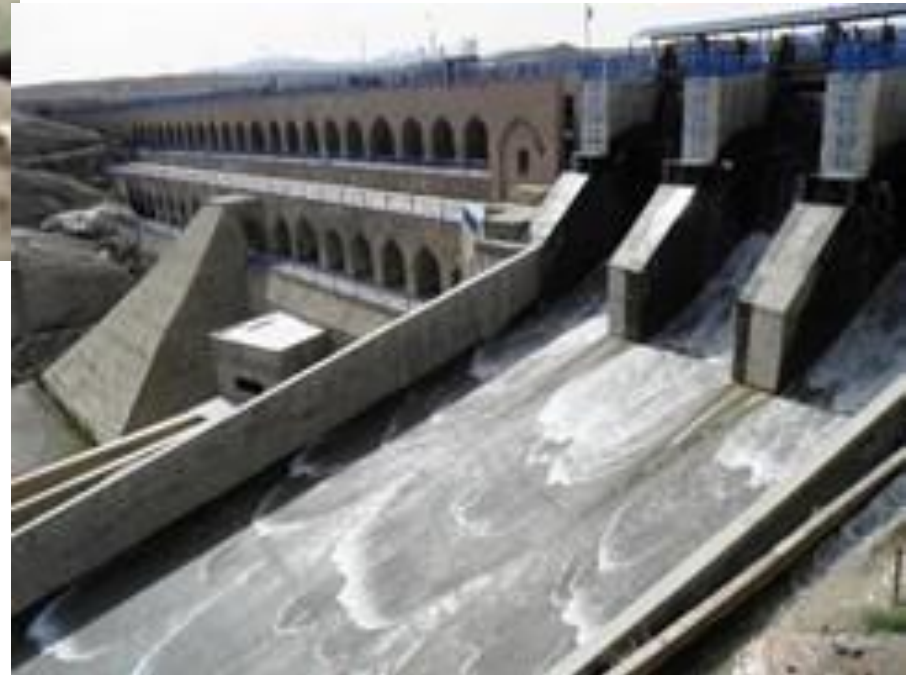
The dam has been rehabilitated due to overtopping occurring almost every year during the flood season and leakage through the dam body. The height of the dam has been increased by about 5 m together with leakage prevention measures for its upstream face as well as strengthening the old structure in 200.

Three alternatives for the prevention of leakage through the dam body and Reinforced Concrete was finally selected not only because of its least cost and lowest permeability but mainly because it strengthens the dam section and provides stability

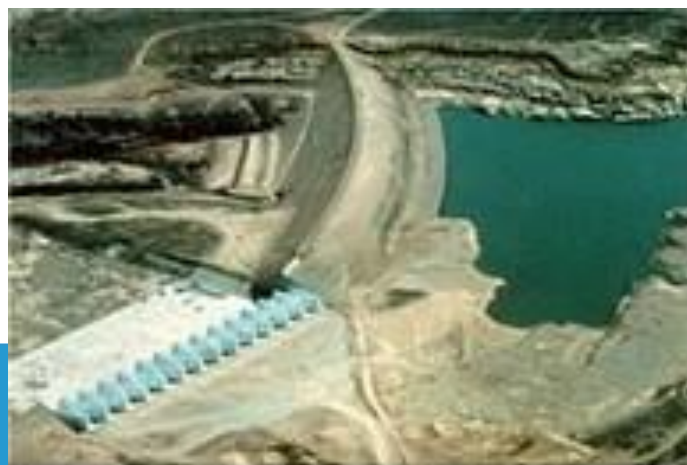
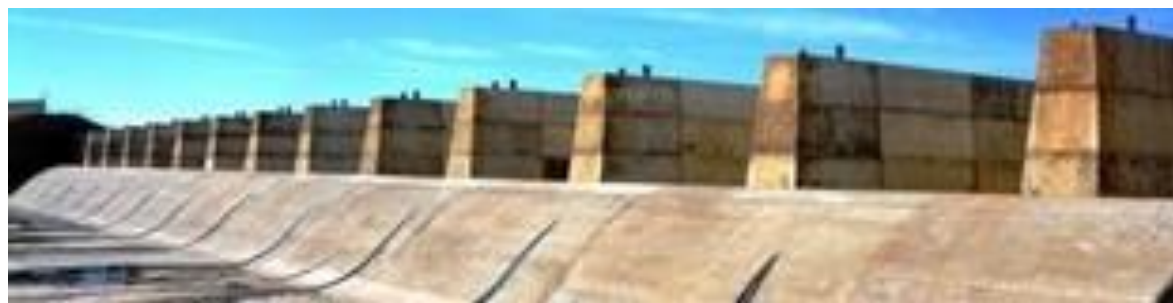
The original structure consisted of an embankment main dam, an ungated ogee-type concrete spillway located to the left of the main dam; and an embankment dike located to the left of the spillway. The dam did not provide sufficient storage capacity to permit use of its full storage allotment

Ute Dam was well suited for a labyrinth spillway in that the dam's approach flow is parallel to the spillway center line; this configuration is required for greatest efficiency of a labyrinth spillway. This cantilever-type free overflow structure can provide reservoir storage capacity of a standard spillway economically without the necessity of manual or mechanical operation.

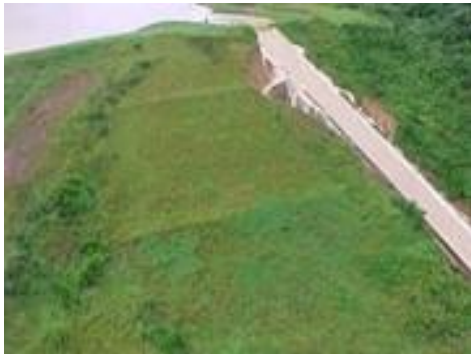
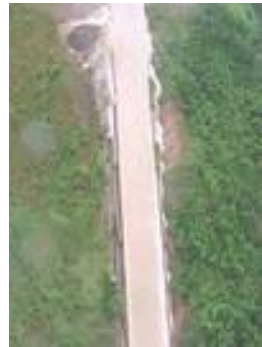
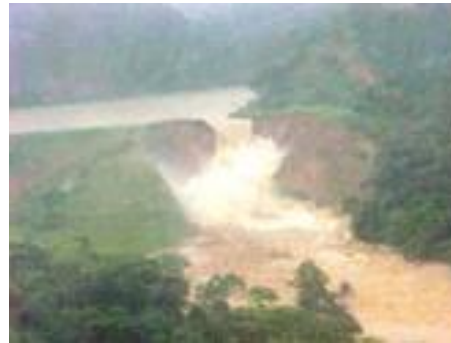
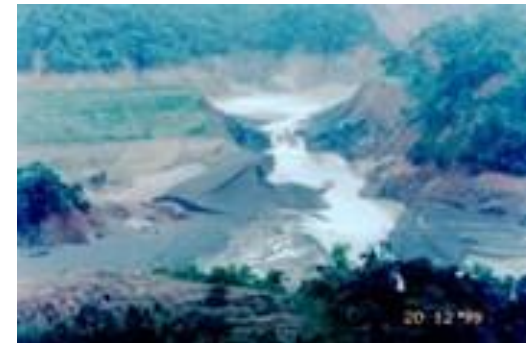
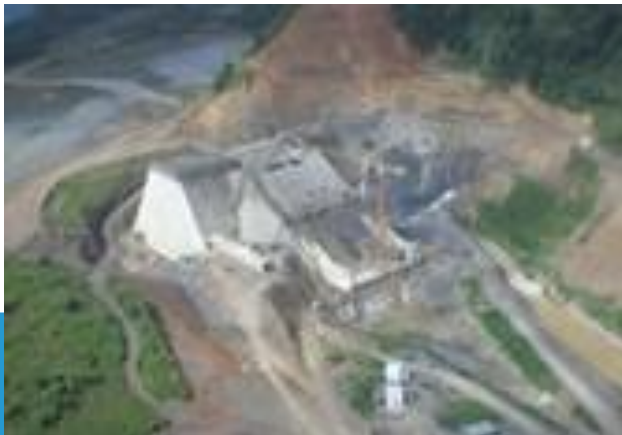
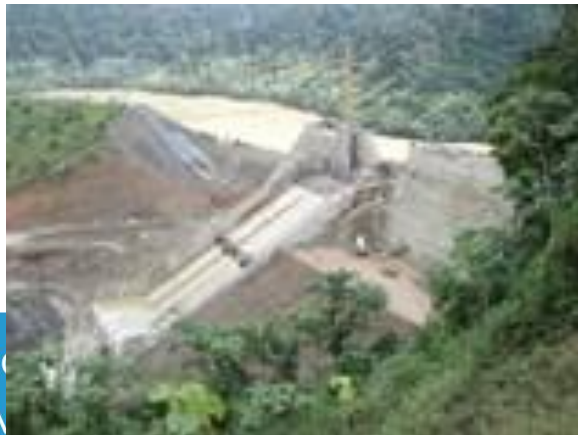
El Guapo dam reservoir was at his peak when he received the flood waters that could not contain due to its great magnitude and occurred a rupture. A new RCC concrete spillway was constructed and the embankment was repaired.

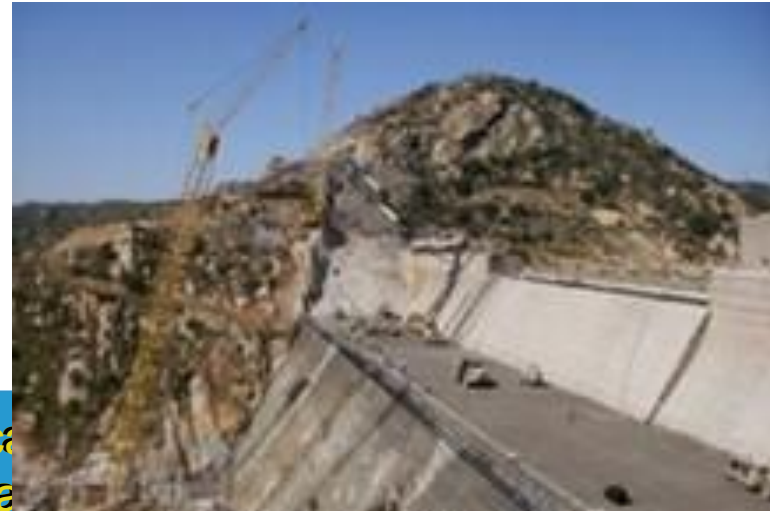
In June 2009, construction to raise the height of the dam by 36 m, in order to more than double its reservoir size, commenced. It is the largest dam raise in the United States and largest RCC dam raise in the world. The dam raise project was completed in early 2014

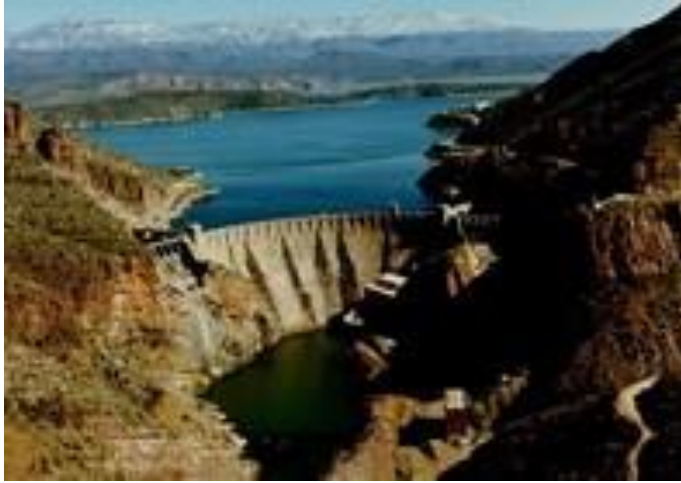
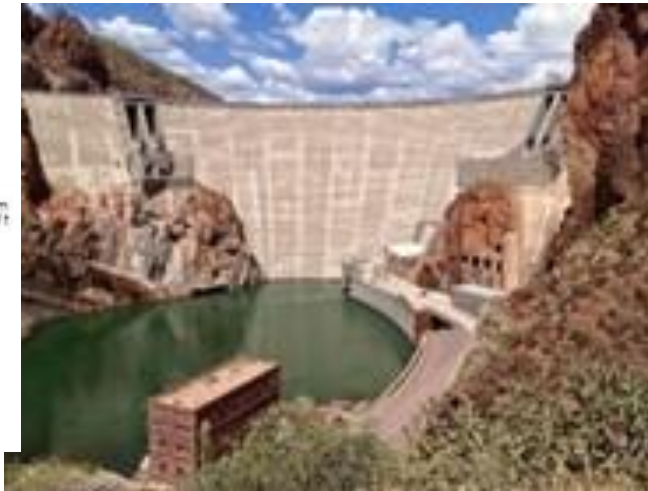
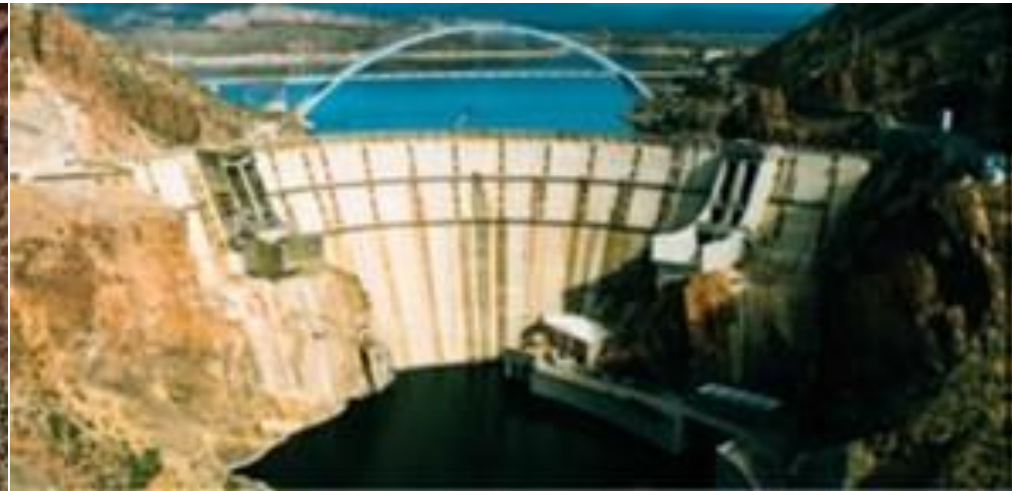
The dam power plant was modified to enable its operation under higher reservoir heads and tailwater.

Before beginning concrete placement, workers cleaned the existing masonry surface by removing all loose, chipped material and then waterblasting the surface. The concrete blocks were then constructed on the downstream face of the dam.

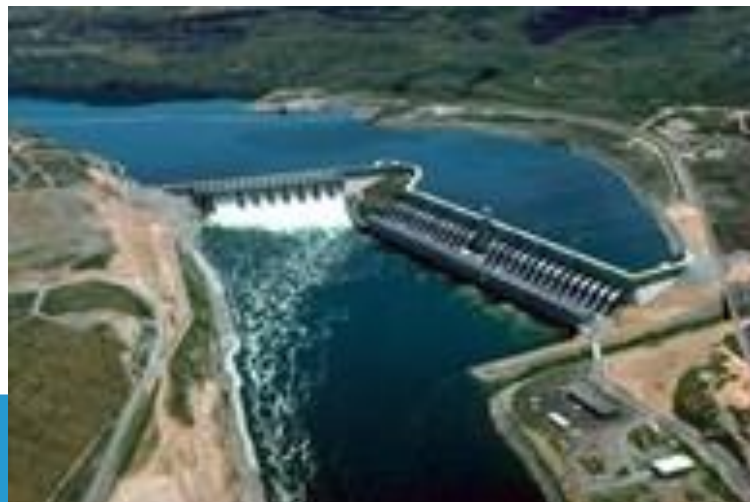
| CASE | IDENTIFICATION | COUNTRY | FINISHED | REHABILITATION/<br>REPAIR | REFERENCES |
|---|---|---|---|---|---|
| 28 | Chief Joseph Dam | USA | 1950 | 1981 | [46; 47] |

The dam was modified to increase hydropower production. Modifications included raising the height of the dam by 3 m, and installing of 11 generating units in the powerhouse to bring the total to 27 as per the original plan. This work had to be done without interruption of power production or the flow of the Columbia River. To solve this problem, engineers decided to use floating cofferdams that would allow several spillway bays to be dewatered at one time without the reservoir having to be lowered. Removal of the reinforced concrete required some experimentation. All repairs were performed underwater.

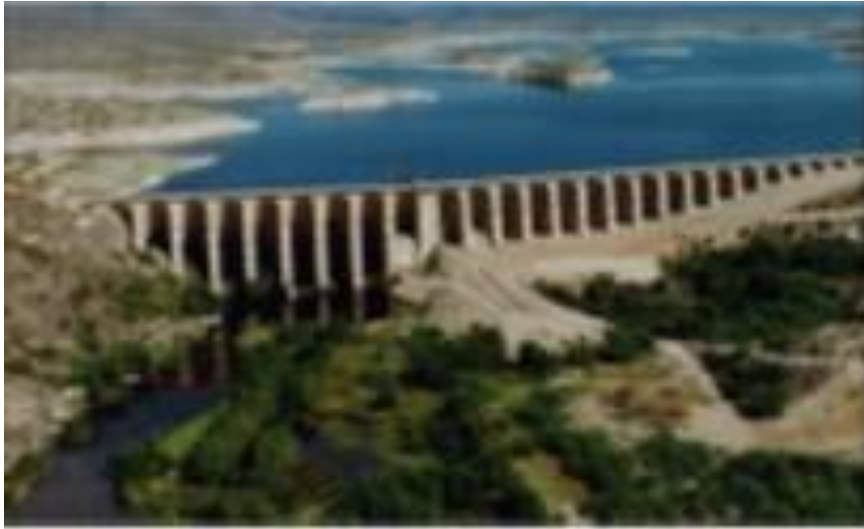
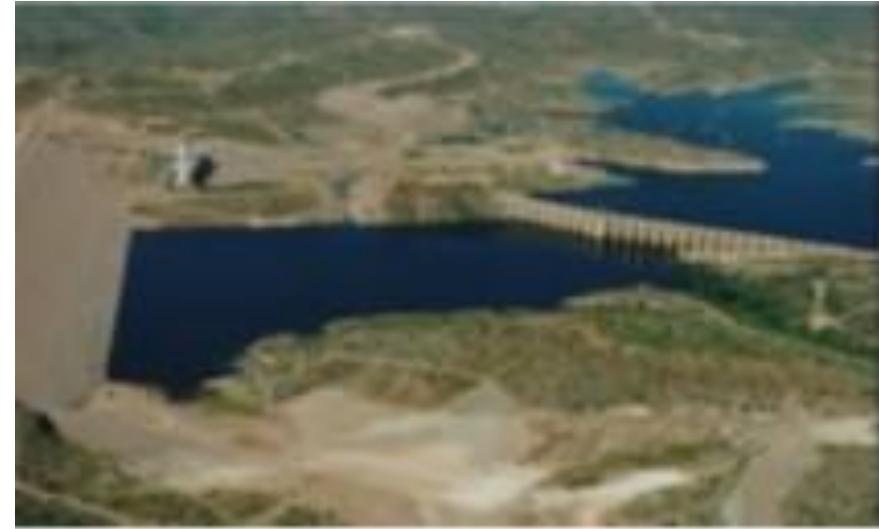
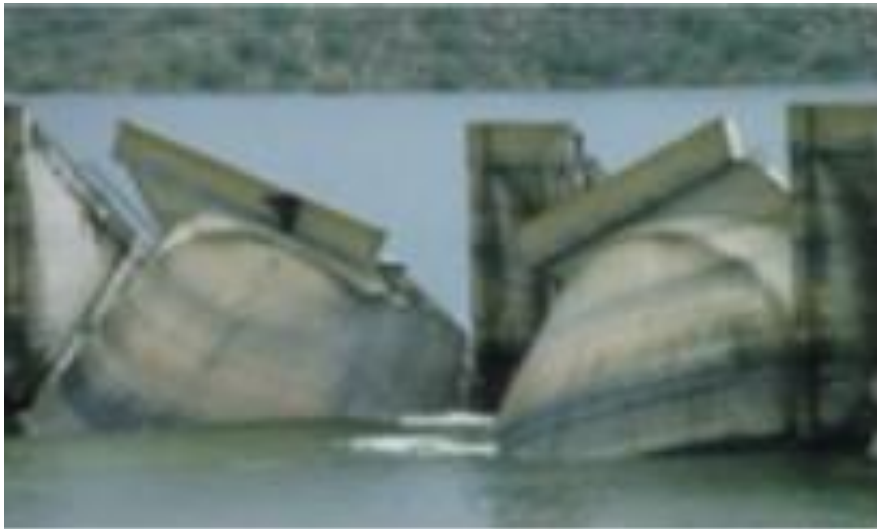
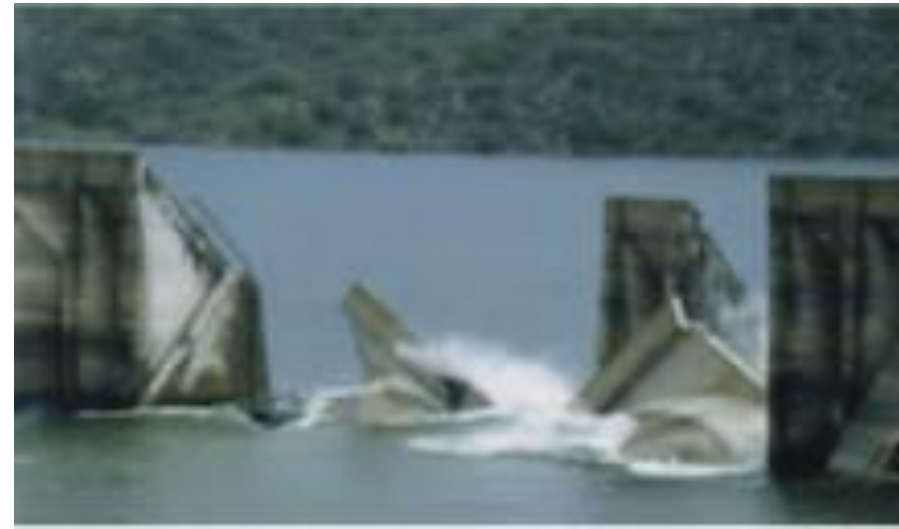
| CASE | IDENTIFICATION | COUNTRY | FINISHED | REHABILITATION/<br>REPAIR | REFERENCES |
|---|---|---|---|---|---|
| 29 | Waddell Dam | USA | 1926 | 1993 | [48] |

Waddell Dam is a concrete multiple arch dam that was constructed during 1924 through 1926. It's function has been replaced by New Waddell Dam, a 104m high rockfill embankment dam, which is located about 0.8 km downstream of Waddell Dam, and which will inundate the old dam.

It was required that Waddell Dam be breached to ensure access to the full reservoir pool at New Waddell Dam and to provide access for boat traffic to a marina located between the two dams. It was decided to create a channel through the existing dam that would be large enough to pass flood flows with minimum restriction and would also be large enough and deep enough to allow for boat traffic at minimum reservoir level. The required breach through the dam was 68-m wide and 21-m deep.

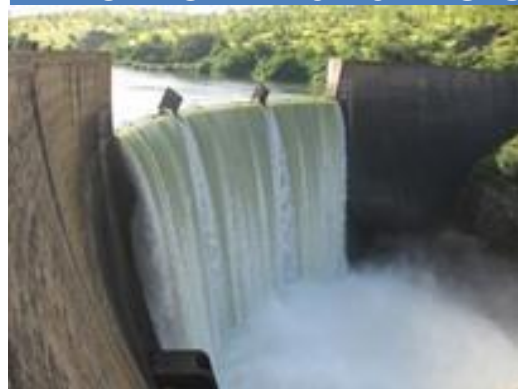
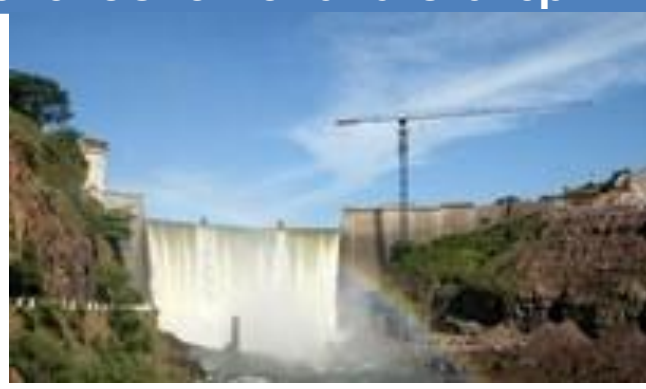
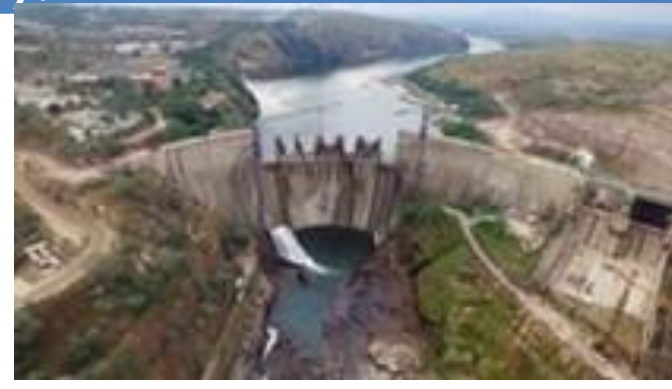
The Cambambe Dam rehabilitation and expansion project forms an integral part of a program that comprises three phases:

- Phase 1: Rehabilitation of the four existing turbine generators that was currently not operational;
- Phase 2: Construction of a second powerhouse with four additional turbine generators, with 700 MW in total, and;
- Phase 3: Heightening of the dam crest elevation by 30 m to the total height of 132 m and the construction of a lateral spillway.

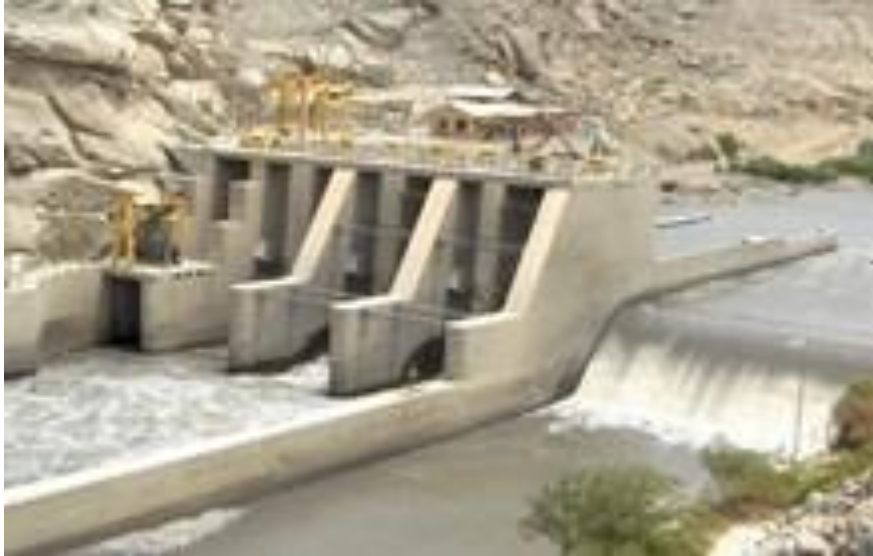
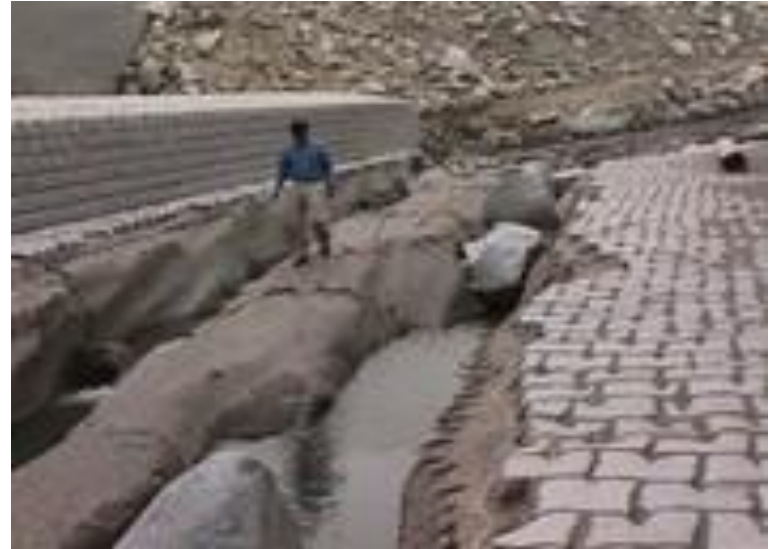
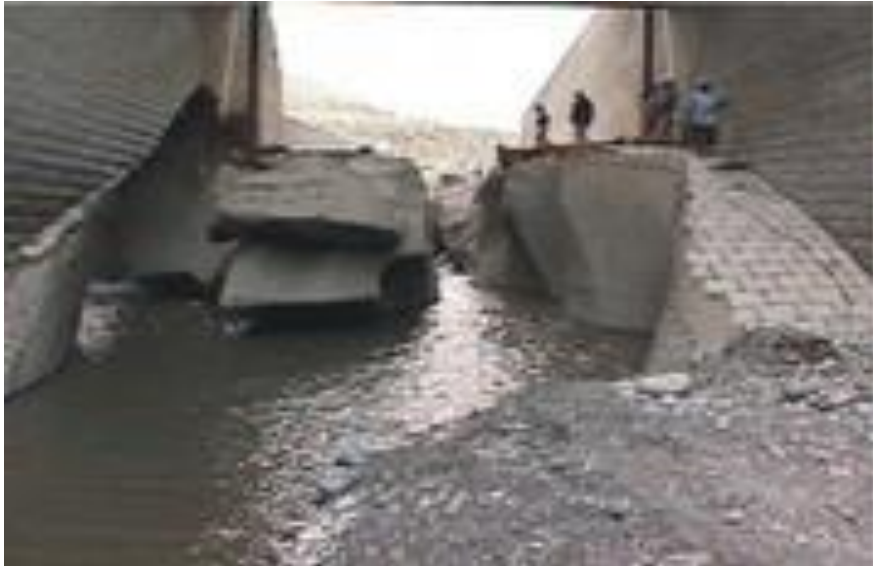
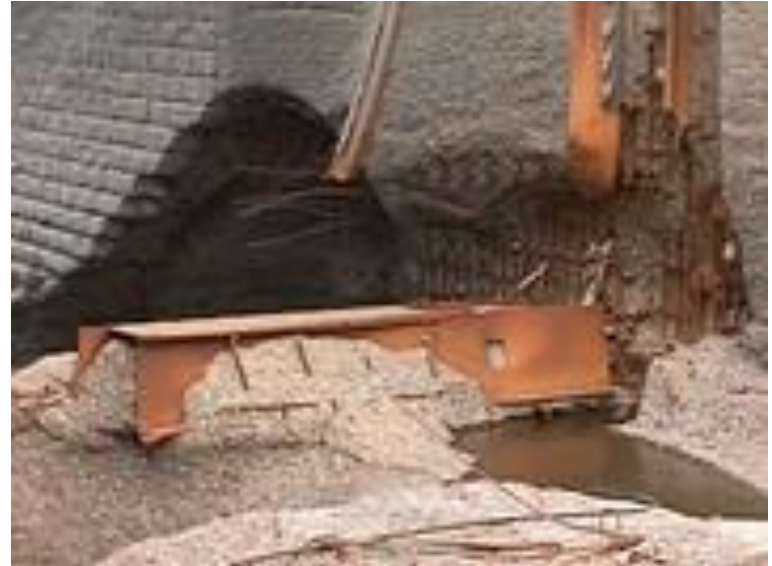
| CASE | IDENTIFICATION | COUNTRY | FINISHED | REHABILITATION<br>/ REPAIR | REFERENCES |
|---|---|---|---|---|---|
| 31 | Chavimochic Dam | Peru | 1993 | 2000 | [50] |

During the rainy period of 1993/1994, which was characterised by being for long periods, flows of the order of 300 to 400 m<sup>3</sup>/s, besides the three floodgates remain open for long time, on the basis of works to be carried out within the water intake spillway.

As a consequence, there was an intense erosion on the pillar between the 2 gates 1 and 2, function of the impact of sediment in high speed and Increased the effect of the abrasion caused by the action of the vortices who graduated from your base, These efforts provoked a cesspool deep around the base of the pillar, which stretched to downstream in the greater inclination of the profile of the Spillways 1 and 2 causing wear and removal of protective coating This protection was done with plates of 0.40 x 0, 40 x 0, 20 m high granite abrasion resistance.

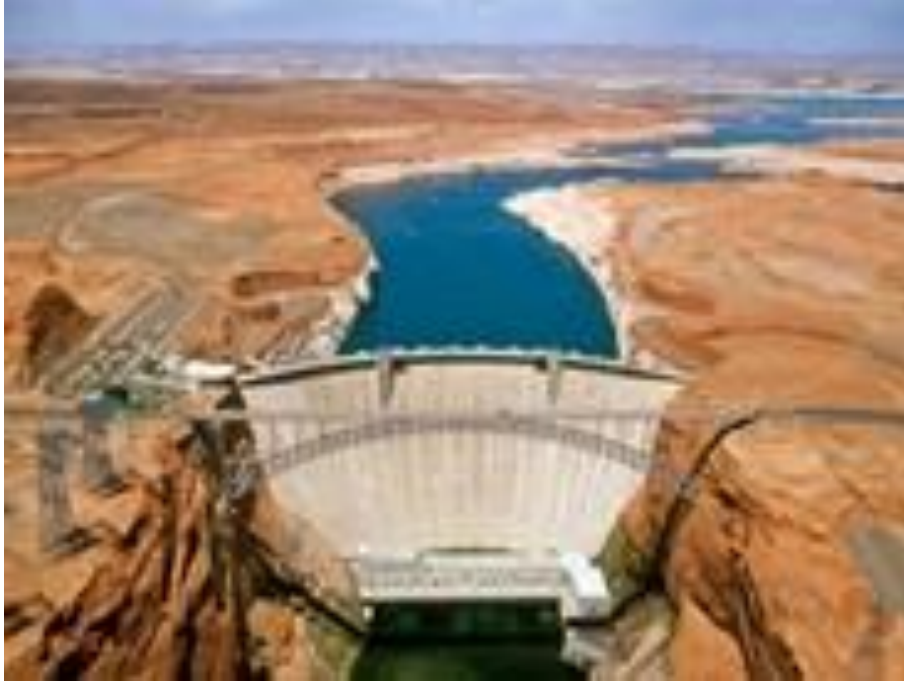
An inspection of the tunnels following the test revealed minor cavitation damage to the liners. Vapor cavities occur in a liquid when water pressure in a high-velocity flow is reduced by an irregularity in the flow surface. As these cavities move into a zone of higher pressure, they collapse, sending out high-pressure shock waves that cause cavitation.

After analyzing the spillway flow, BuRec staff members decided to construct an aeration slot in each tunnel. The aerators were located in the conical reducing section of the tunnel about one-half of the way down the tunnel between the intake and the vertical bend.

Repair work began with the removal of the entire tunnel lining, including sections that were not damaged, to improve safety, speed construction, and produce satisfactory, long-lasting results. Damaged and missing reinforcement was replaced. New reinforcement was manually welded to existing reinforcement in most cases. In areas where drainage water prevented welding, steel dowels were epoxied into drill holes in the liner and then wired to the existing reinforcing in a splicing technique.

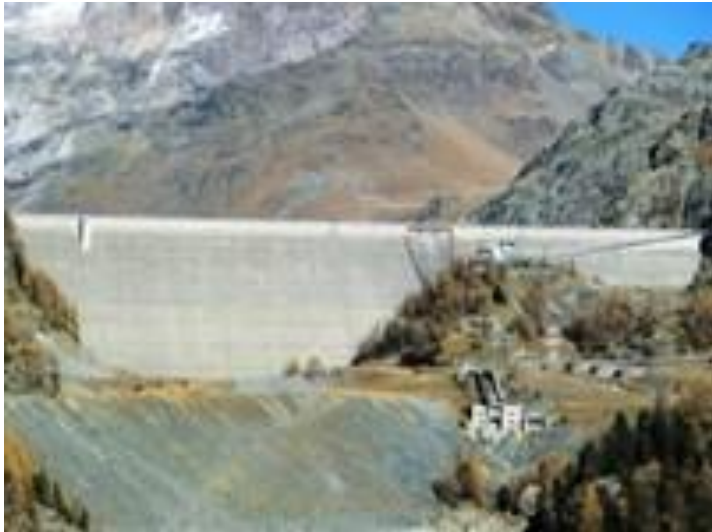
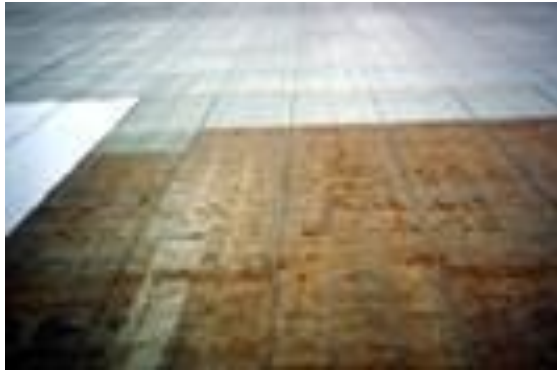
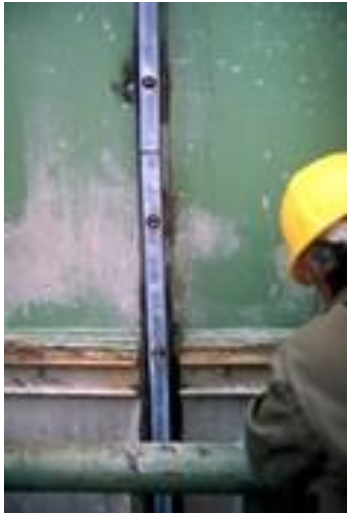
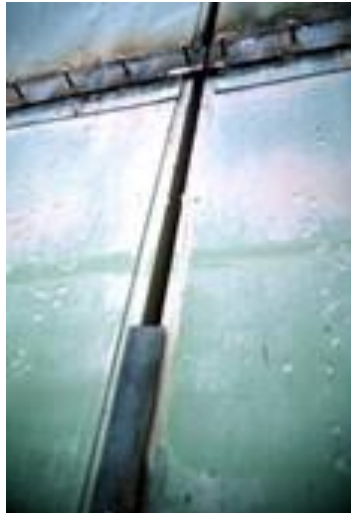
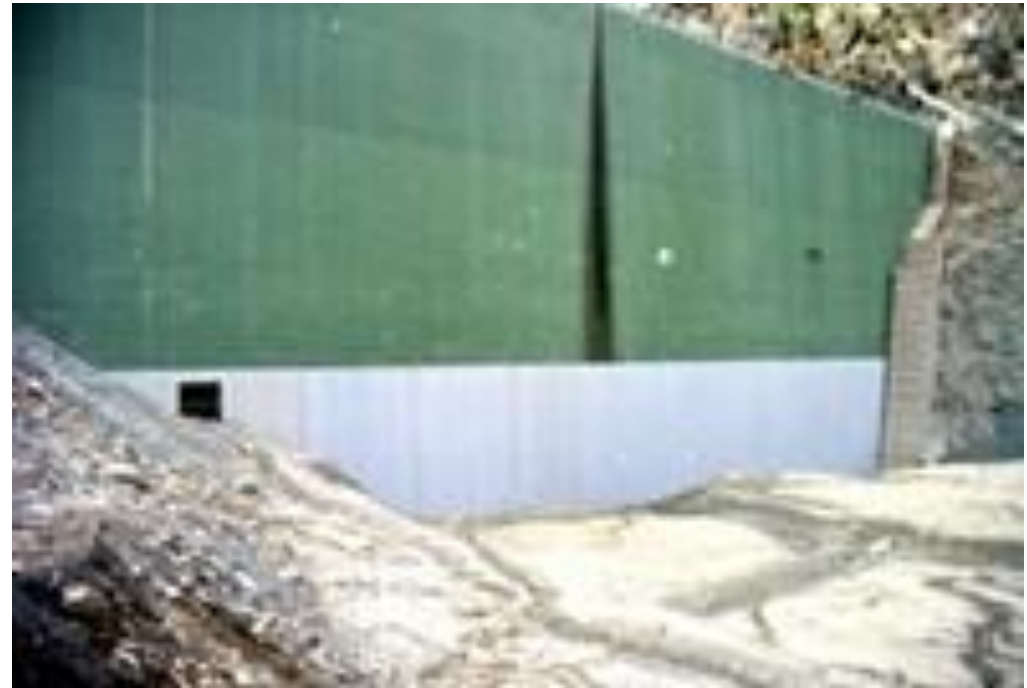
| CASE | IDENTIFICATION | COUNTRY | FINISHED | REHABILITATION/<br>REPAIR | REFERENCES |
|---|---|---|---|---|---|
| 33 | Alpe Gera Dam | Italy | 1964 | 1994 | [22; 52] |

Most of the corrosion of the steel lining occurred in this lower area. Leakage increased to more than 50 l/s. A drained PVC geomembrane was adopted to protect the corroded steel facing. Steel patches were installed as anti-intrusion supports to the PVC geomembrane over the numerous holes formed in the steel.

The amount of water leaking from the area covered with PVC was reduced to practically zero.

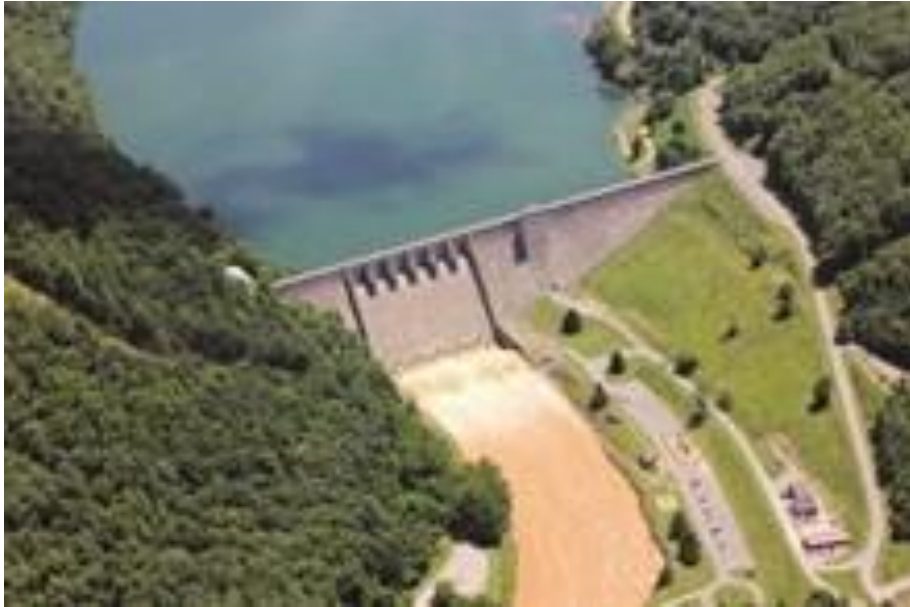
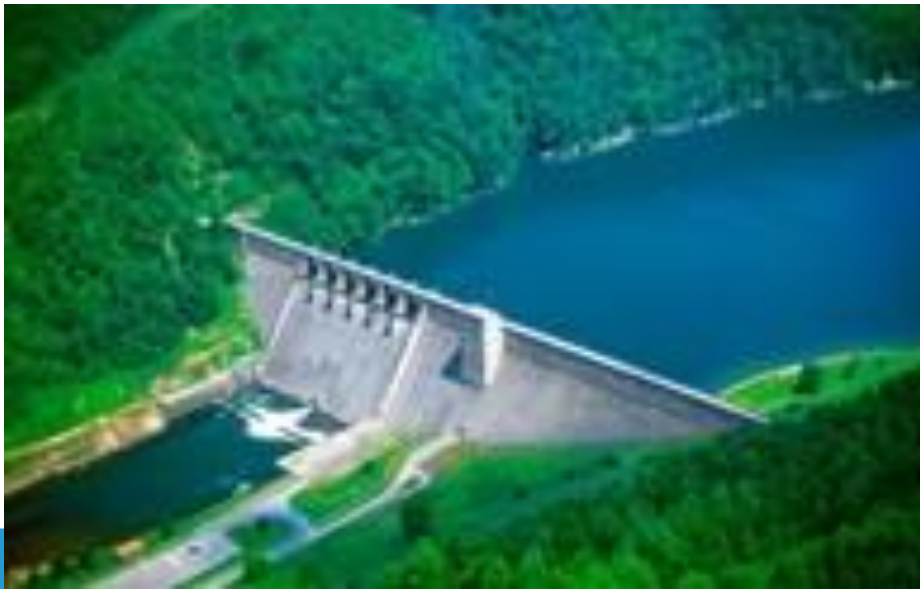
| CASE | IDENTIFICATION | COUNTRY | FINISHED | REHABILITATION/<br>REPAIR | REFERENCES |
|---|---|---|---|---|---|
| 34 | Sutton Dam | USA | 1961 | 1980 | [53; 54; 55] |

The obvious solution to the problem of downstream water temperature and turbidity was to relocate the intake to permit the outflow of warmer, less turbid water from the highest stratum of the reservoir. Making this change required the construction of a high-level intake connected to one of the sluices of the dam. An inlet-with-bulkhead was installed below the top of the structure to permit the passage of water during low lake levels.

Finally, the top of the structure was capped with concrete. The concrete cap would improve flow, provide support for the trashrack, and provide an aesthetically finished appearance.

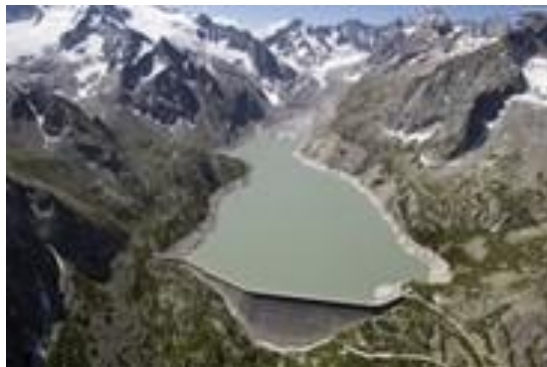
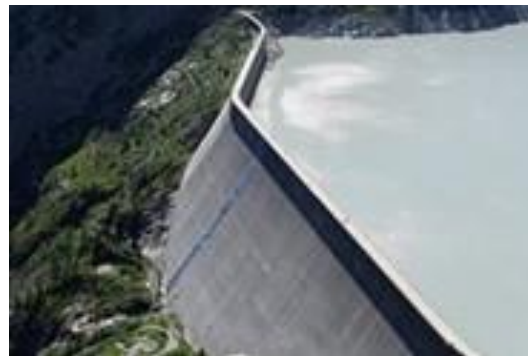
During an investigations an open joint was detected along the upstream heel of the dam, extended over a length of 300 m with a width locally up to 8 mm. It became clear that the crack completely crossed the grout curtain. As a first measure in 1977 the water level was lowered immediately.

To repair the dam it was necessary to reduce the water pressure in the fracture opening. Grouting would not have been effective since, as previously mentioned, the rock valley deforms at every change of the reservoir water level.
