Structural analysis and rehabilitation  
of concrete dams and spillways

# **HISTORIC CASES ON CONCRETE DAMS REHABILITATION**

Third International  
Dam World Conference

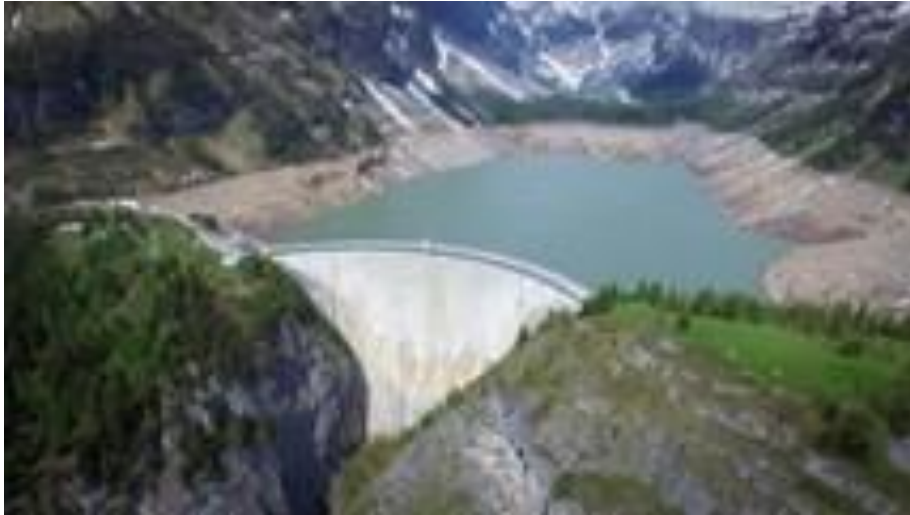
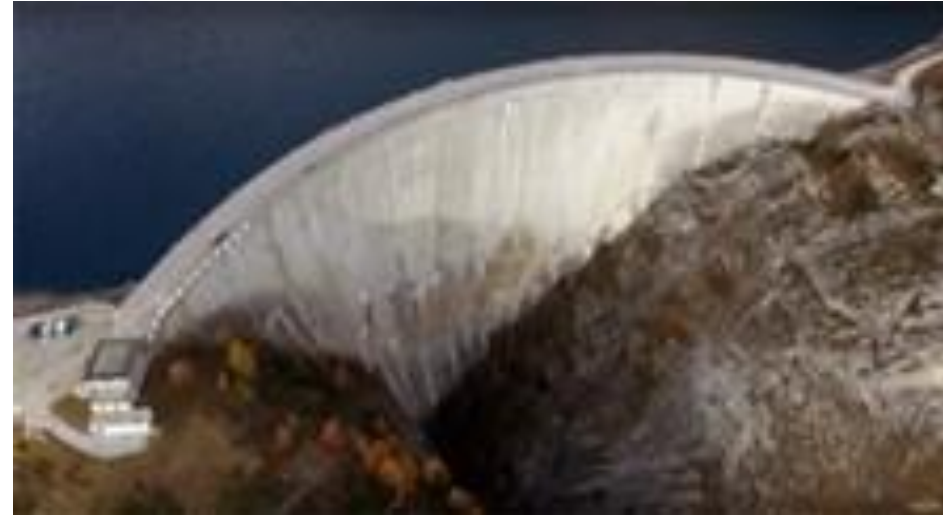
Fig. 3.2.2

At the end of 1978, after more than 20 years of trouble free operation, abnormal deformations were detected during the regular inspection of the dam. Although the deficiencies originated in the rock mass of the foundation, they affected the dam body itself. They increased for two years, until May 1980 and then tended to slow down. Finally they almost stopped. In comparison to the geodetic measurements made in 1976, a settlement of 100 mm and an upstream displacement of 90 mm were observed at crest level, as well as a 60 mm shortening of the distance between the abutments of the crest arch. Owing to these deformations, some of the vertical contraction joints in the upper part of the upstream face opened and cracks developed along the downstream toe. The major cracks are located mainly in the lower third of the dam and along the foundation. Other cracks also appeared in the inspection galleries and shafts.

A program was established for examination of the condition of the dam and its foundations and for evaluation of methods suitable for repairing the damage to it. Three zones were defined: grout curtain, abutment and dam body.

Zetter Dam Longitudinal section

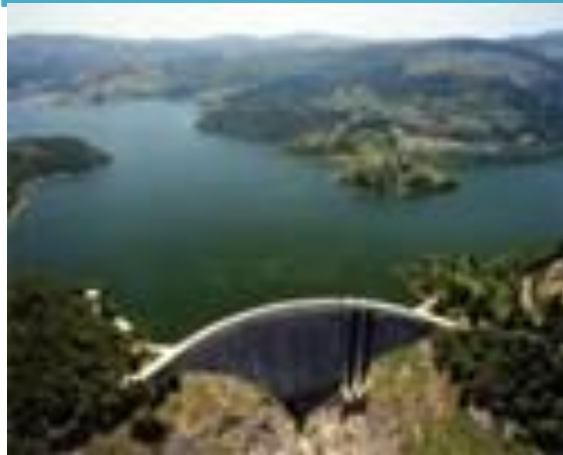
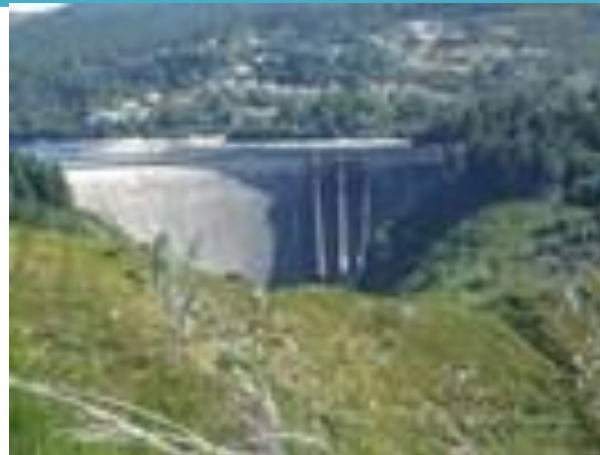
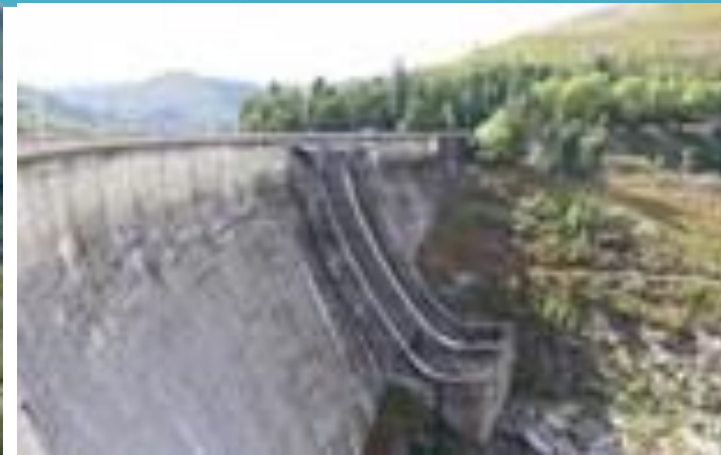
A monitoring system installed in the dam showed the seepage remaining and the uplift pressure increasing. This was due to the opening of faults and sub-horizontal joints at the left bank and valley bottom. It was accompanied by washing out and the dissolution of filling materials. Repair work was carried out to improve the hydraulic behavior of the foundation. This aimed at improving the strength and watertightness at the lower zone of the foundation rock mass

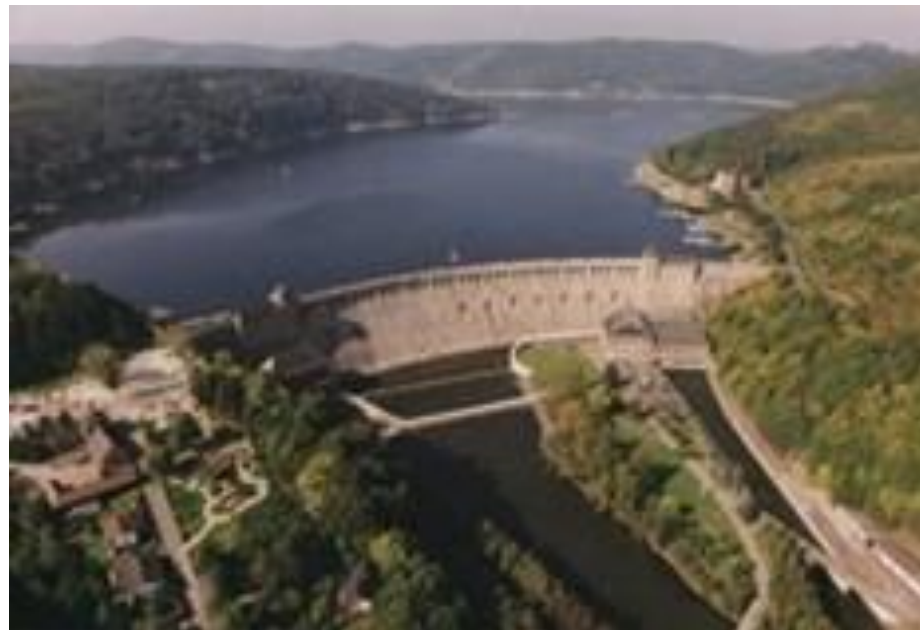
To improve the stability of the dam, a drainage gallery was excavated at the bottom of the dam, to reduce the uplift pressure. After some years it was observed that joint filling material was transported to the gallery, increasing the permeability of the rock below the dam. Additional calculations proved the dam to be stable with the gallery flooded from the downstream side and the gallery has been allowed to fill, preventing further erosion.

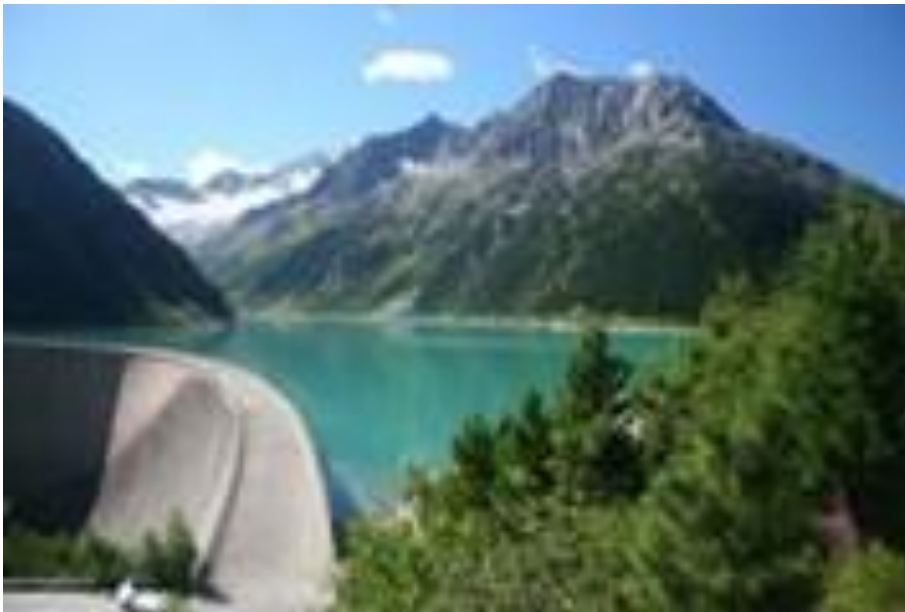
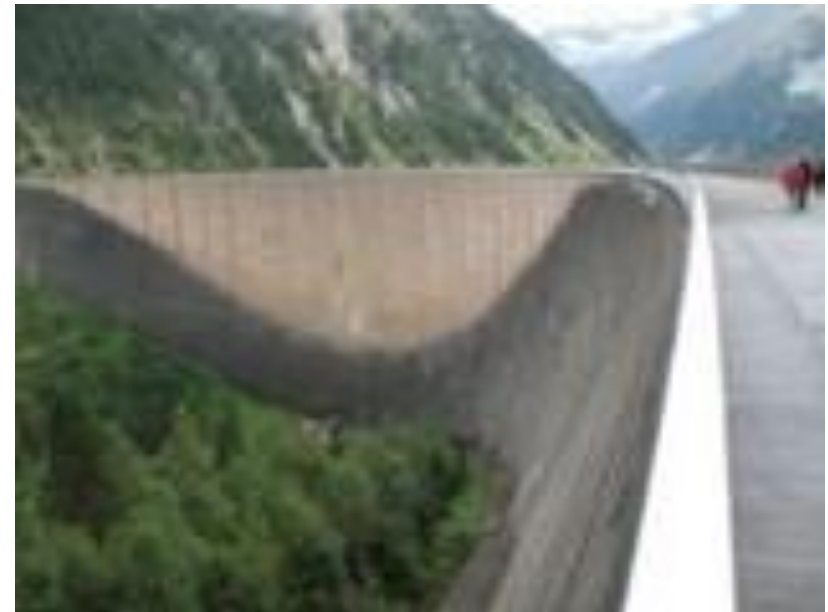
The volume of seepage water emerging in the inspection gallery at the dam base increased markedly during the final stage of reservoir filling. Ninety percent of the seepage was concentrated over a 150 m length of the foundation. Investigations showed that the grout curtain, situated between the upstream toe and the inspection gallery, was cracked due to tension. Cracked grout curtain repaired with a new 5m deep cut off wall.

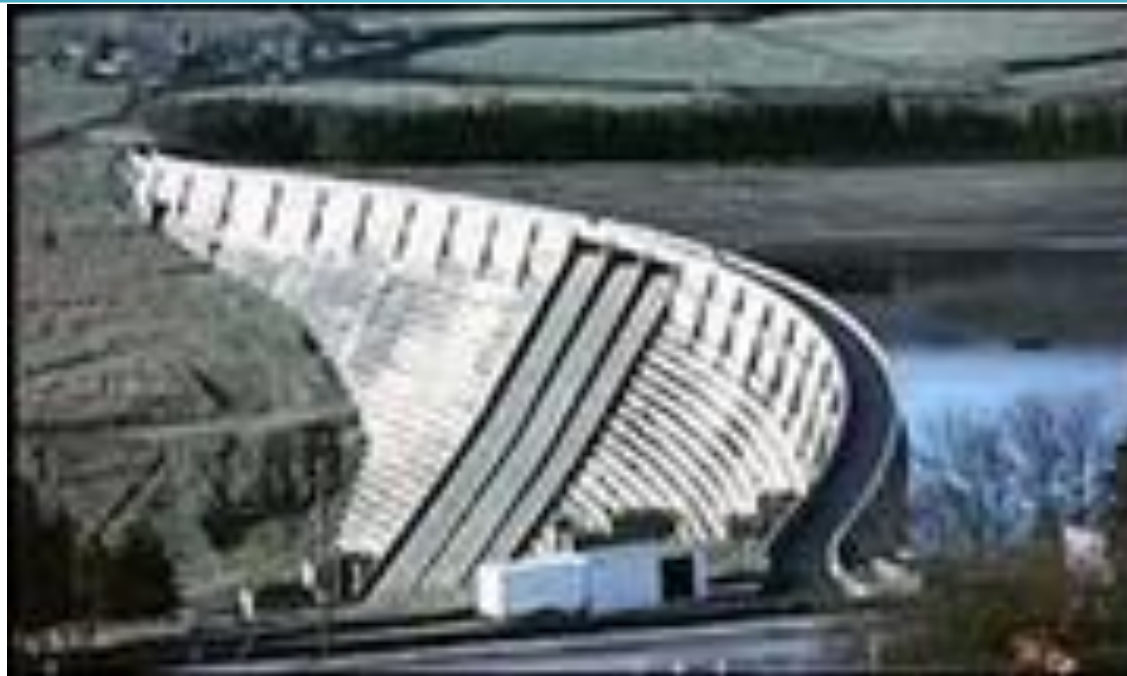
It was required that choked pressure relief holes should be cleared and if this could not be achieved, they should be replaced. A shrinkage crack should stay under regular observation. Nine new vertical pressure relief holes were drilled from the lowest gallery into the foundation rock

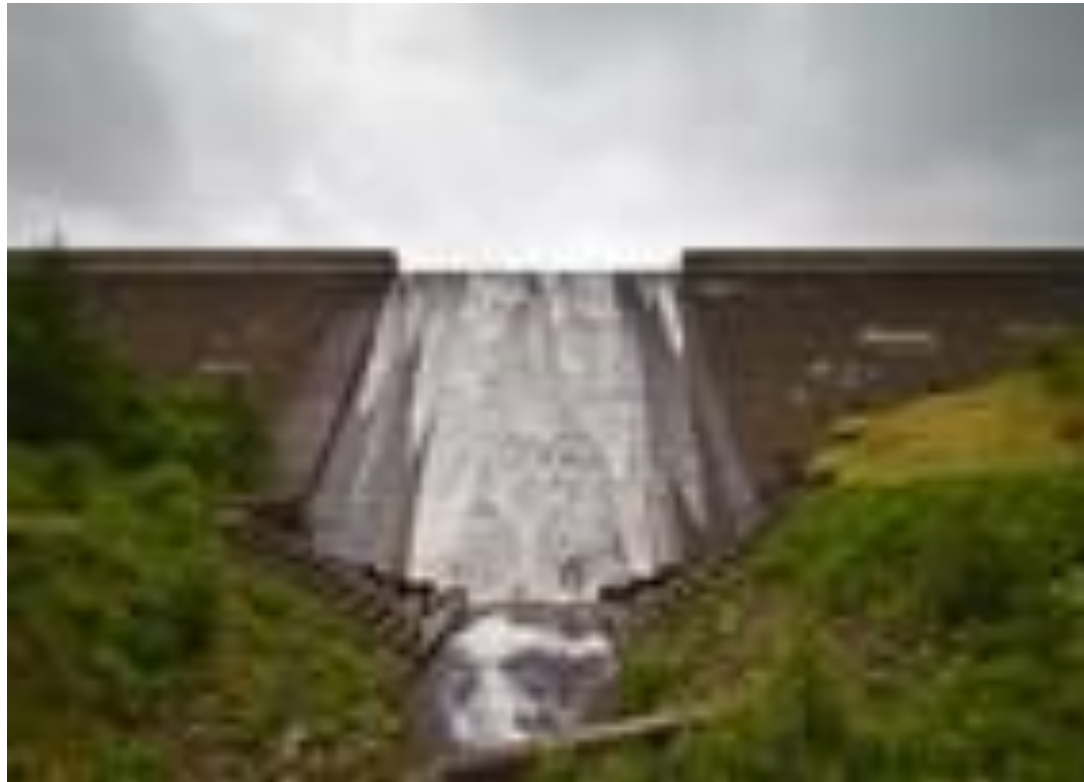
A shrinkage crack should stay under regular observation. Pressure relief holes were drilled from the lowest gallery into the foundation rock

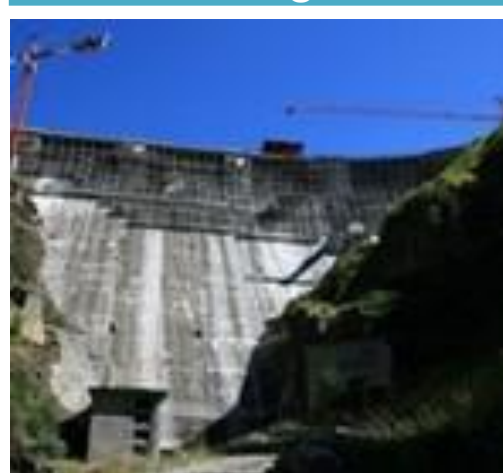
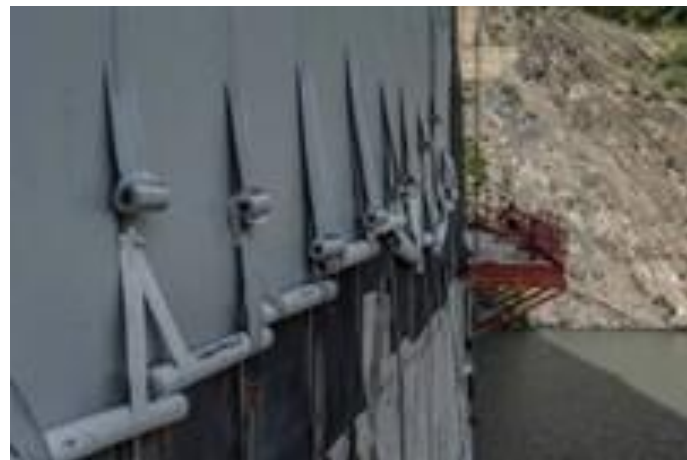
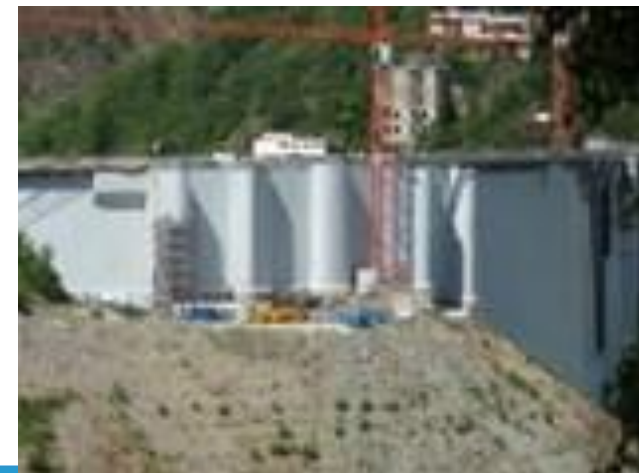
The dam is affected by ASR swelling which has lead to progressive cracking and irreversible strains. The swelling had the effect of producing a 120 mm deformation upstream and an increase in height of 70 mm over 25 years.

After a program of grouting and the application of an upstream impermeable membrane to reduce the volume of water feeding the reaction. It was sawed 11 mm wide slots through the dam to relieve the compression within the upper 20 m of the dam and to relieve the left abutment of the heavy thrust of the swelling concrete. After sawing and before refilling the reservoir, the upstream watertight membrane was restored.

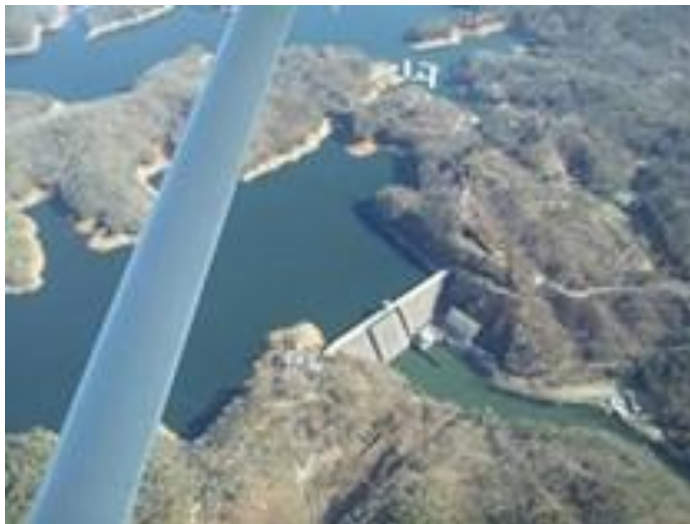
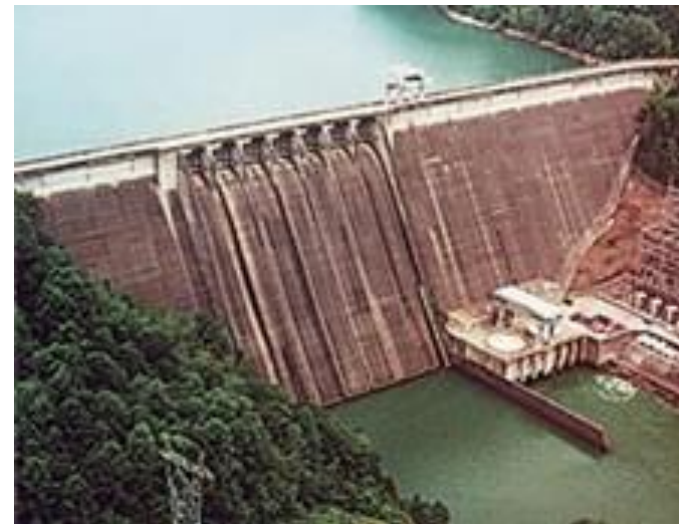
Expansion of the concrete was caused by AAR- alkali aggregate reaction resulting in high stresses and deflections in the dam. The nonoverflow sections were post-tensioned using high-strength multi-strand tendons. Two 12 mm slots 15 m deep were cut. Other modifications that are required to correct the AAR growth problems include recutting of closing slots, instrumentation for monitoring the slot behavior, and permanent monitoring. Over the years various types of remedial action have been undertaken, including the cutting of slots and the installation of post tensioned anchors on the spillway piers.

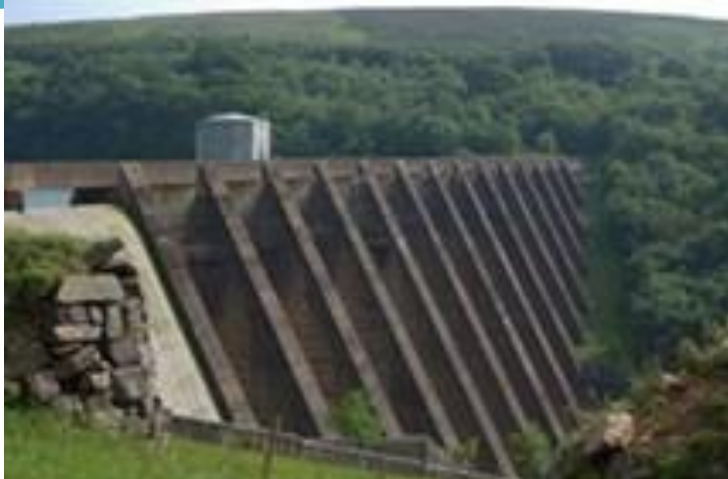
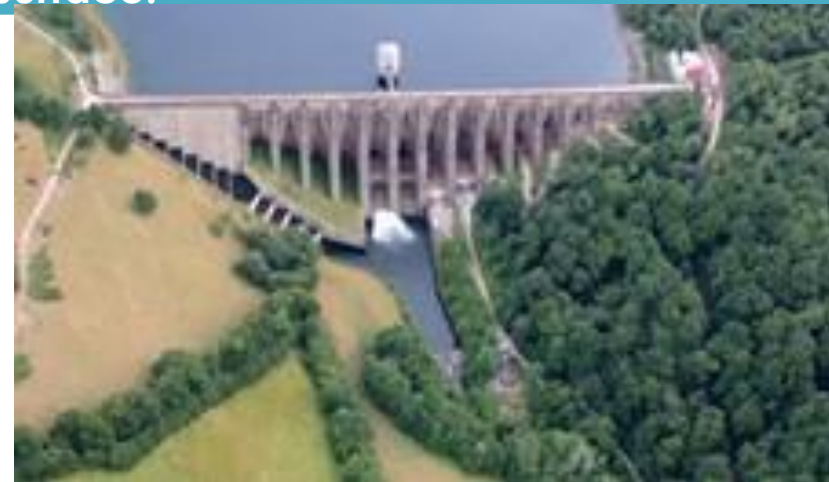
The concrete surface of the dam has suffered from spalling. Even towards the end of the construction of the dam, small pop-outs were observed on the inside concrete faces of the dam parapet walls. These were 10 mm in diameter with soft dark aggregate (pyrites-rich shale) exposed and a rust coloured stain below.

Thus the reinforced concrete valve tower and access bridge only need to be protected. The work involved breaking out all patches of soft or reactive aggregate near the surface and patching with a cementitious mortar, then coating the whole surface to reduce the quantity of oxygenated water penetrating the surface.

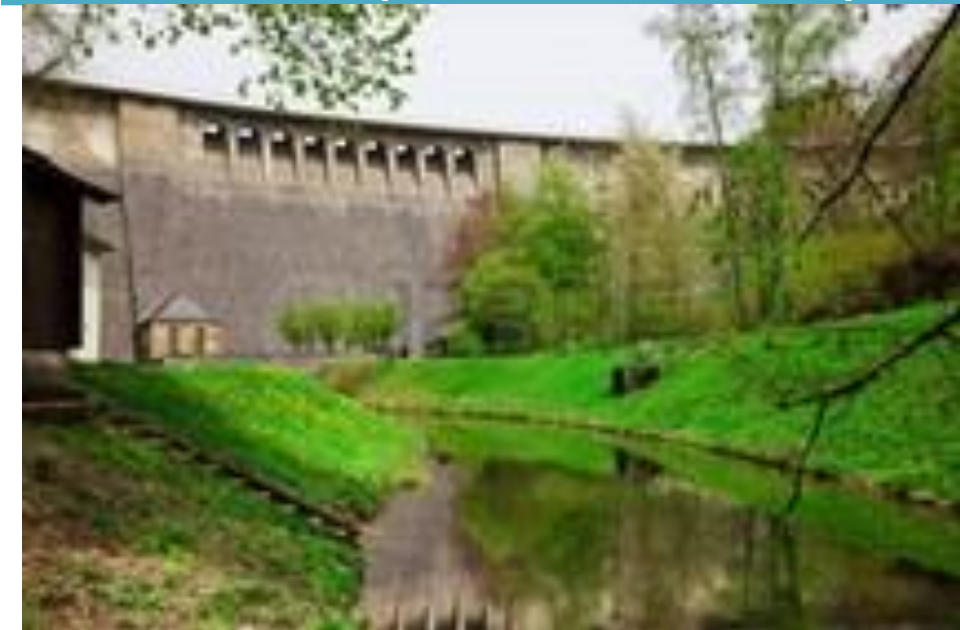
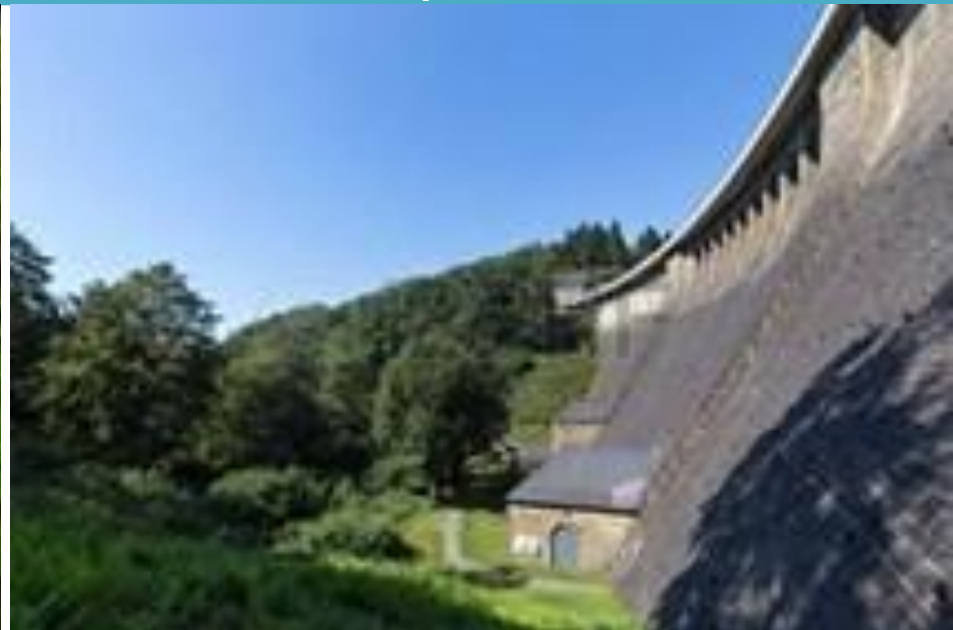
The upstream face of the dam was attacked severely by the water for a period of 40 years and considerable water losses due to seepage and finally required rehabilitation measures. This consisted of a complete renewal of the crest and sealing of the upstream face. The latter comprise a 120 mm asphaltic concrete seal behind a 280 mm reinforced, nearly vertical concrete protection wall fixed by anchors to the dam body.

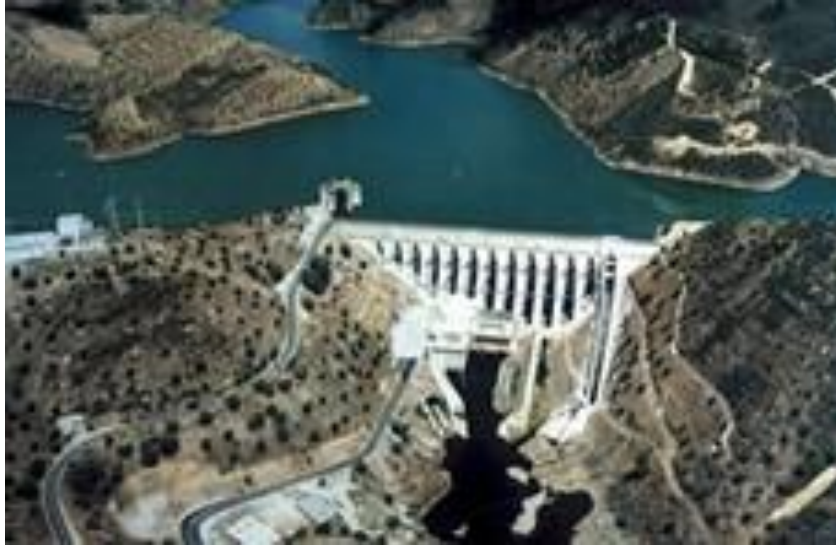
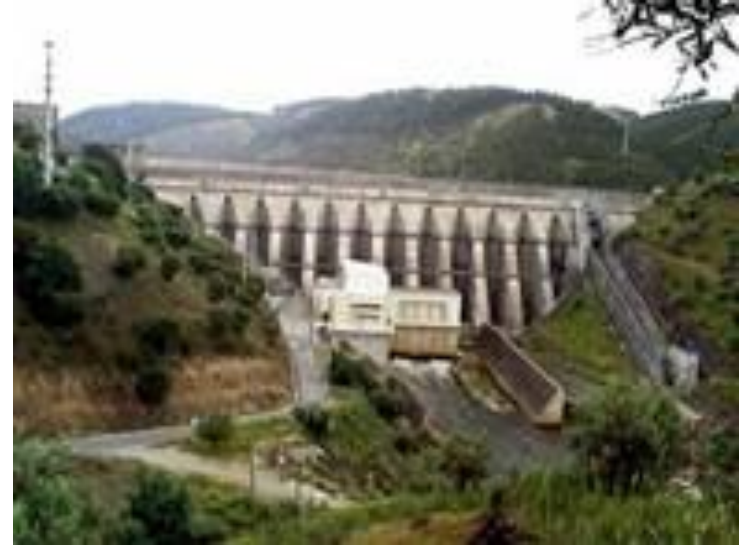
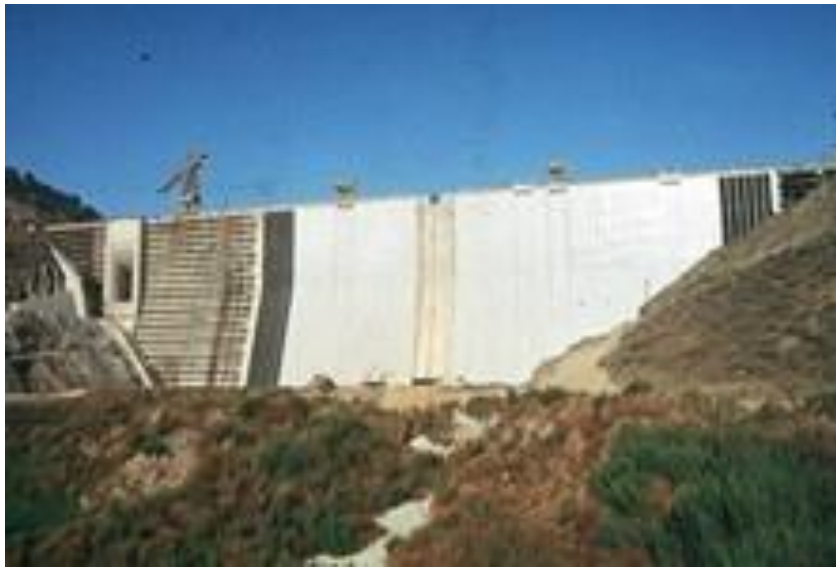
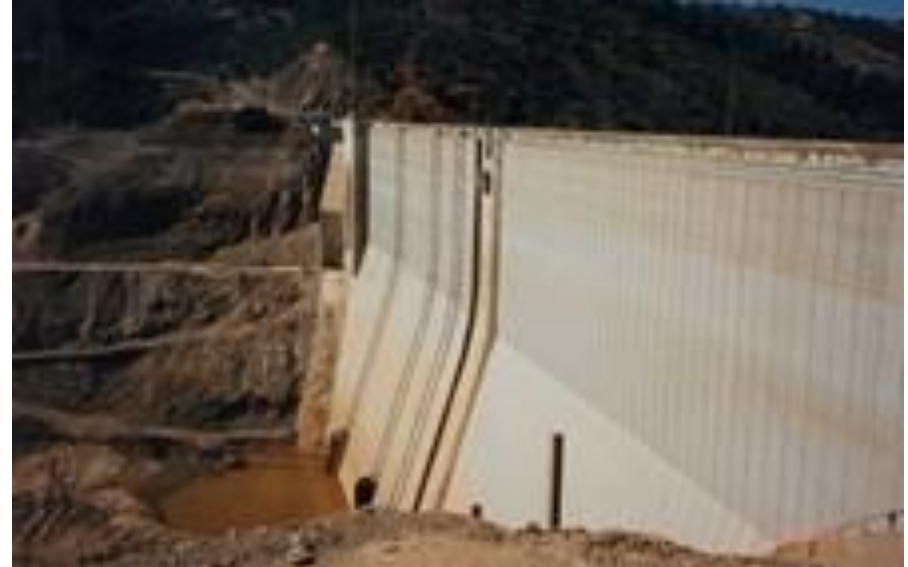
Pracana Dam shows extensive cracking, owing to an expansive process, during the initial 25 years of operation. Important repair works were developed including the treatment of the cracks by grouting using cement and epoxy resin. The joints between the diamond heads of the buttresses were treated as well and the upstream face was sealed with a PVC geomembrane. All the cracks were mapped and strengthened by grouting.

A new separate spillway and a new water intake were constructed. A drained PVC geomembrane was installed on the upstream face not only to inhibit the flow of water feeding the reaction but also to reduce the uplift pressure in the horizontal cracks in the dam body. The PVC membrane was connected to the new foundation plinth to achieve continuity between it and the new grout curtain.

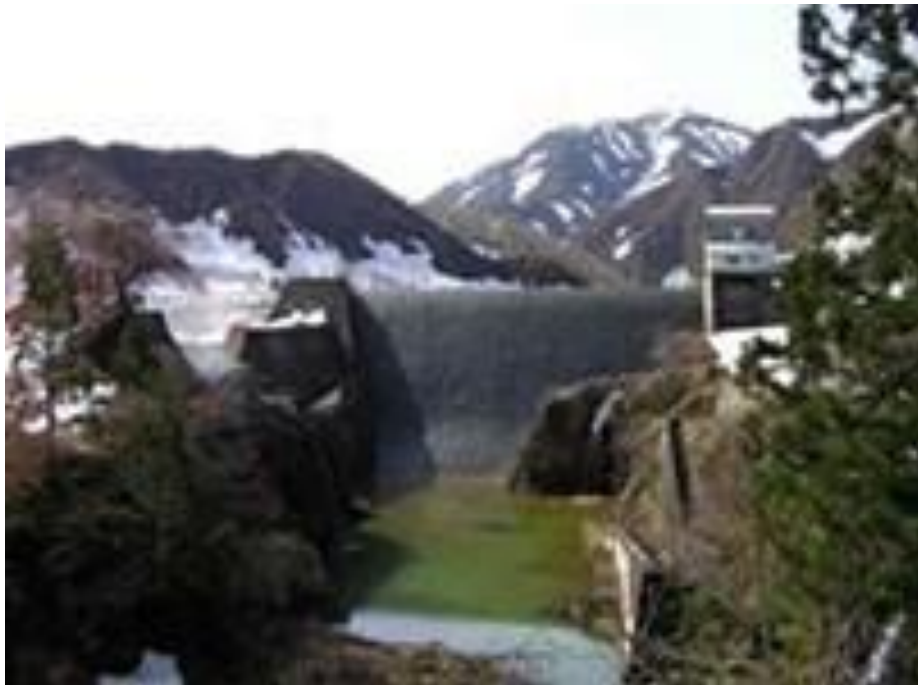
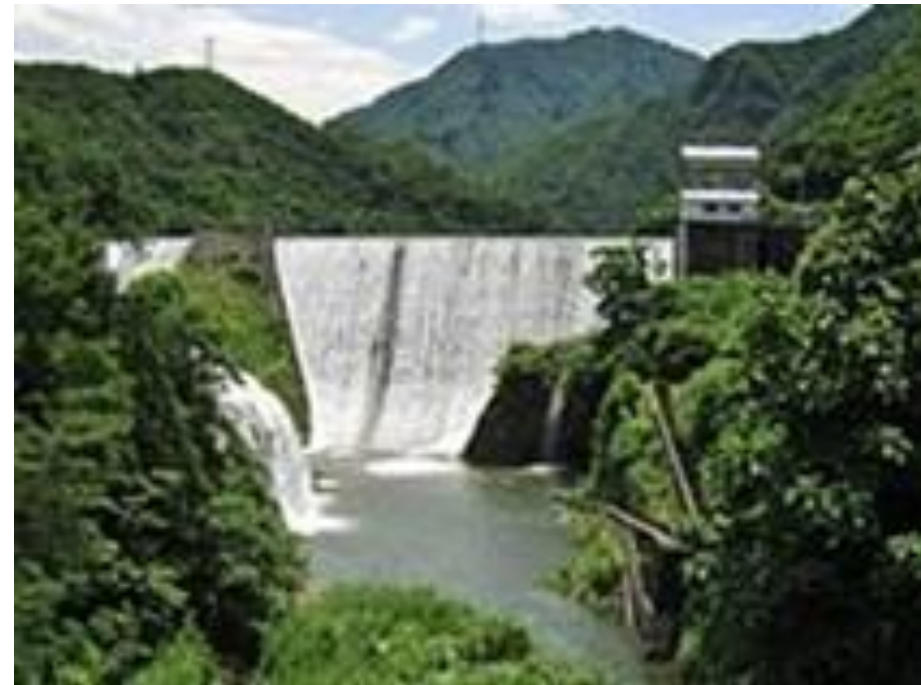
The dam had served for more than 50 years with a progressive deterioration, resulting in considerable leakage from the downstream surface of the dam. Therefore, grouting was applied to the dam body and its foundation rock to reduce their permeability to water.

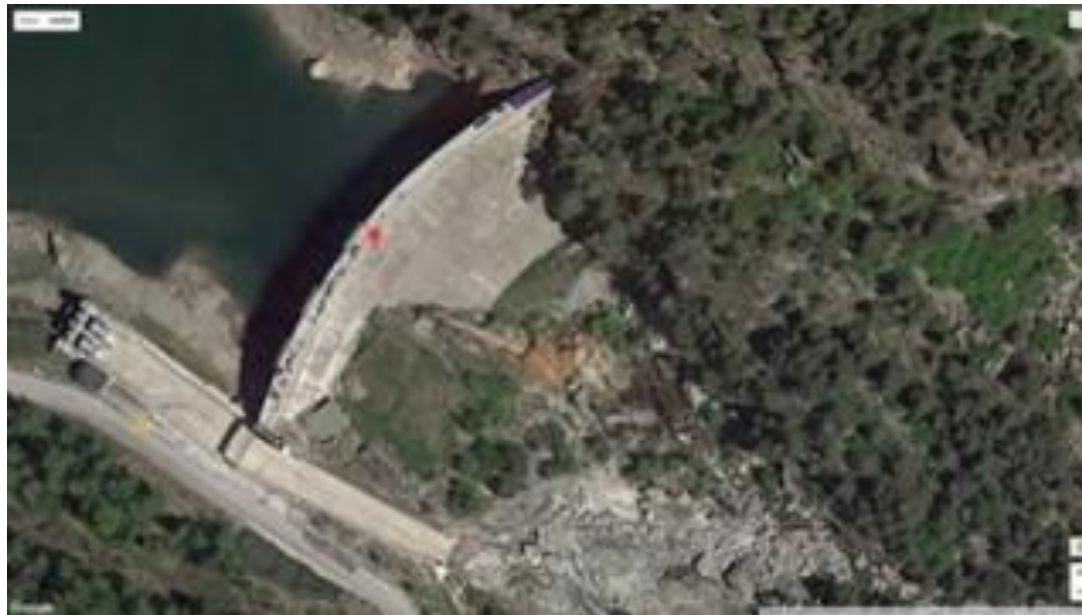
This masonry dam, built without any drainage devices, did not meet the current standards. Among others the seepage at the whole downstream face contributed to this judgement. To minimize seepage, a drainage gallery had been excavated in the foundation of the dam and a system of vertical drains installed from the crest to the gallery. Epoxy resin grouting has been performed over the lower third of the height and near the upstream face, and a grout curtain carried out from the upstream toe into the bedrock.

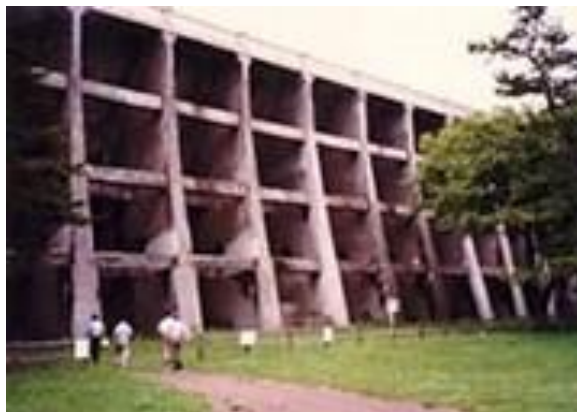
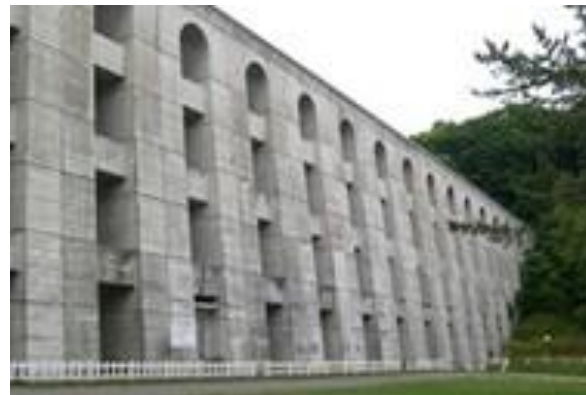
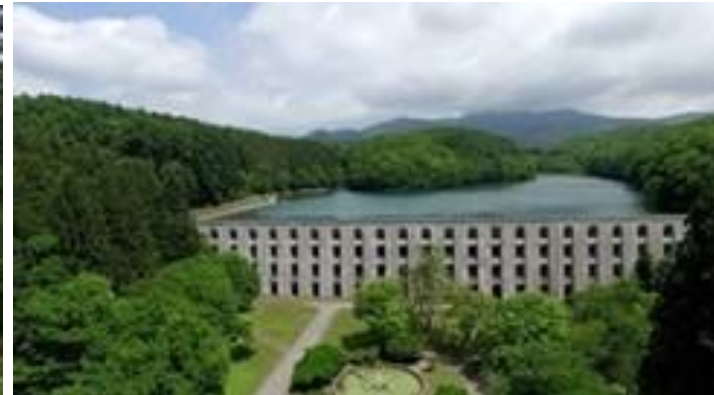
Deterioration occurred at all parts of the dam, particularly the buttresses and slabs. A preliminary repair was made but this only revealed temporary improvement to the extent that in 1965, concrete began to fall off from the surface of the dam. In 1983-1984, after a careful ageing survey, the buttresses were overlaid at both sides by 700 mm to 1100 mm thick concrete layers and the upstream slab by 300 mm to 700 mm thick concrete. The whole dam was overlaid by new concrete.

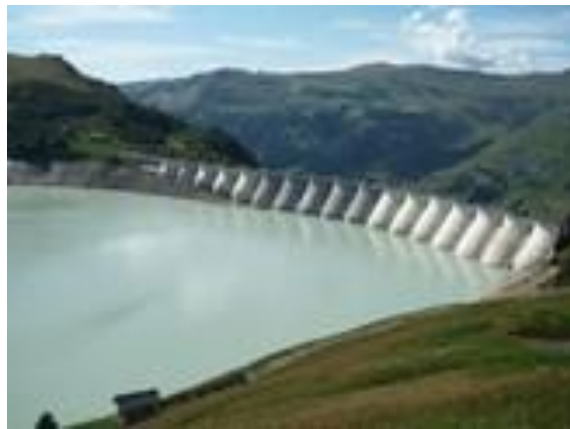
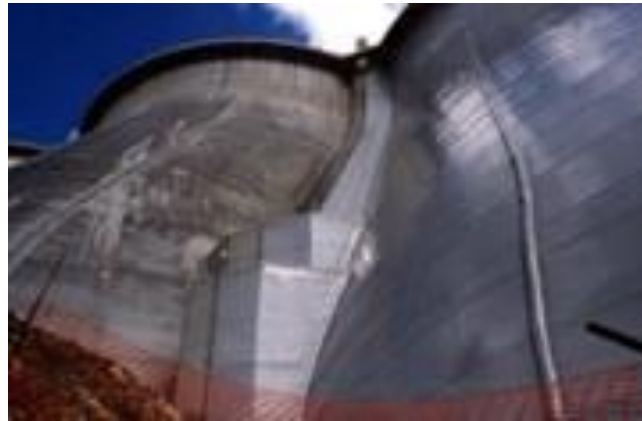
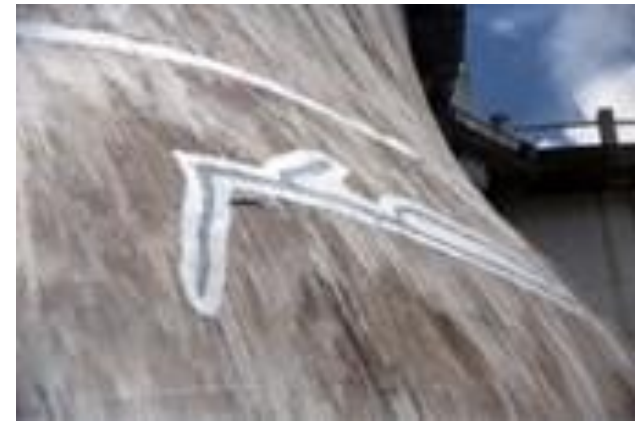
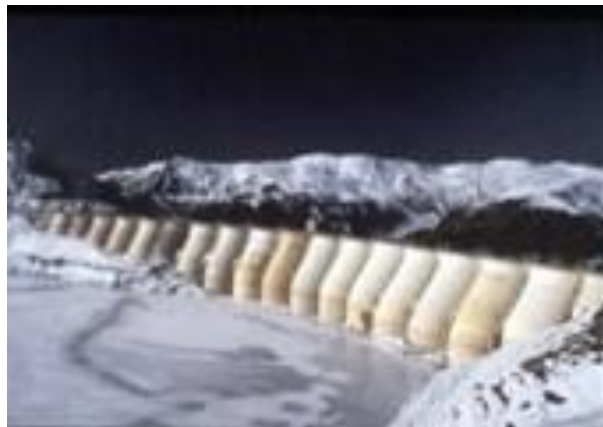
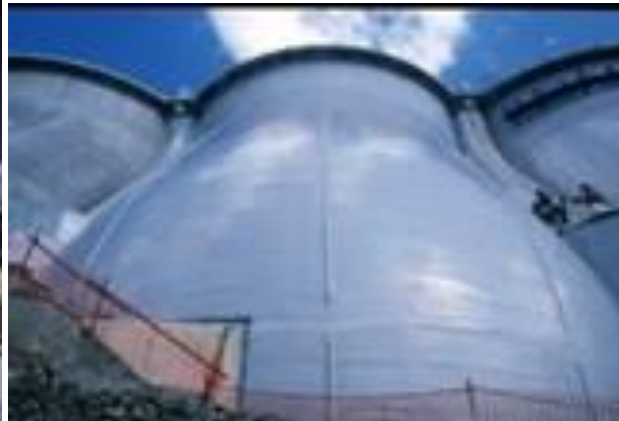
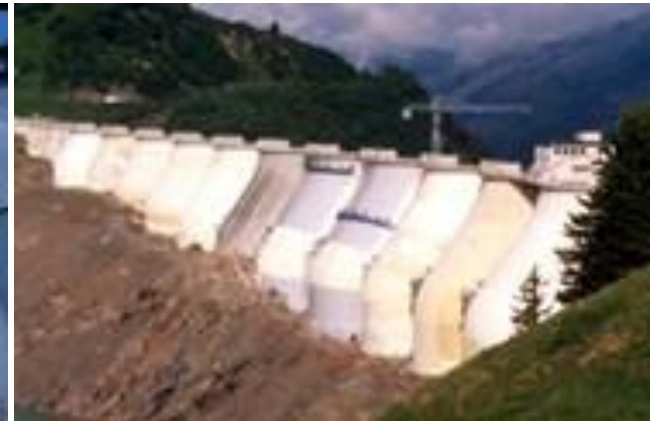
| CASE | IDENTIFICATION | COUNTRY | FINISHED | REHABILITATION/<br>REPAIR | REFERENCES |
|---|---|---|---|---|---|
| A-016 | La Grotte Dam | France | 1949 | 19931994/1998 | [22; 75] |

- In winter the reservoir water level is usually at the bottom of the arches and the effects on the concrete of freezing and thawing are at their maximum. Many cracks have been observed and these are attributed to thermal effects on the thin concrete elements.
- The quality of concrete is not suitable to combat the acid waters coming from the glaciers.

Due to the deterioration and leakage of the face of the dam it was repaired using PVC geomembrane.

The best results were obtained by applying a resin facing on the concrete surface that had been cleaned by sandblasting. One coat of epoxy resin was applied and this was covered with two or three coats of polyurethane-resin, applied at a rate of about 1.5 kg/m<sup>2</sup>. This technique has been used for 25 years, since 1970. It was found to last for 12 to 15 years with some local repairs. After this it was necessary to replace the facing. The major disadvantage was the time it took to complete the sandblasting to take off the old facing. This was considered to be too costly and alternatives were sought. Since 1994 the owner has experimented with a new PVC geomembrane facing. Five vaults have been covered and it is anticipated that the results concerning the behavior against ageing will be better than those with resin.

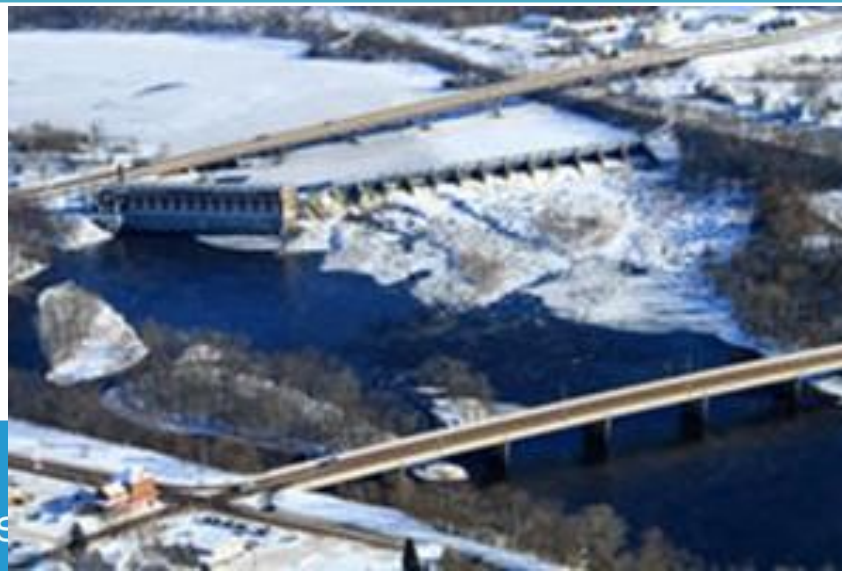
| CASE | IDENTIFICATION | COUNTRY | FINISHED | REHABILITATION/<br>REPAIR | REFERENCES |
|---|---|---|---|---|---|
| A-017 | Wissota Dam | USA | 1918 | 1990 | [76] |

The sloping surface of the north and south hollow dams were affected by freeze-thaw actions. Deterioration of concrete was most severe at the buttress-slab, cold-joint junctions, where joint filler materials apparently failed, and near the edge of previous repairs. Rapid deterioration developed due to seepage through cracks and joints on the upstream slab, which saturated the downstream face. The dam was declared to be of high hazard and rehabilitation was carried out. The remedial measures included installing steel cofferdam sheeting along the downstream buttress faces down to bedrock; removal of soils between sheeting and slab face; cleaning of rock contact surfaces and concrete, and mass concrete pours for entire height.

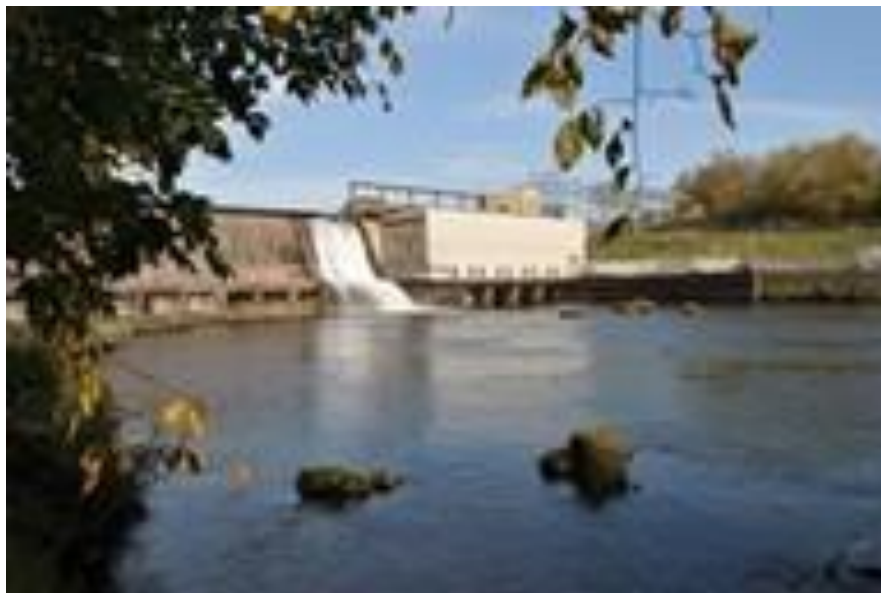
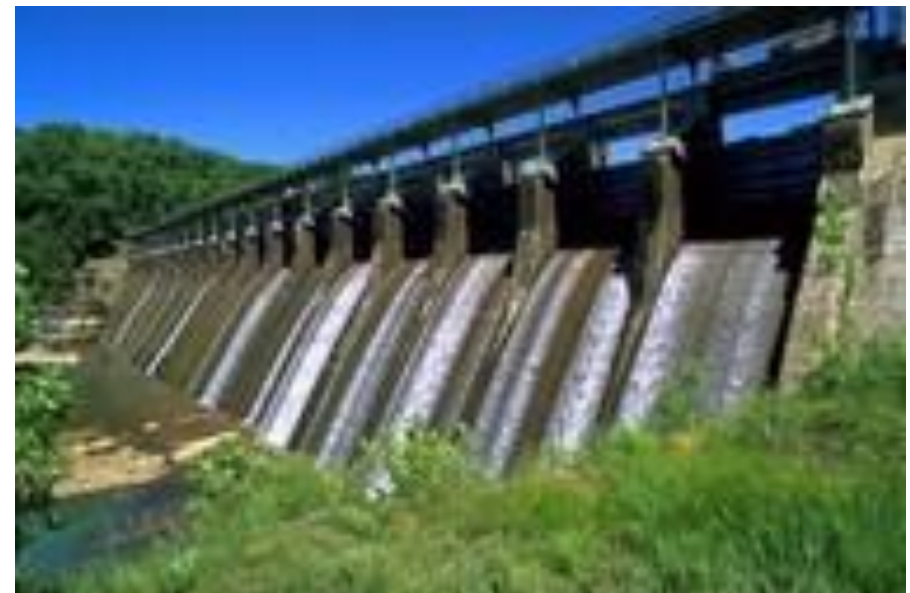
The concrete buttresses and corbels were significantly deteriorated due to seepage coupled with freeze-thaw cycles to the extent that the structure was judged to be a high hazard. The repair program consisted of innovative corbel post-tensioning, as well as the more traditional repair using buttressing.

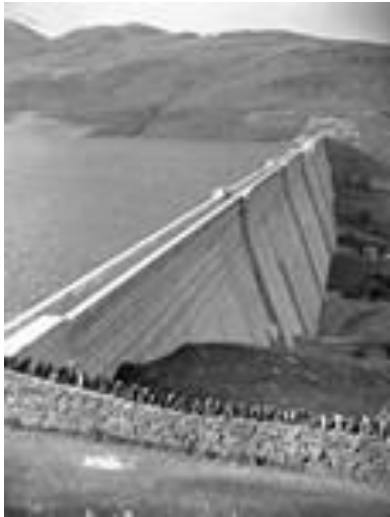
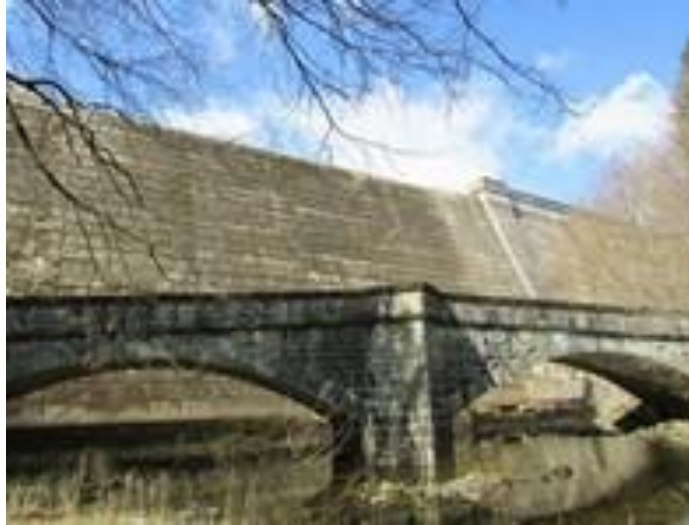
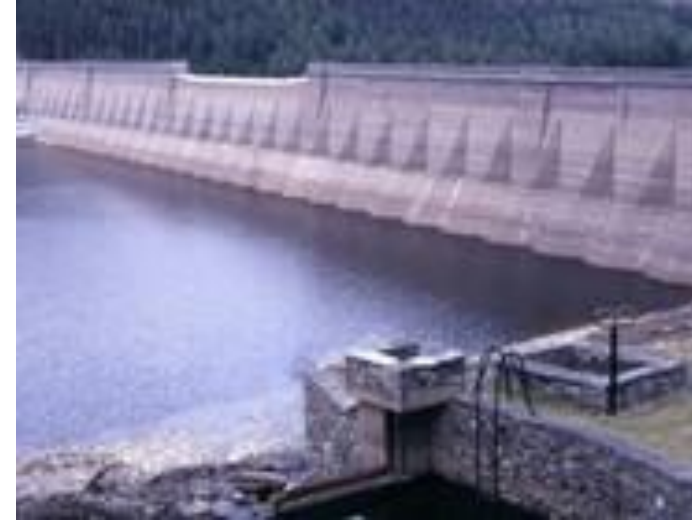
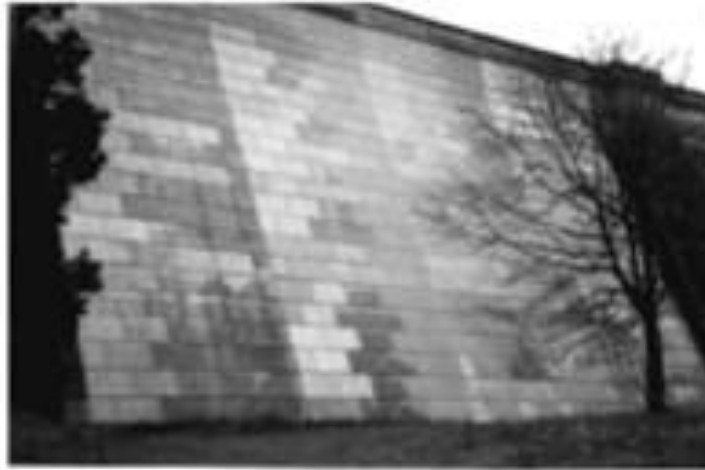
| CASE | IDENTIFICATION | COUNTRY | FINISHED | REHABILITATION/<br>REPAIR | REFERENCES |
|---|---|---|---|---|---|
| A-019 | Haweswater Dam | United Kingdom | 1942 | 1987 | [77] |

The buttresses forming the dam are dumbbell shaped in plan, giving a continuous face downstream as well as upstream. The surface of the concrete showed spalling over 30 % of the downstream face, mainly in the lower two thirds of the face, with penetrations up to 100 mm. The problem appeared to be caused by high levels of condensation on the internal faces of the buttresses and of freezing and thawing of saturated concrete.

The whole of the downstream face was repaired using a system as:

- The concrete was prepared by mechanical cleaning and grit blasting.
- A surface sealer incorporating saline primer and acrylic top-coat. The purpose of the saline is to penetrate the concrete surface and by chemical reaction to form a hydrophobic block.
- A fairing coat or render which smooth the surface, fills minor blemishes and helps to prevent weak spots through which the cementitious mortar can be attacked.
- A cementitious mortar applied to the damaged area with an acrylic bonding agent.

It appears that the repairs have been successful in the main. After some years there is some cracking of the repair mortar.

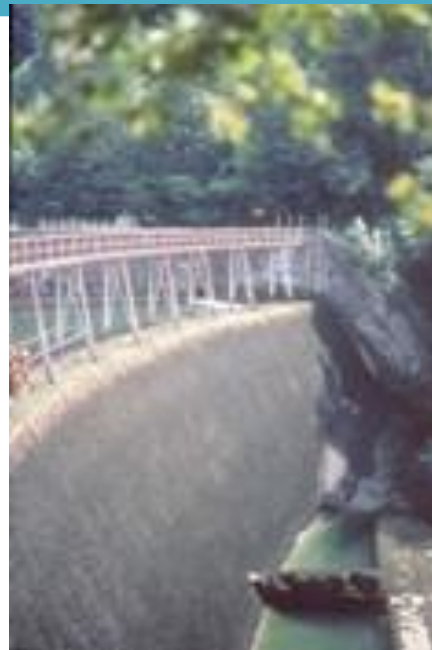
| CASE | IDENTIFICATION | COUNTRY | FINISHED | REHABILITATION/ REPAIR | REFERENCES |
|---|---|---|---|---|---|
| A-020 | La Bourne/ Auberives Dam | France | 1878 | 1984 | [78] |

This is an example of a dam rehabilitated through the addition of prestressed anchors. Auberives (La Bourne) was rehabilitated by adding tendons of 500 kN capacity, at 2 m centers along the dam crest. The anchor heads were incorporated within a reinforced concrete beam, shaped as a spillway crest, which also improved the discharge of the flow over the dam.

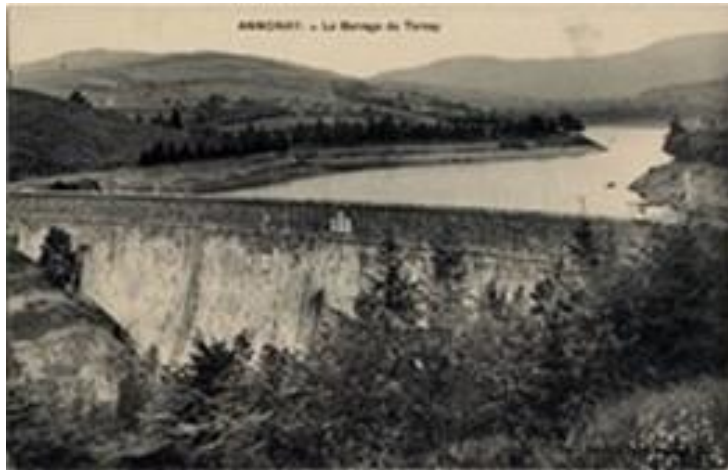
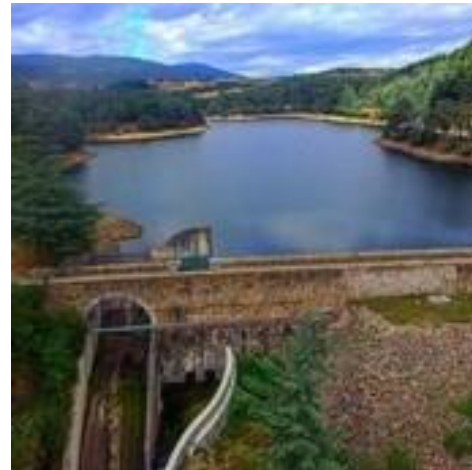
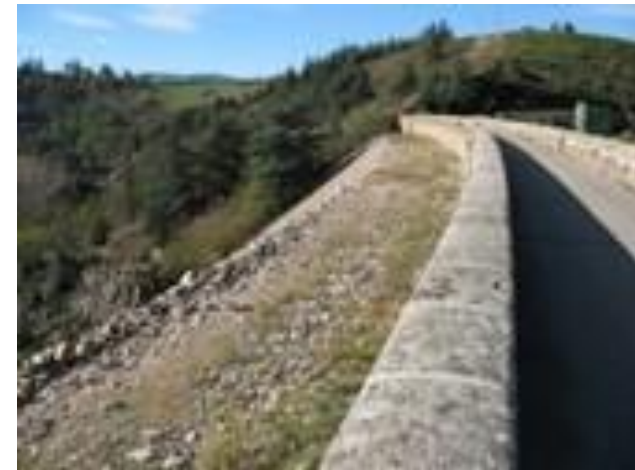
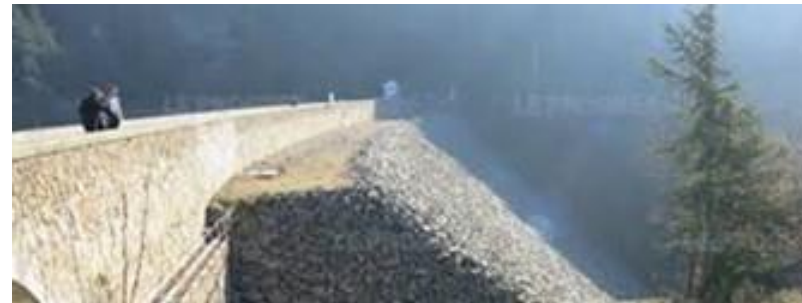
| CASE | IDENTIFICATION | COUNTRY | FINISHED | REHABILITATION/<br>REPAIR | REFERENCES |
|---|---|---|---|---|---|
| A-021 | Ternay Dam | France | 1867 | 1990 | [79] |

Stability problems and cracks were repaired by strengthening and by shape correction. An earth and rockfill embankment was placed downstream
