Structural analysis and rehabilitation  
of concrete dams and spillways

# **HISTORIC CASES ON CONCRETE DAMS REHABILITATION**

Third International  
Dam World Conference

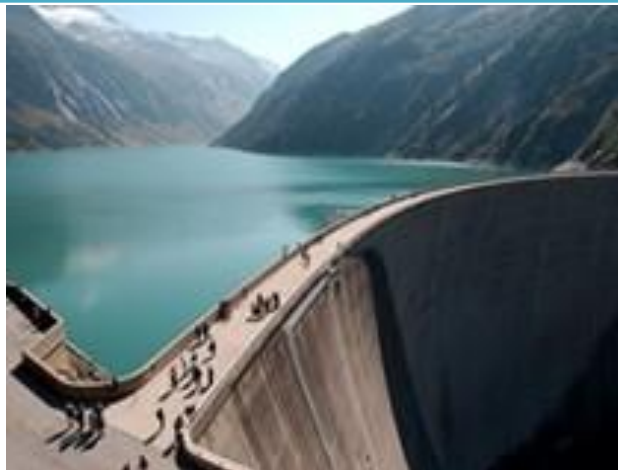
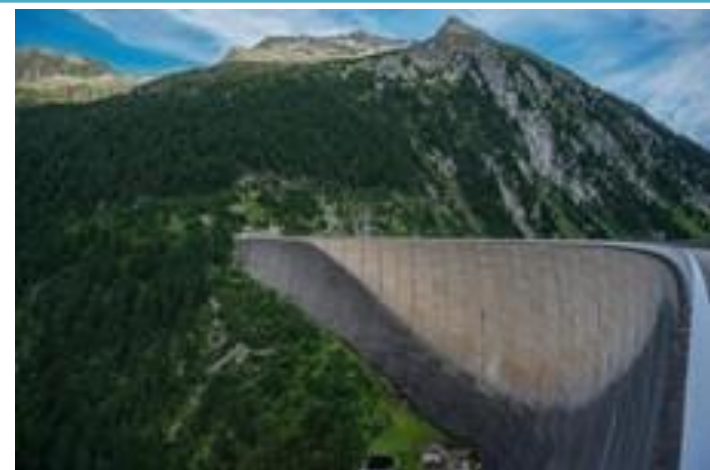
During first impoundment, at a water depth of 175 m, suddenly a 1 mm wide flat crack developed in a block allowing the release of some 1601/s of seepage water. Rehabilitation measures consisted of force-locking injection of the crack with synthetic resin carried out in two stages.

As a result of the level of the injection pressure of the grout secondary joints appeared and also had to be sealed. Among the lessons learnt was the need to design the level of grout pressure to ensure that local tensile stresses do not exceed the tensile strength of the rock or concrete.

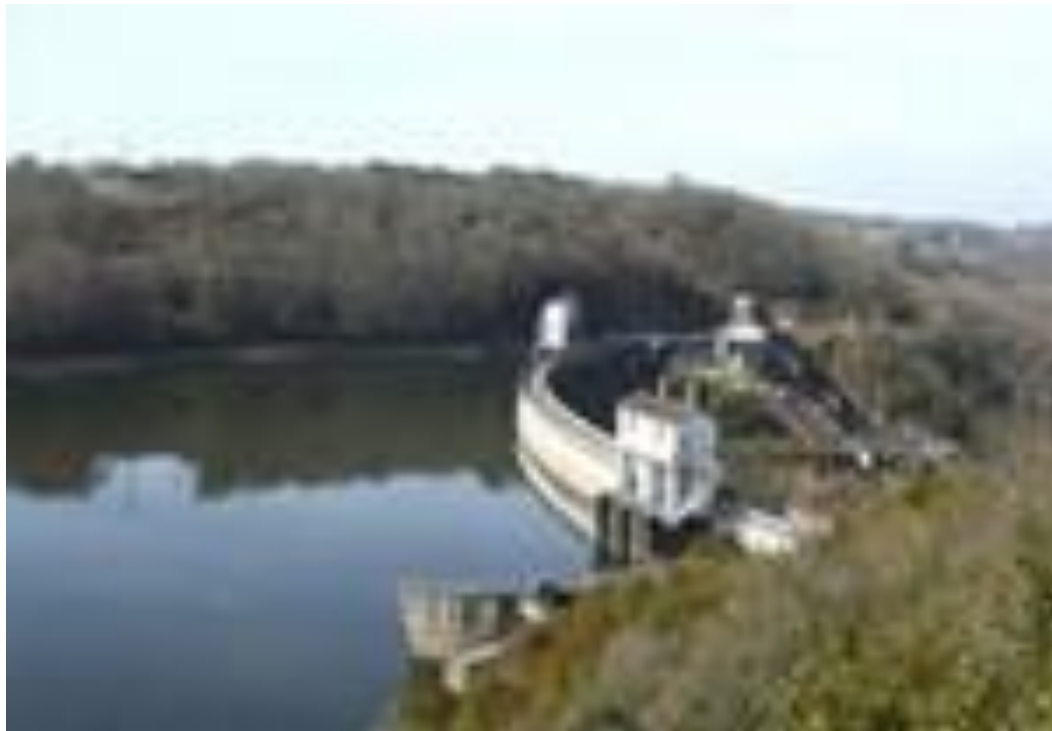
| CASE | IDENTIFICATION | COUNTRY | FINISHED | REHABILITATION/<br>REPAIR | REFERENCES |
|---|---|---|---|---|---|
| A-023 | Eguzon Dam | France | 1926 | 1984 | [82] |

The joints and waterstops were rehabilitated by demolition of the squared stone masonry of the upstream face and the cyclopean concrete of the dam body, near the joint comers, and reconstruction with concrete, after inserting a new waterstop

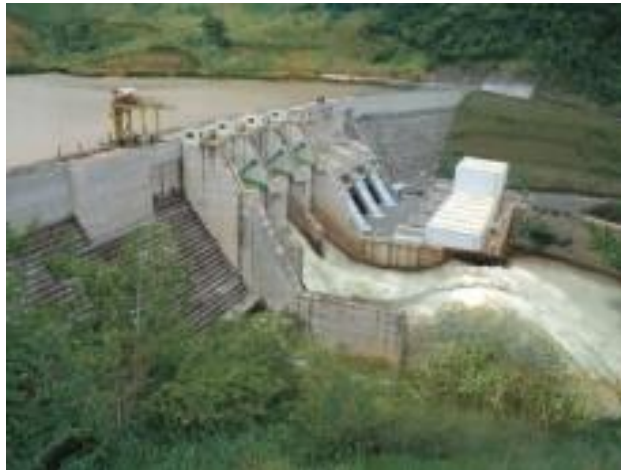
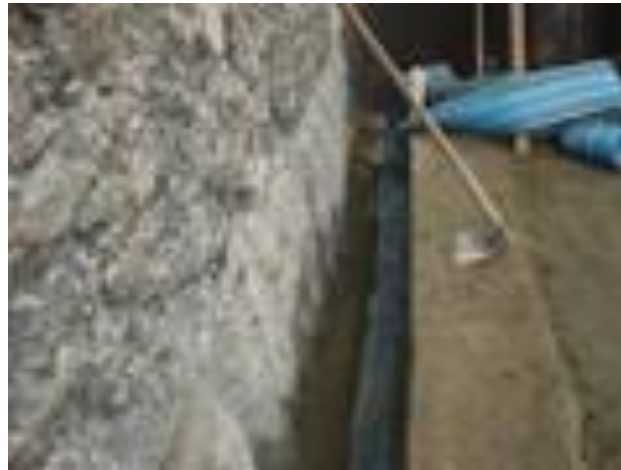
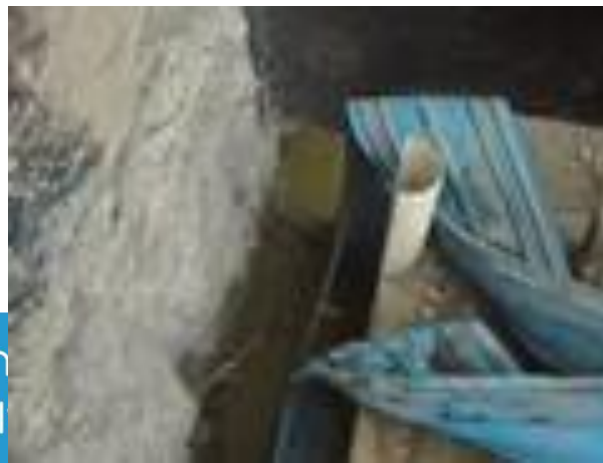
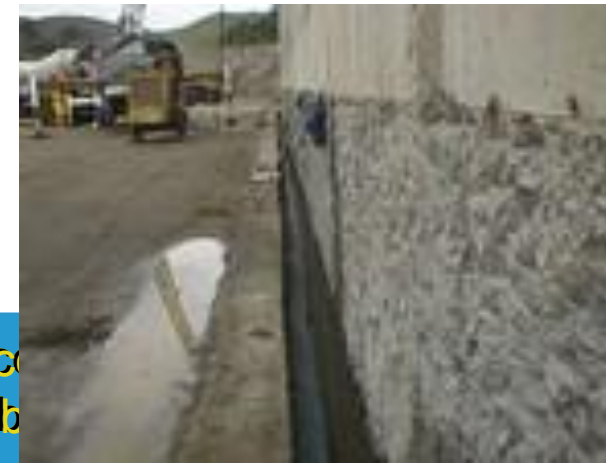
The joints and waterstops were rehabilitated by demolition of the concrete in the design line and reconstruction with concrete, after inserting a new waterstop

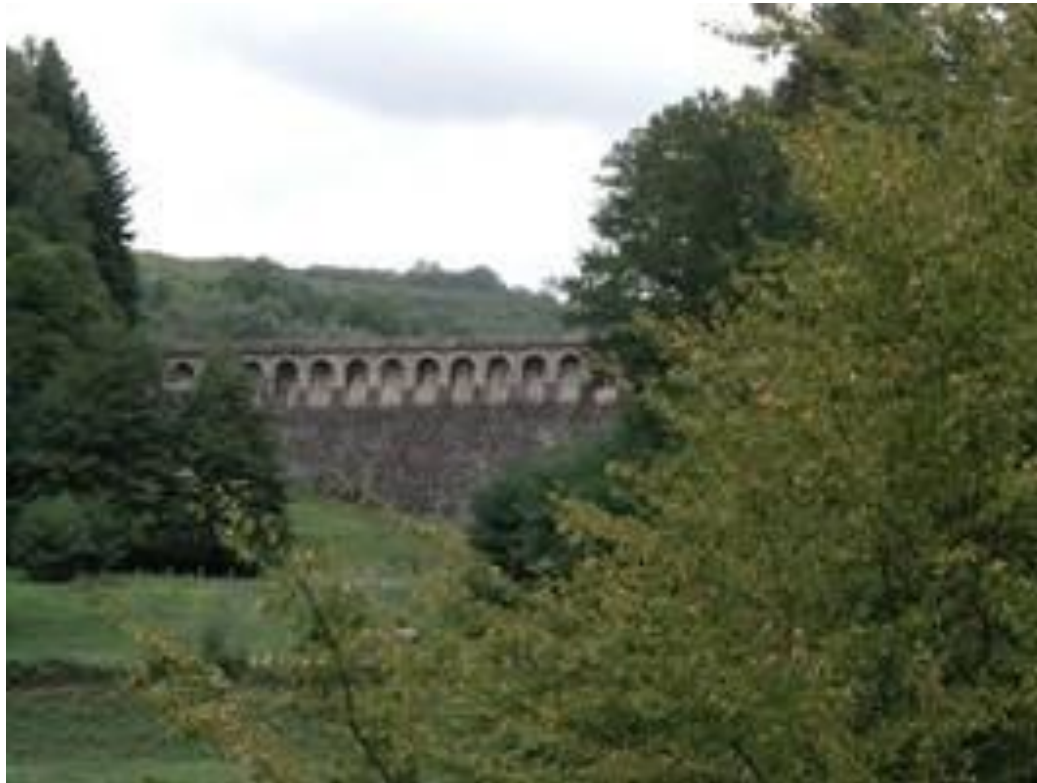
The Saint-Sernin Dam was treated by means of polyurethane resin and by application of pre-stressing forces respectively

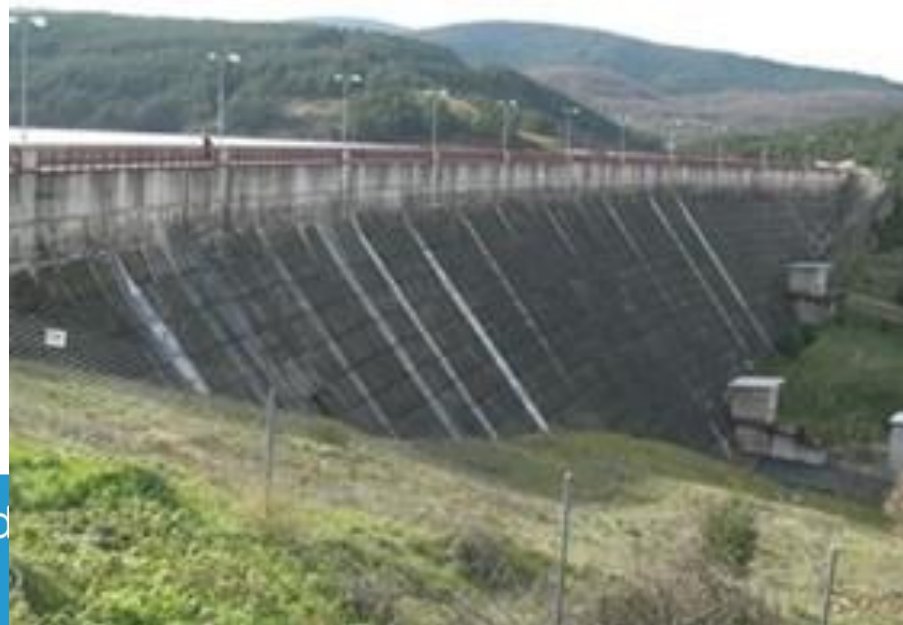
Arlanzon concrete dam was constructed without contraction joints. Fifteen large vertical cracks developed, from the upstream to the downstream faces, causing leakage that damaged the dam, particularly at the downstream face, owing to frost.

The rehabilitation works included the treatment of the cracks, by grouting with an epoxy resin, as well as the treatment of the dam faces and the consolidation and drainage of the dam body.

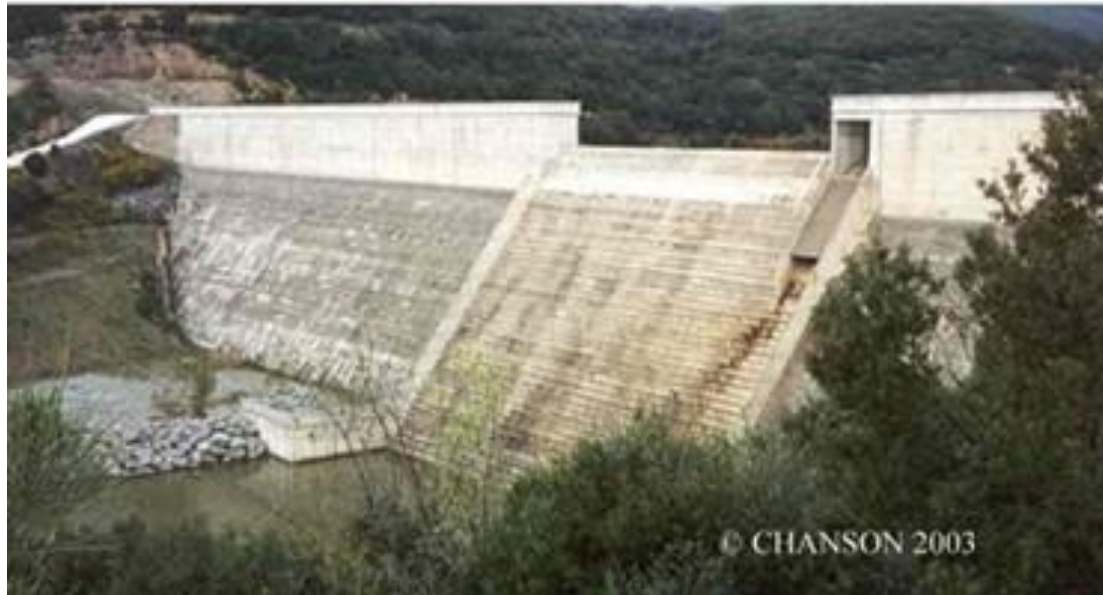
| CASE | IDENTIFICATION | COUNTRY | FINISHED | REHABILITATION/<br>REPAIR | REFERENCES |
|---|---|---|---|---|---|
| A-027 | Les Olivettes Dam | France | 1987 | 1991 | [86] |

The Olivettes RCC dam, with a crest length of 254 m, was constructed without contraction joints with concrete containing 130 kg of cement per cubic meter. Three vertical cracks developed, the treatment of which included the application of an elastic sealant in strips a few millimeters deep and 50 mm to 100 mm wide at the upstream face; and grouting the joint near the downstream face

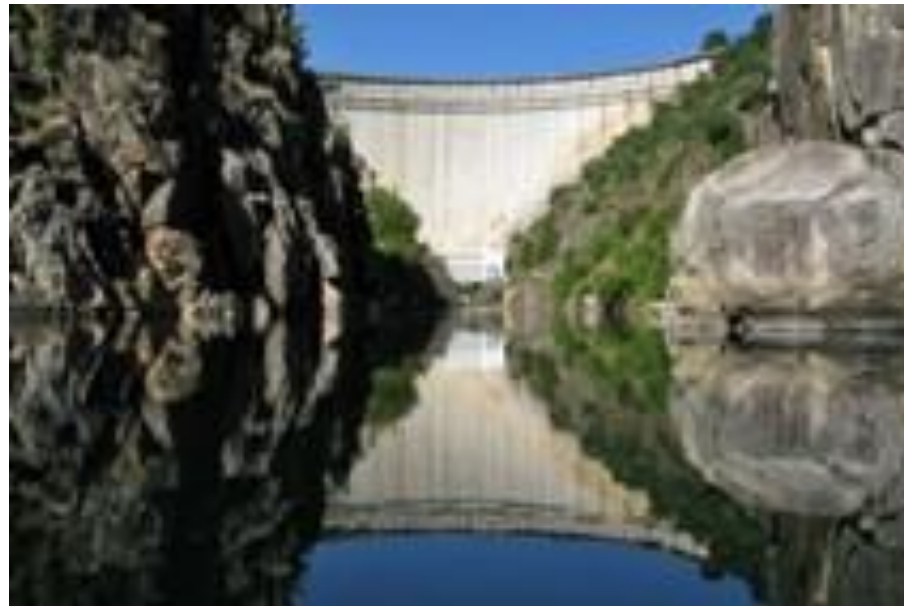
| CASE | IDENTIFICATION | COUNTRY | FINISHED | REHABILITATION/<br>REPAIR | REFERENCES |
|---|---|---|---|---|---|
| A-028 | Cabril Dam | Portugal | 1954 | 1981 | [87; 88; 89] |

Cabril Dam showed cracking at the downstream face, concentrated in a narrow band about 10 m below the crest and following a construction lift joints. The transverse contraction joints opened, particularly at the downstream face, and when the reservoir operating level was low. The rehabilitation works included grouting of the cracks and transverse joints with epoxy resin

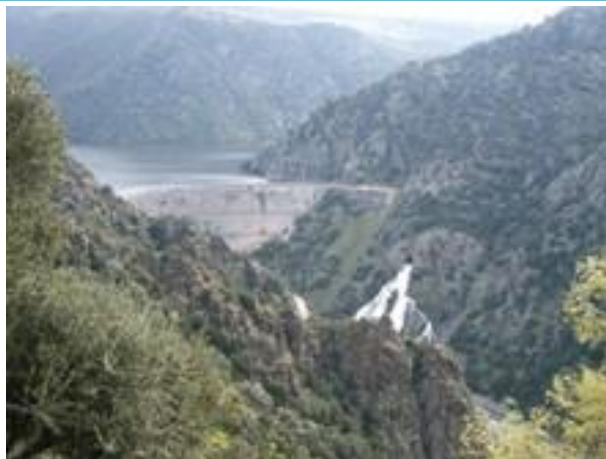
| CASE | IDENTIFICATION | COUNTRY | FINISHED | REHABILITATION/<br>REPAIR | REFERENCES |
|---|---|---|---|---|---|
| A-029 | Flumendosa Dam | Italy | 1957 | 1995 | [90] |

At Flumendosa Dam the cracks developed along construction lift joints, at the higher elevations of the upstream face. These were grouted with epoxy resin.

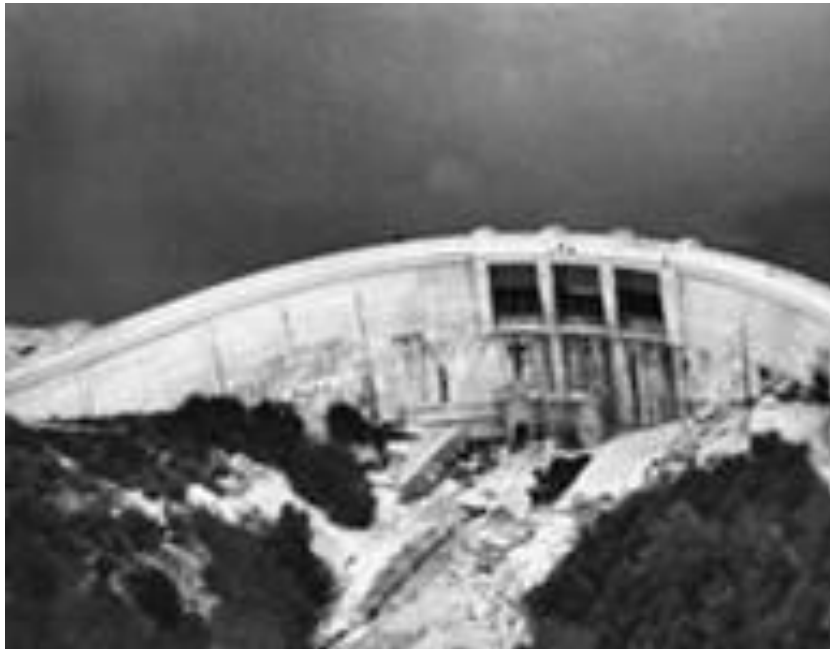
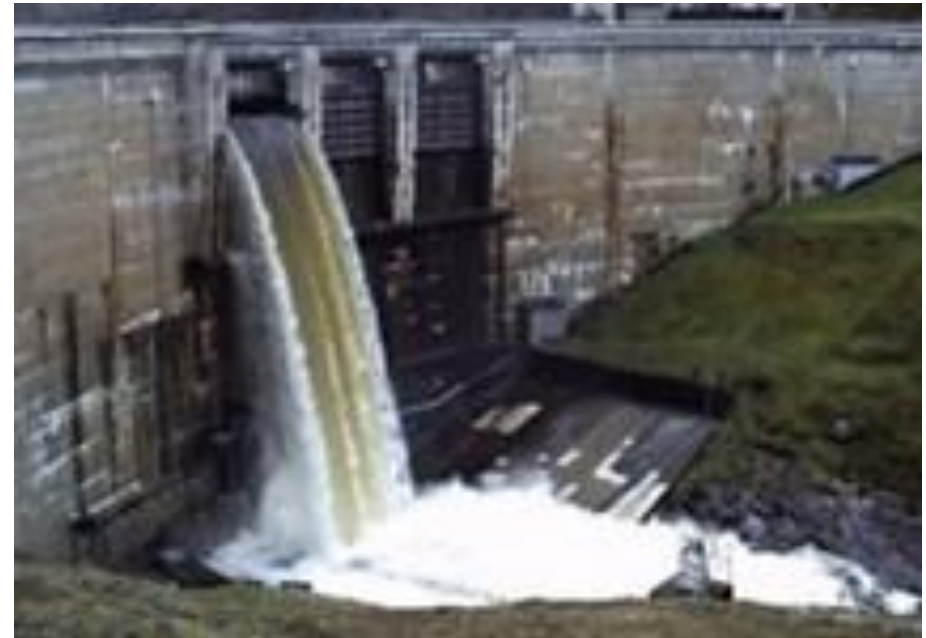
At Monceaux la Virole Dam the cracks developed along construction lift joints, at the higher elevations of the upstream face. These were grouted with epoxy resin. The contraction joints, which were constructed without a waterproofing system, were treated first with a bituminous mastic and some years later with silicone

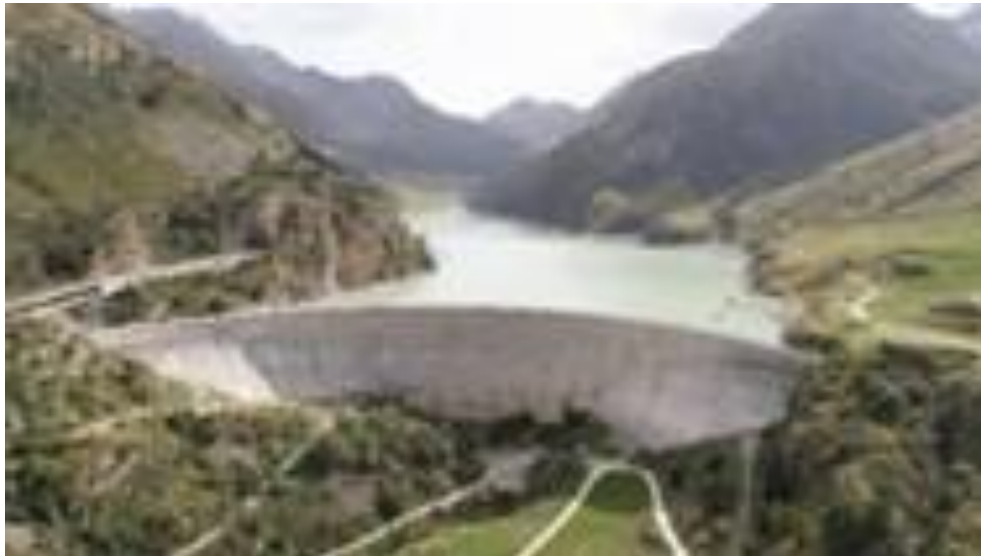
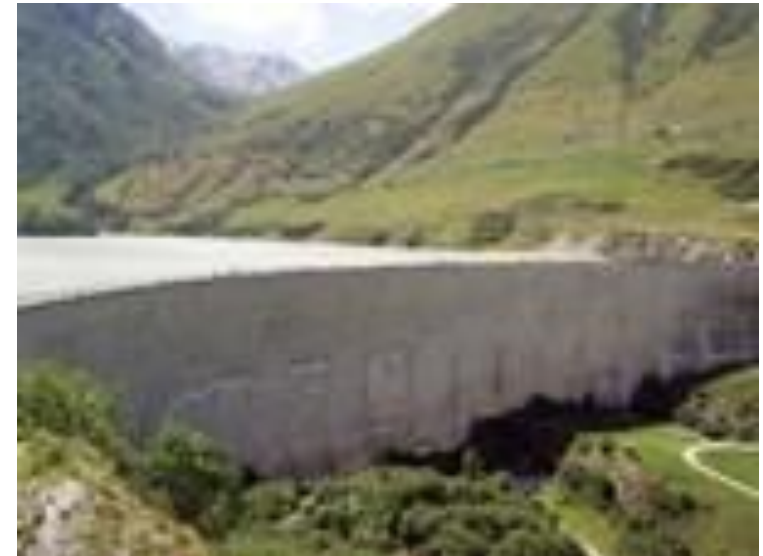
| CASE | IDENTIFICATION | COUNTRY | FINISHED | REHABILITATION/<br>REPAIR | REFERENCES |
|---|---|---|---|---|---|
| A-031 | Les Toules Dam | Switzerland | 1963 | ??? | [84] |

Les Toules Dam was constructed in phases, the interface between the old and the new concrete being in general a critical zone. This double curvature arch dam was initially constructed to 26 m high only, and the prepack joint between the old and new concrete had to be re-grouted after a few years of operation

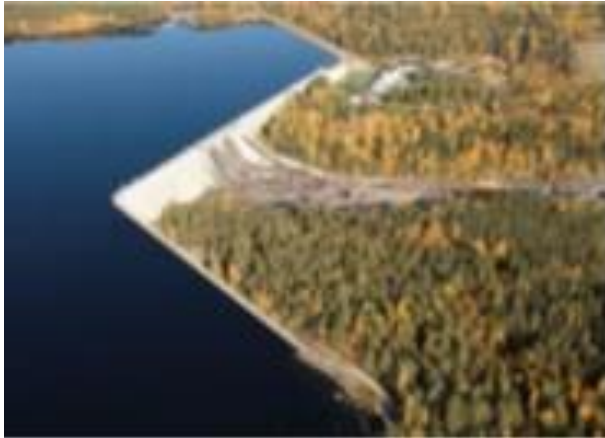
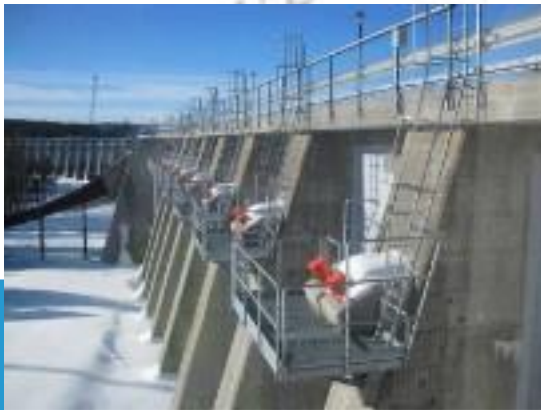
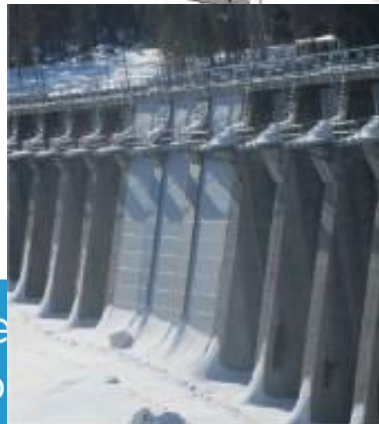
A few years after completion, horizontal cracks were found in the lower parts of the front-plates and freeze-thaw damage was detected on the upstream side of the front-plates. This resulted in a structural rehabilitation program where cracks were grouted and an insulating wall was installed to reduce the thermal gradient over the thickness of the front-plate. The program consisted of moving the insulating walls, improving the stability with ground anchorage tendons, strengthening the front-plates and in addition to widen the road on the dam crest to allow for heavy traffic.

Post-tensioned anchors was the practical and cost-effective method of strengthening the dam. They was used to stabilize the concrete and to combat the effects of alkaline and aggregate reaction. The post-tensioning technique requires minimum demolition, has only a minor impact on the dam, and was relatively inexpensive using a small number of anchors.

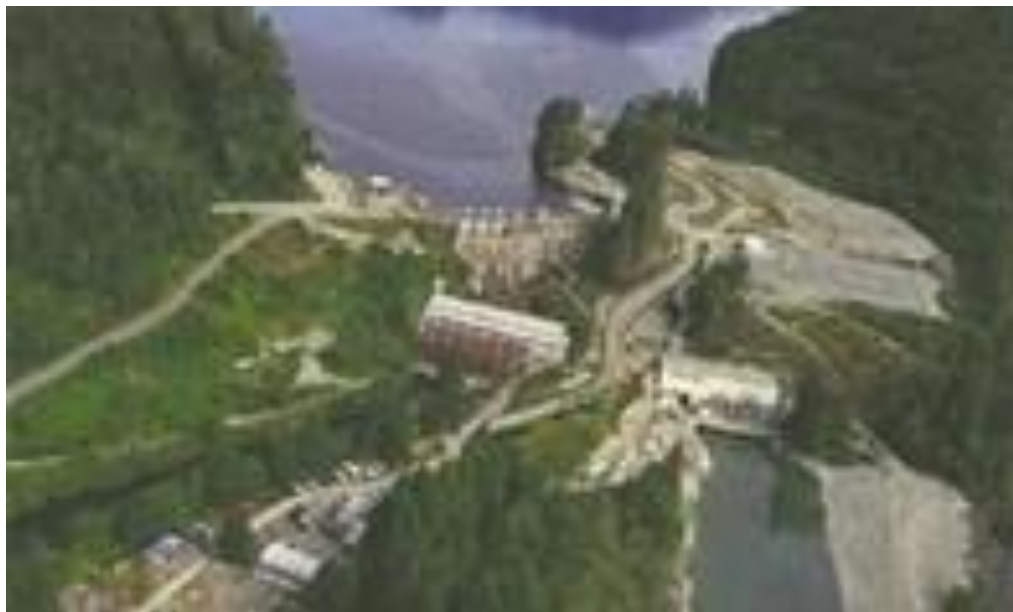
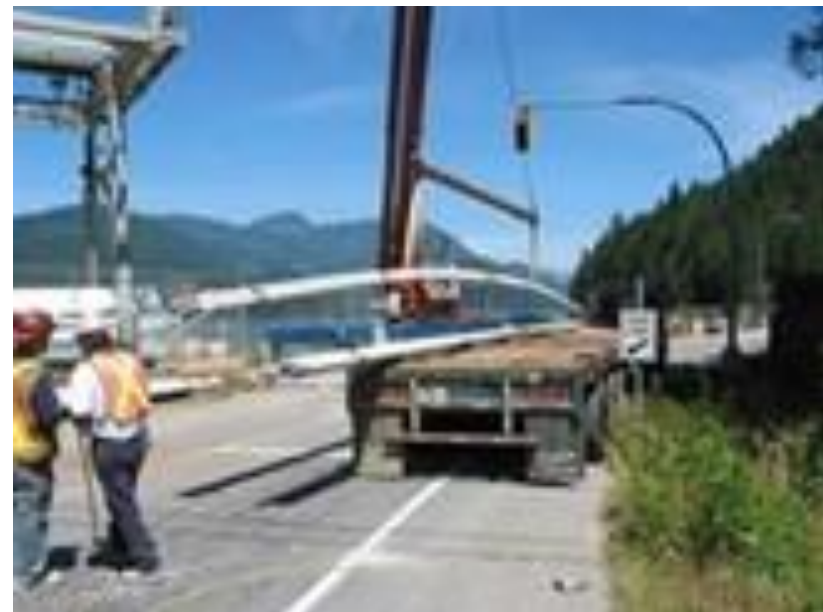
At Stave Falls dam, load cells were installed in some anchor heads and arrangements were made to facilitate the inspection and the re-tensioning of the tendons, should this become necessary.

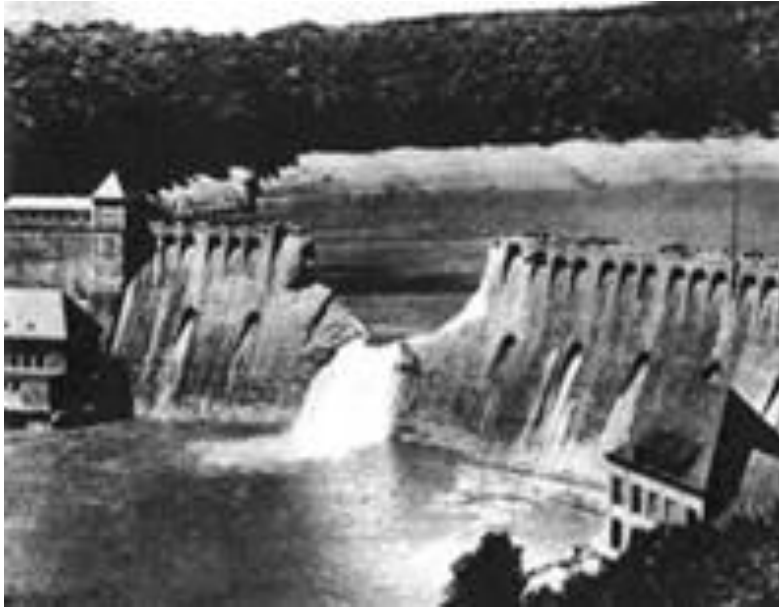
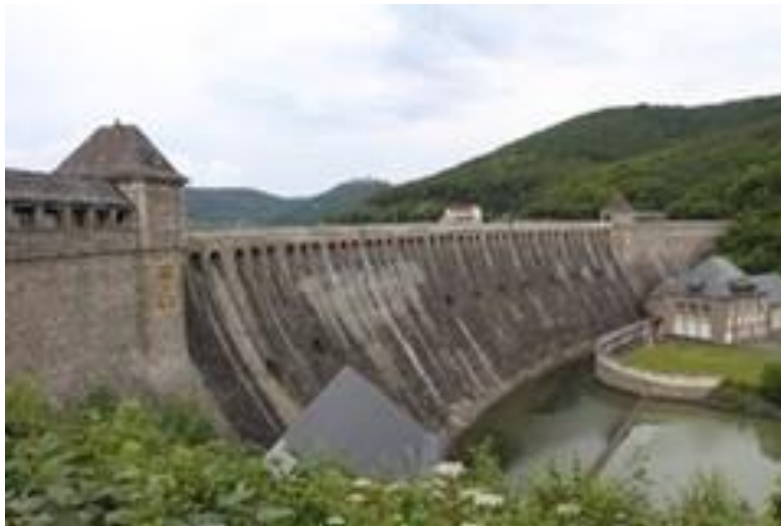
Fig. 3.4.3

In the early eighties the stability of the Eder Dam was considered to be inadequate. From six options considered it was selected: Prestressed anchors between crest and foundation rock. For this it was planned to build a new dam crest including a gallery for the anchor works. The cables were assembled at a workshop at the site and were transported without bending to the crest where they were taken by a steel frame designed to avoid strong bending.

Eder Dam. Six alternatives for rehabilitation

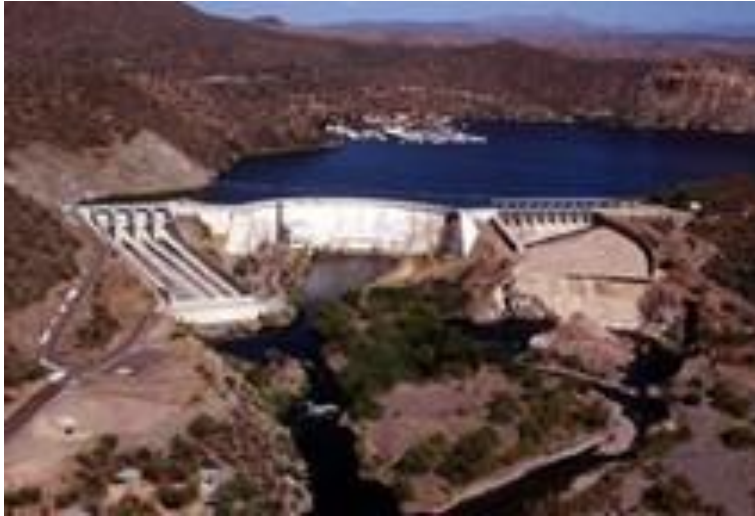
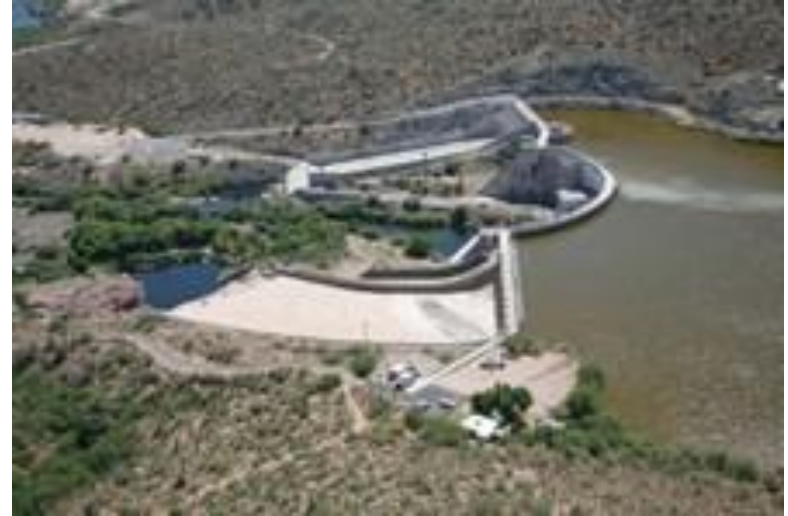
The installation of posttensioned cables was judged to be the least expensive, most viable solution for stabilizing the arch dam.

After drilling, every hole was water-pressure tested, pre-grouted, and re-drilled if necessary. The epoxy-coated strands for the tendons were delivered to the site on special uncoilers. Workers used extreme care to prevent abrasion of the epoxy coating when they installed the tendons in the holes. A special high-strength, plasticized grout was tremied into each hole to provide the exact bond length.

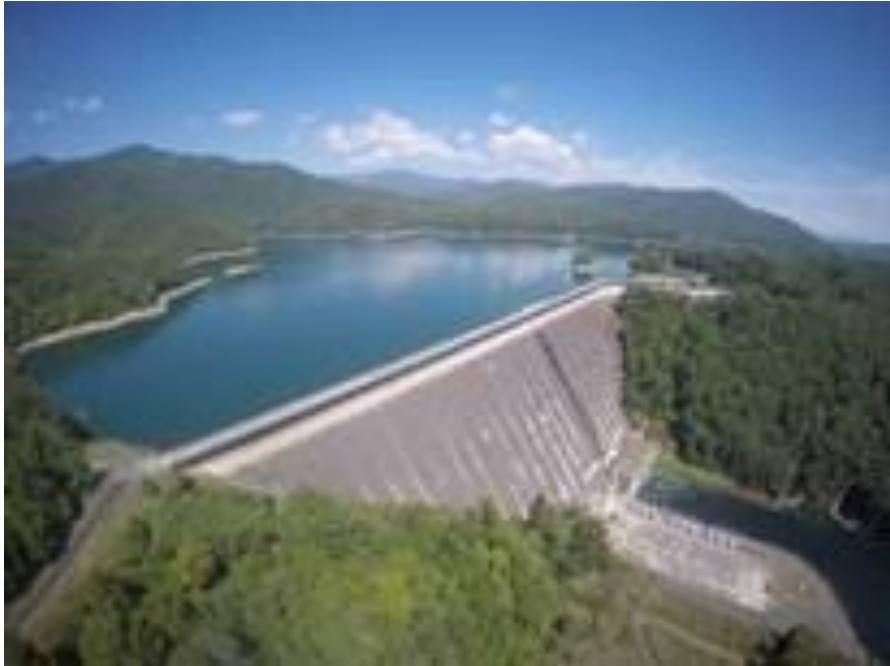
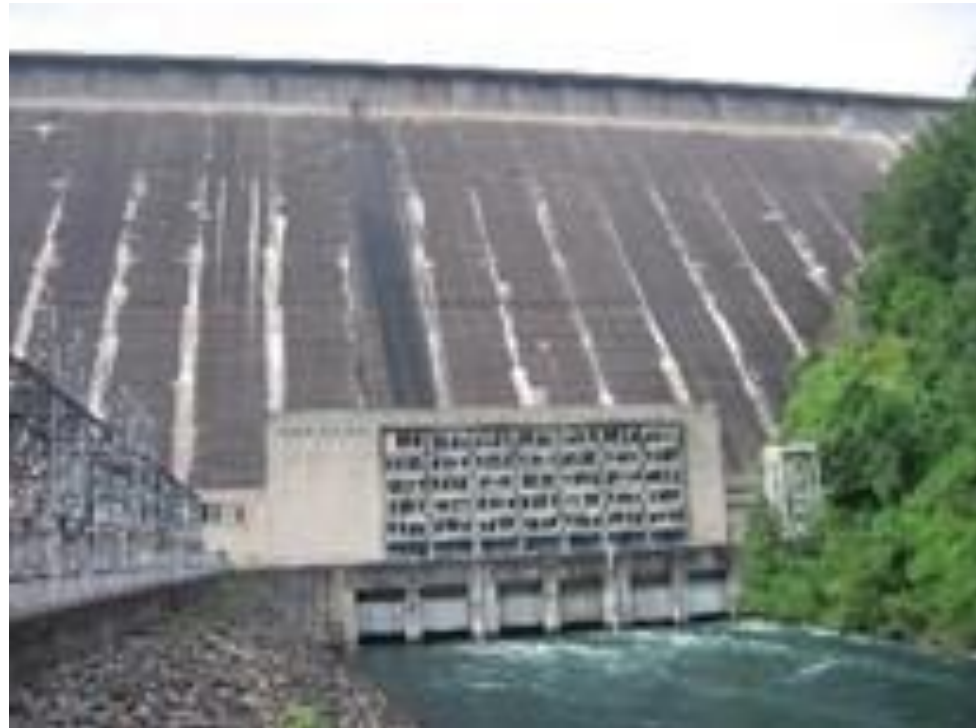
A series of investigations and laboratory analyses on core samples led engineers to the conclusion that cutting the slot in the curved portion of the dam would have no adverse effect on the stability. In 1976, this slot was cut transverse to the dam adjacent to the curve at this location. A system of flexible primary and secondary seals was installed at the slot to prevent leakage during high reservoirs. Both seals consisted of industrial rubber conveyor belt stock 0.8 m wide. The primary seal on the upstream face was extended to the foundation.

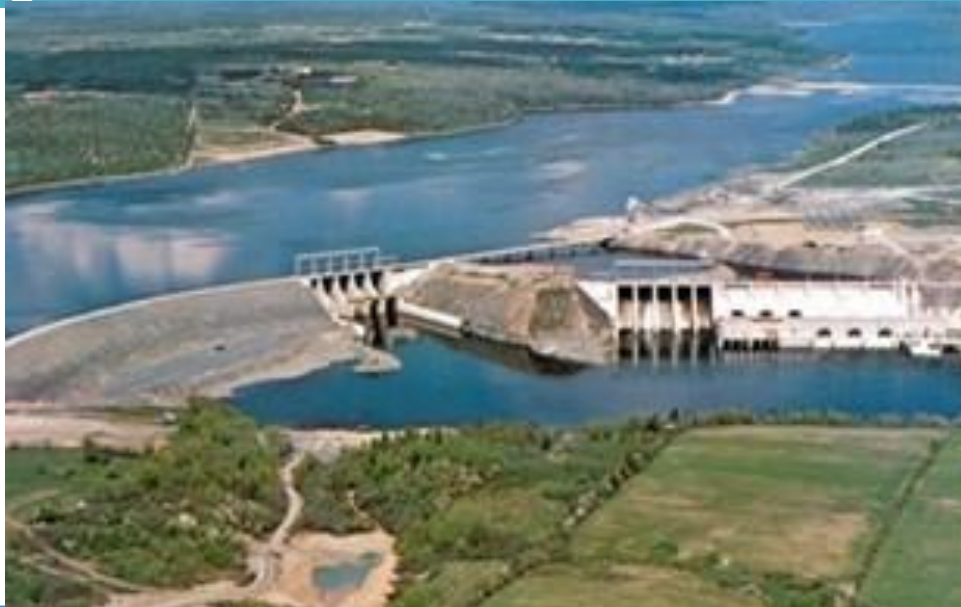
From the time the dam was constructed in the late 1960s, it had been slowly but steadily expanding. The expansion of the concrete was attributed to alkali-aggregate reaction. A program for making two vertical cuts in the concrete cross section of the dam, was set. Before the cutting could begin, the work area had to be dewatered. The saw has a drive unit with a large diameter drive wheel that is hydraulically powered, idler wheels, and a diamond-plated cutting wire.

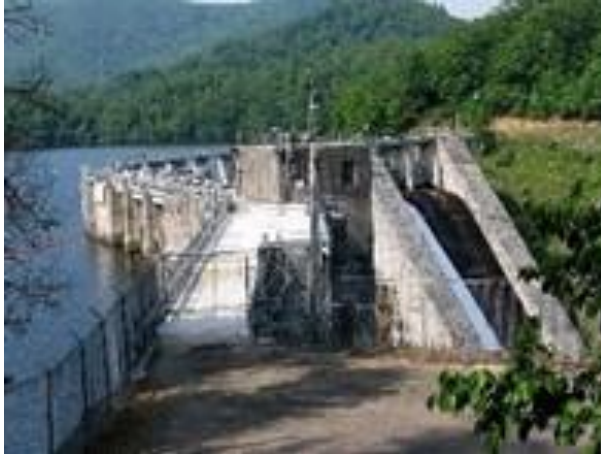
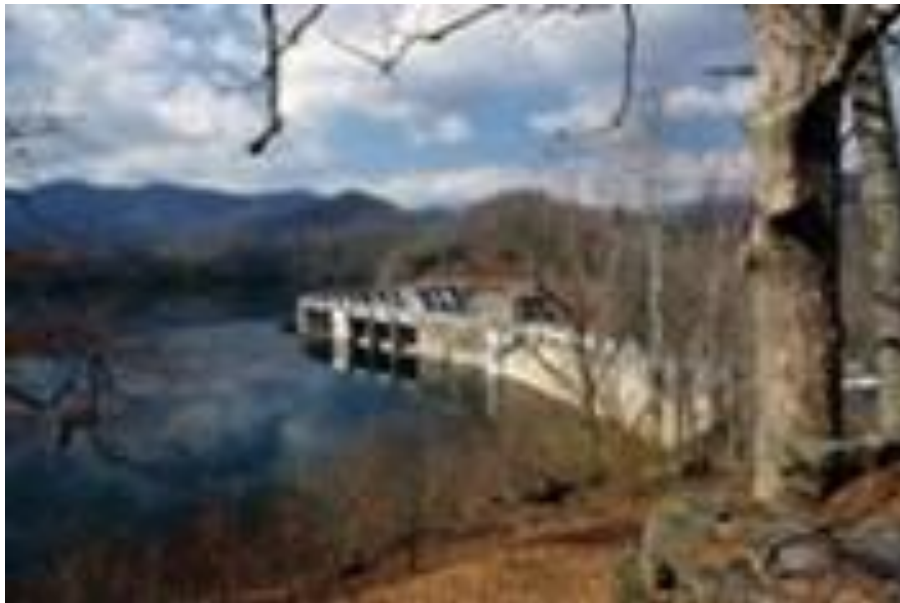
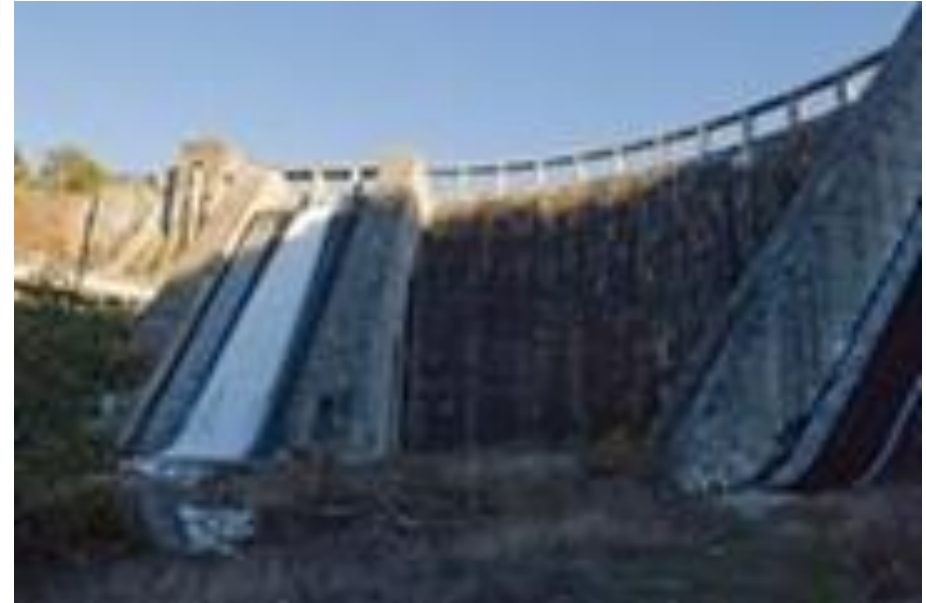
Santeetlah Dam has recorded history of continuous movements in the upstream and vertical direction which studies have shown to be a direct result of alkali-aggregate reactivity (AAR). This expansion has the potential of resulting in cracking, heaving, joint displacement, and spalling of concrete.

Repairs were also made in 1950 and 1967. A decision was made to use epoxy-resin grout to seal the joints and cracks. Expansion joints have been introduced using diamond wire saws in several existing concrete gravity dams to control deformations and release accumulated compressive stresses due to concrete swelling induced by alkali-aggregate reaction (AAR).

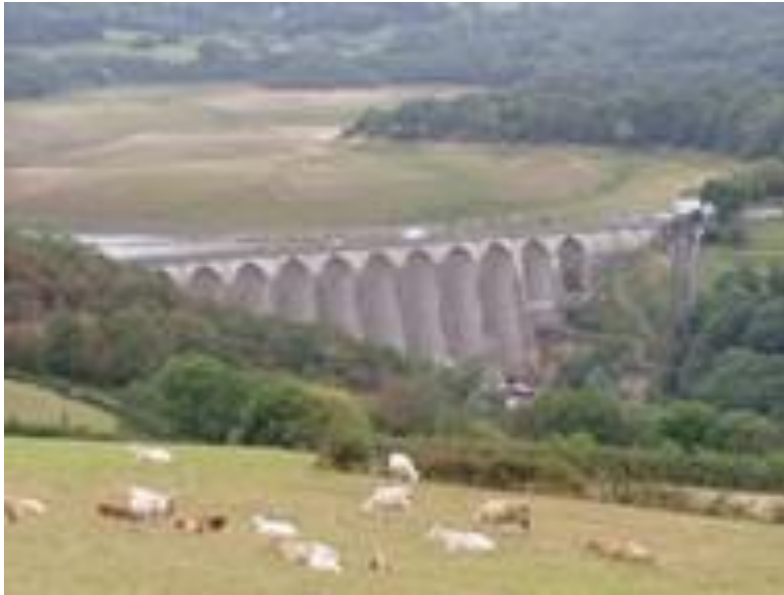
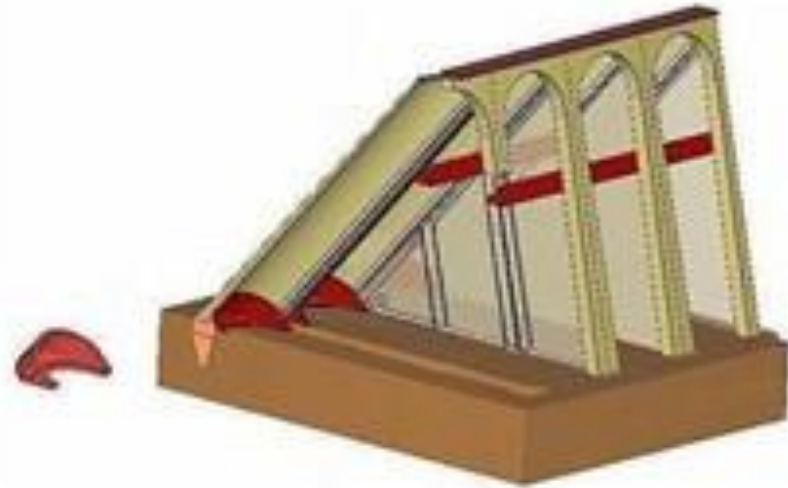
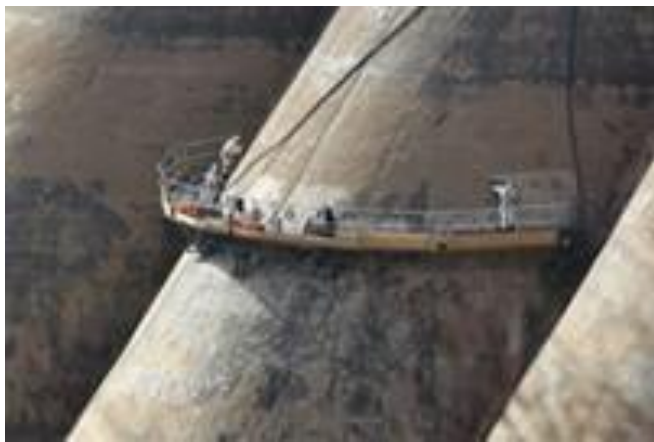
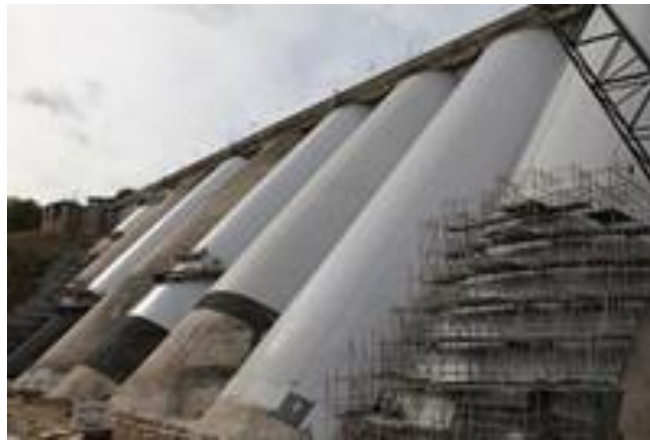
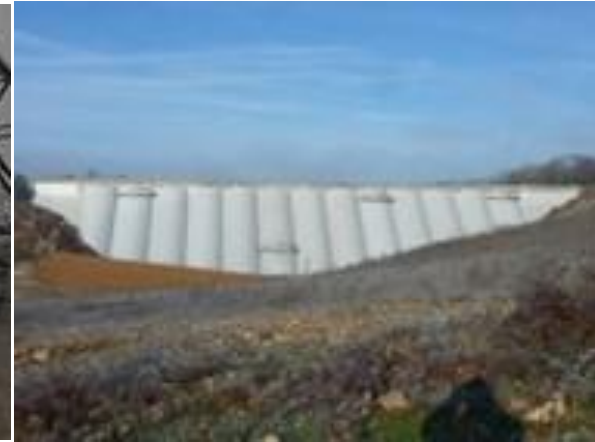
| CASE | IDENTIFICATION | COUNTRY | FINISHED | REHABILITATION/<br>REPAIR | REFERENCES |
|---|---|---|---|---|---|
| A-049 | Panneciere Dam | France | 1949 | 2005 | [22; 117] |

- a loss of monolithism due to water circulating through a network of cracks resulting from post-war construction methods and concrete formulation;
- slight swelling due to alkali-aggregate reaction in the sealing mortar (gunite) on the upstream side;
- undesirable rotation and collapsing movements in the buttresses on the downstream side.

To rectify these various problems and set up the rehabilitation site, there were required several types of repair as well as strengthening against the risk of earthquakes.

In addition, on the downstream side, the structure's earthquake resistance was improved by the installation of braces, prefabricated on site, between each buttress. 26 braces, each 14 meters long and weighing 20 tons, were installed in two rows inside the dam's arches, with the aim of both stabilizing and stiffening the structure in the event of an earthquake by preventing the buttresses from oscillating. A PVC membrane was applied.

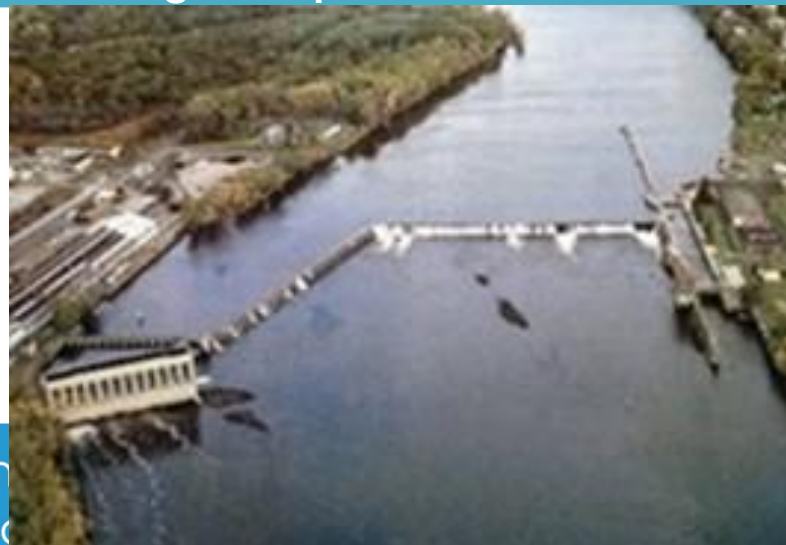
| CASE | IDENTIFICATION | COUNTRY | FINISHED | REHABILITATION/<br>REPAIR | REFERENCES |
|---|---|---|---|---|---|
| A-051 | Troy Lock and Dam | USA | 1915 | 1990 | [119] |

The dam, which is founded on bedrock, was constructed with nonair-entrained concrete and river gravel aggregate. Cracked concrete on top of the piers was removed to sound concrete and replaced with air-entrained, reinforced concrete. Dowels were used to anchor the new concrete to the existing concrete.

Cracks in the dam access were sealed with a moisture-reactive, polyurethane chemical grout that helped control leakage. It was elected to use the polyurethane grout as it could be applied in wet conditions.

A follow-up inspection indicated repairs to the piers, the spalled areas, and cracks in the shafts and tunnels were performing as expected.

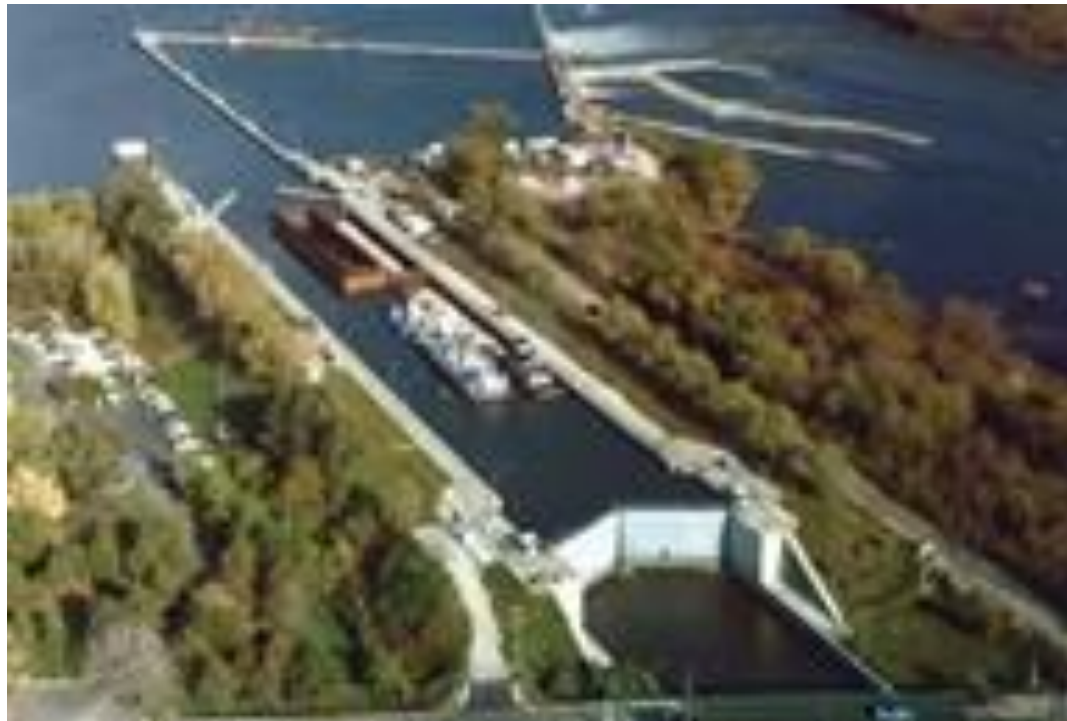
| CASE | IDENTIFICATION | COUNTRY | FINISHED | REHABILITATION/<br>REPAIR | REFERENCES |
|---|---|---|---|---|---|
| A-052 | Brandon Road Dam | USA | 1933 | 1988 | [120] |

Rehabilitation included repair and replacement of gates. On the upstream portions of the piers, deteriorated concrete was removed to a depth of approximately 203 mm. Replacement concrete was conventionally placed air-entrained reinforced concrete.

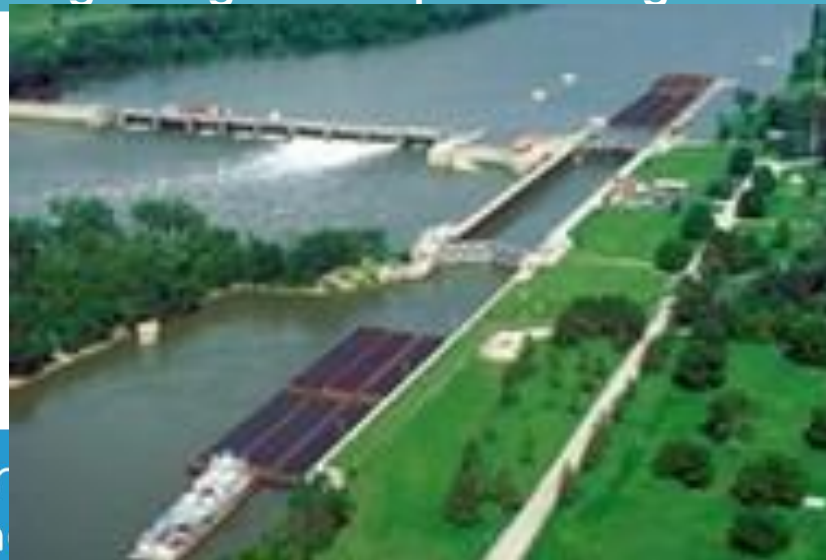
| CASE | IDENTIFICATION | COUNTRY | FINISHED | REHABILITATION<br>/ REPAIR | REFERENCES |
|---|---|---|---|---|---|
| A-053 | Dresden Island Lock and Dam | USA | 1933 | 1980 | [121;122] |

A 1980 inspection of the 47-year-old dam revealed severe deterioration of the concrete as a result of years of being subjected to cycles of freezing and thawing and impact and abrasion. Deteriorated concrete in the roof of the head gate opening was removed, and grout was troweled on to provide a smooth surface. The surface was then painted with bituminous mastic. A waterstop was installed along the horizontal joint at the top of the closure panel.

Rehabilitation of the tainter gate section primarily consisted of removing and replacing 229 mm of concrete and installing new gate seal plates along the sides of the piers

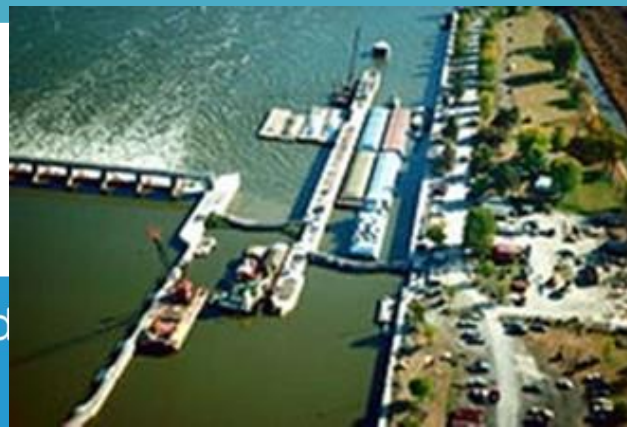
Over time the structure experienced concrete deterioration, especially around the tainter gates and service bridge piers. Cause of the deterioration is attributed to the lack of entrained air in the concrete, which decreased its resistance to cycles of freezing and thawing, alkali-silica reactions. The repair method was to use high pressure to inject a low-viscosity epoxy grout into the crack.

Ultrasonic velocity measurements were made before and after the injection, and, where practical, tests were run on core samples. The major problem was that the epoxy sealant used to waterproof the pier tops did not completely seal them, and seepage still occurred through unfilled cracks.

The surface was then sealed with an epoxy gel. The epoxy injected into the pier was an ultra-low viscosity, two-component, 100 percent solids epoxy resin, insensitive to the presence of water.

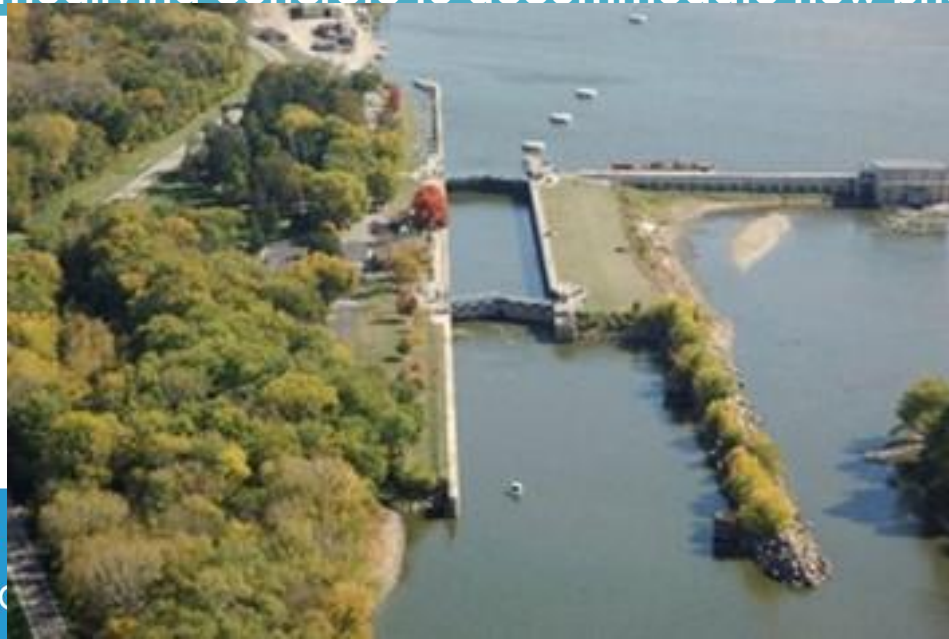
| CASE | IDENTIFICATION | COUNTRY | FINISHED | REHABILITATION<br>/ REPAIR | REFERENCES |
|---|---|---|---|---|---|
| A-055 | Starved Rock Lock and Dam | USA | 1933 | 1980 | [124] |

After almost 50 years of exposure to cycles of freezing and thawing and impact and abrasion from ice and debris, the nonair-entrained concrete in the structure showed signs of deterioration. An evaluation of the dam indicated that the rehabilitation should include construction of closure panels for the head gate section, conversion of the gated ice chute to an uncontrolled ogee crest, and resurfacing of the tainter gate piers. Rehabilitation of the tainter gate section consisted of removing and replacing concrete on the surface of the piers, installing new gate seal plates and heating elements along the sides of the piers, and modifying concrete to accommodate new bridge bearing details.
