Structural analysis and rehabilitation  
of concrete dams and spillways

# **HISTORIC CASES ON CONCRETE DAMS REHABILITATION**

Third International  
Dam World Conference

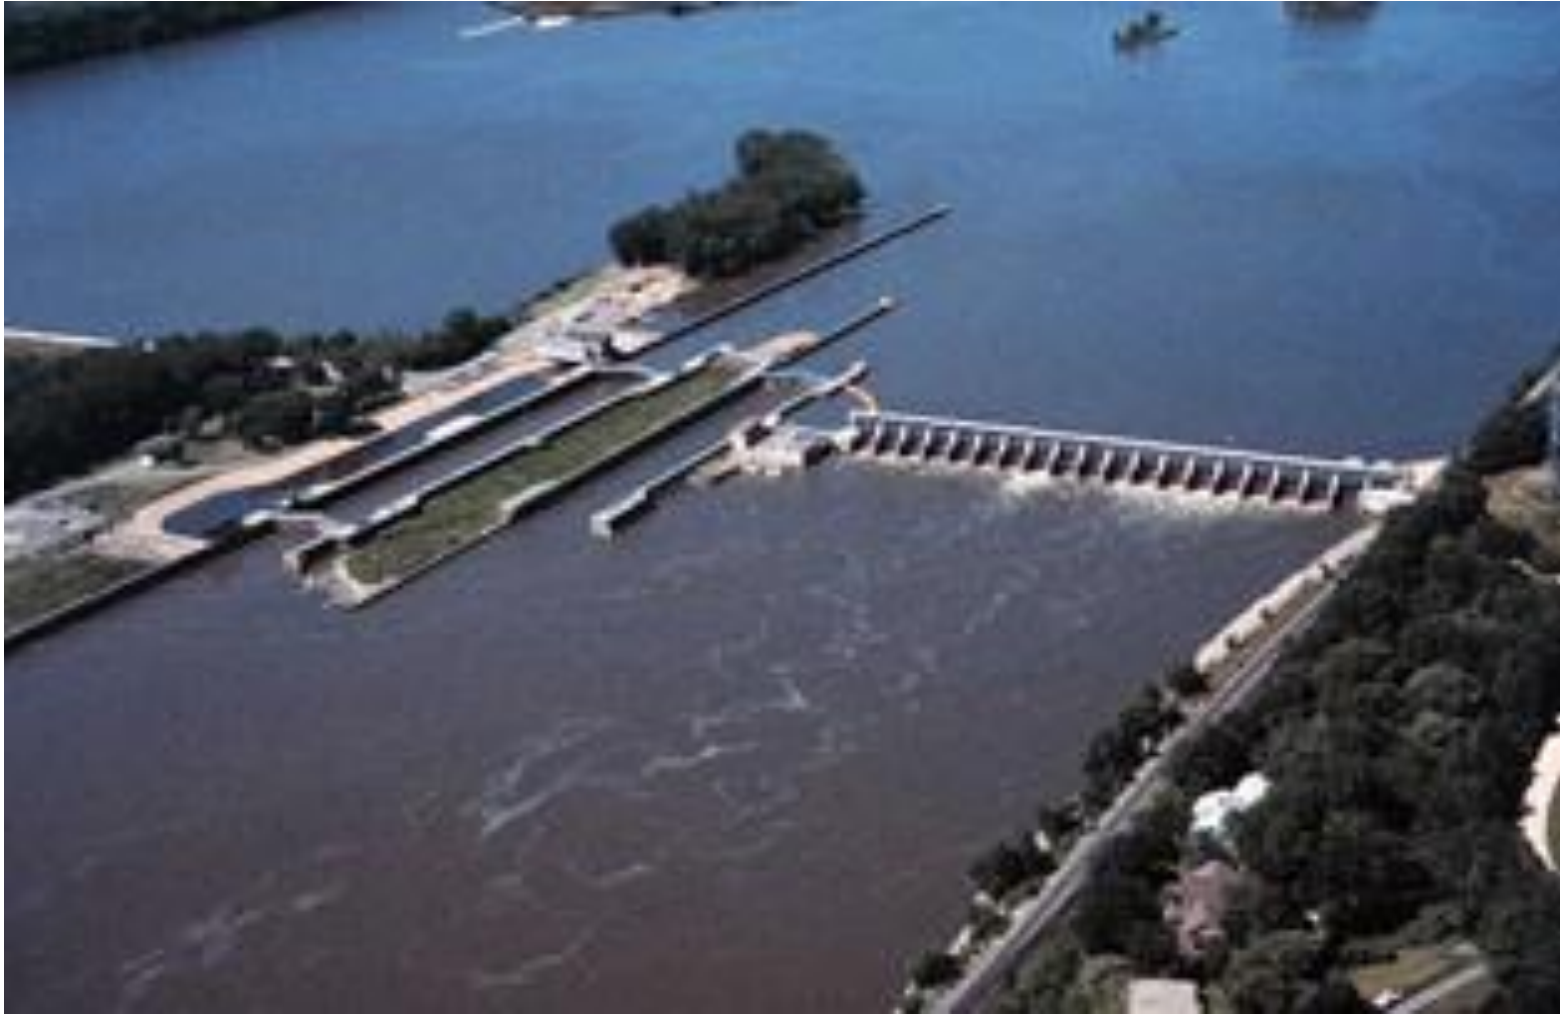
| CASE | IDENTIFICATION | COUNTRY | FINISHED | REHABILITATION/<br>REPAIR | REFERENCES |
|---|---|---|---|---|---|
| A-056 | Lock and Dam No. 2 | USA | 1930 | 1987 | [125; 126] |

Concrete on the piers directly beneath the existing bridge had deteriorated, and there was surface spalling of the concrete on the faces of the piers and in the trunnion recesses.

Repair of the piers and trunnion recesses consisted of removing the deteriorated concrete and replacing it with fiber-reinforced, acrylic-polymer modified concrete (FRAPMC) and eliminating leakage into the trunnion recesses. FRAPMC consists of mortar, coarse aggregate, and reinforcement fibers. It is mixed in a mortar mixer as a two-component system consisting of a liquid polymer emulsion of acrylic polymer and additives and a mixture of cements, aggregates, and admixtures. Polypropylene fibers and aggregate are mixed with the polymer emulsion mixture until the fibers are conditioned and dispersed, and then the cement mixture is added.

Typically, FRAPMC is mixed in batches that can be placed within 30 min or less. Cracks were injected with epoxy to seal them; joints were sealed with joint sealant. The epoxy was a two-component, 100 percent solids, low viscosity water insensitive material especially made for sealing concrete cracks.

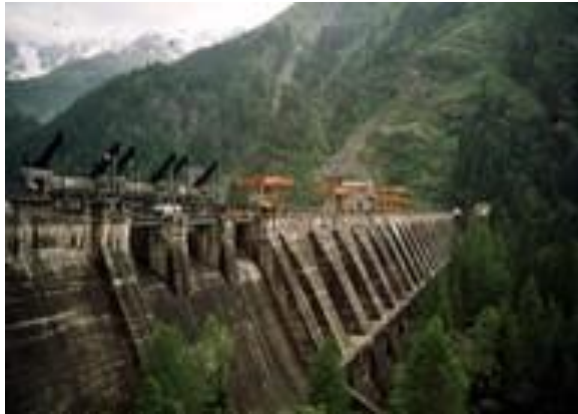
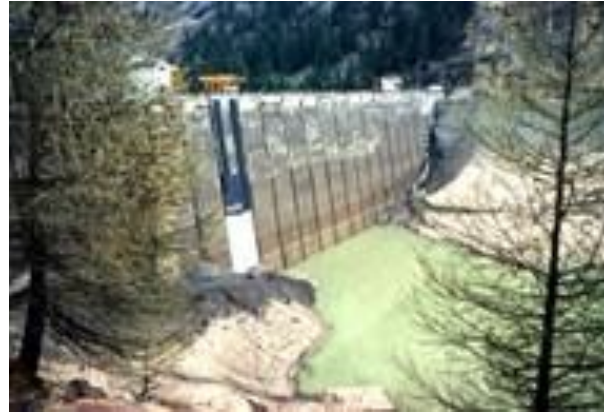
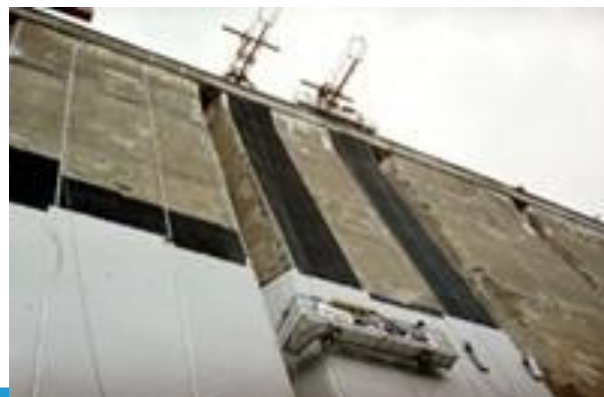
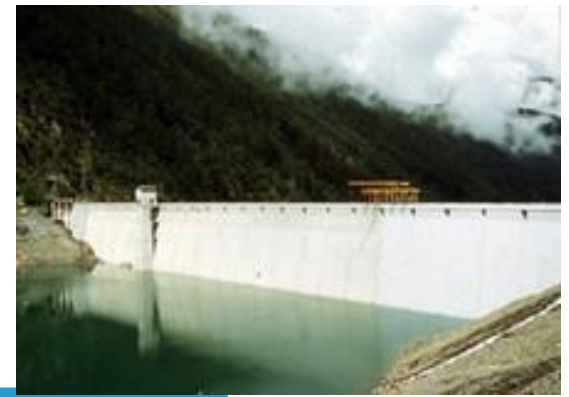
Due to the deterioration (cycles of freezing and thawing) and leakage of the face of the dam it was repaired using PVC geomembrane.

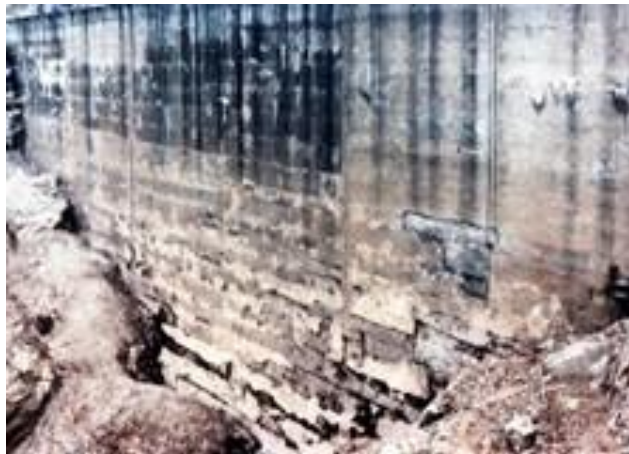
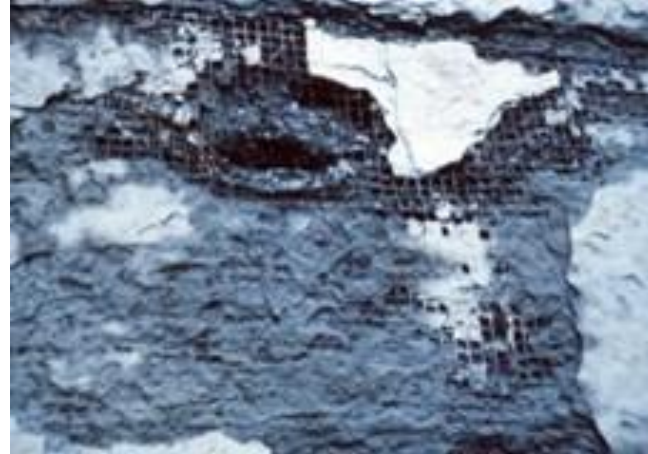
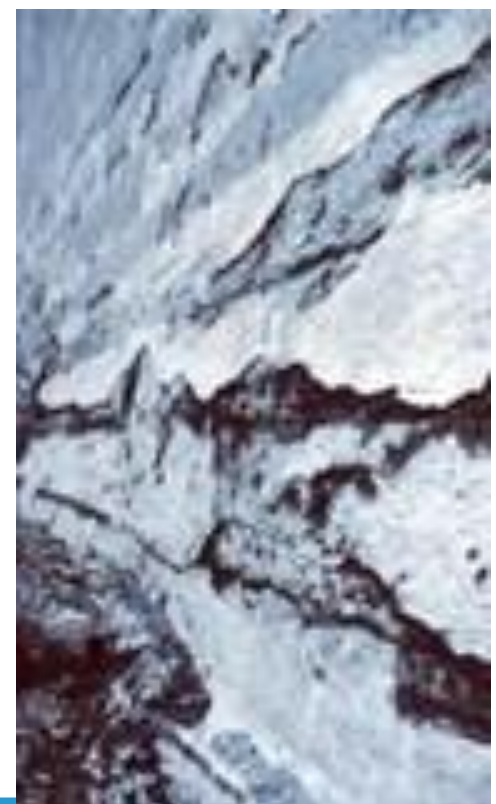
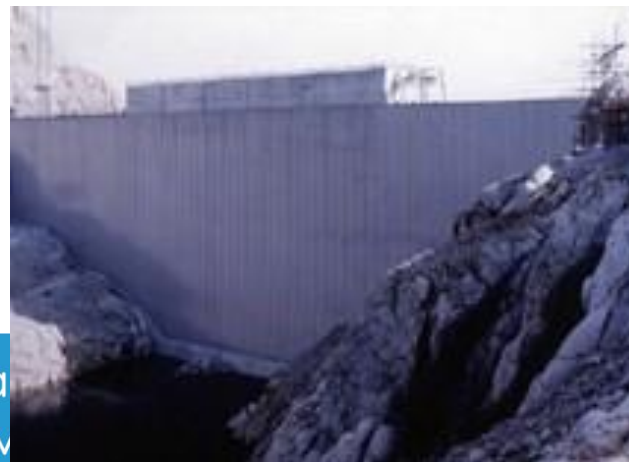
Due to the deterioration (cycles of freezing and thawing) and leakage of the face of the dam it was repaired using PVC geomembrane.

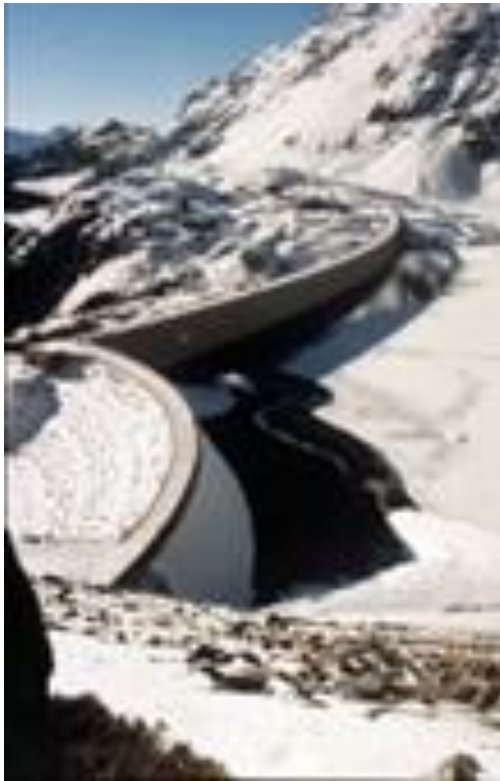
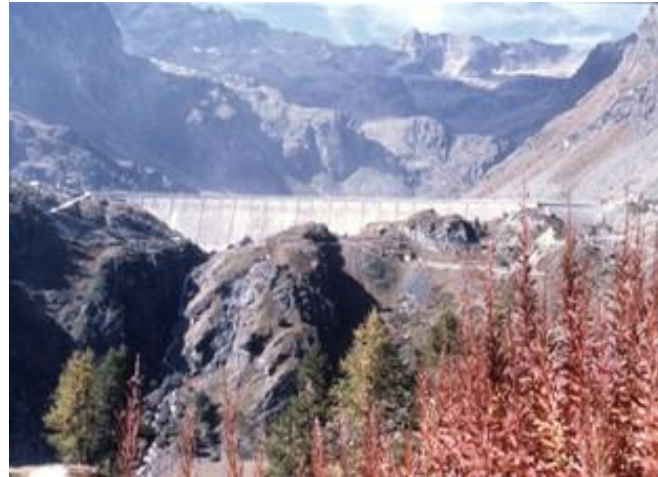
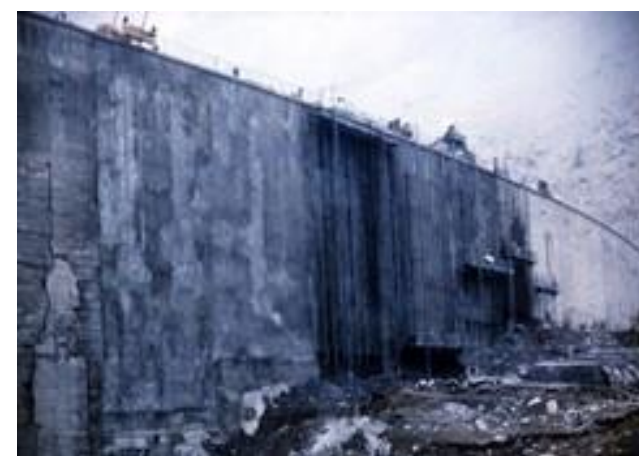
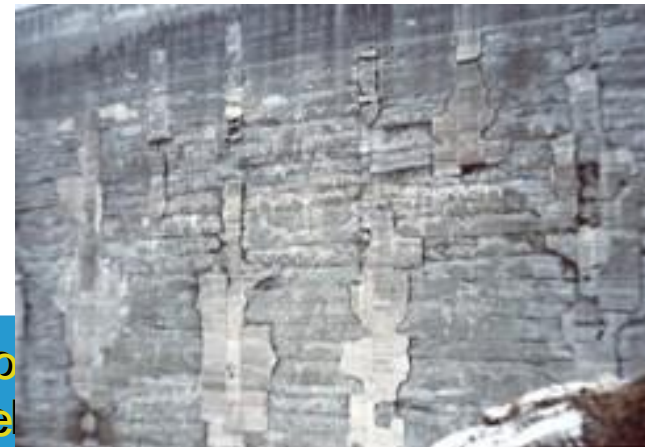
Due to the deterioration (cycles of freezing and thawing) and leakage of the face of the dam it was repaired using PVC geomembrane.

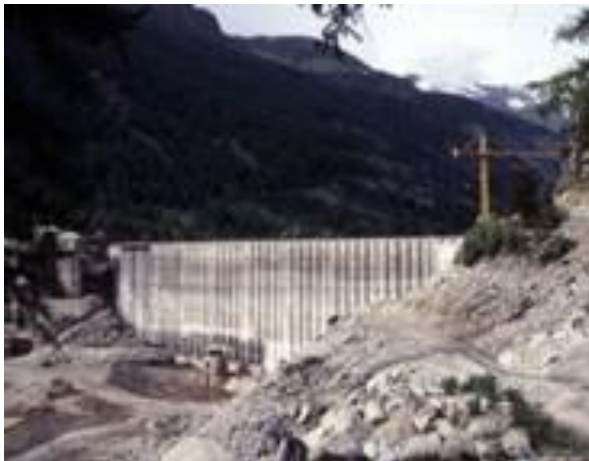
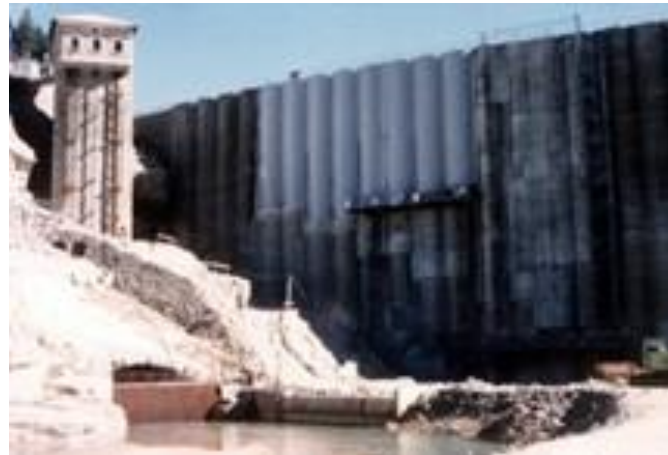
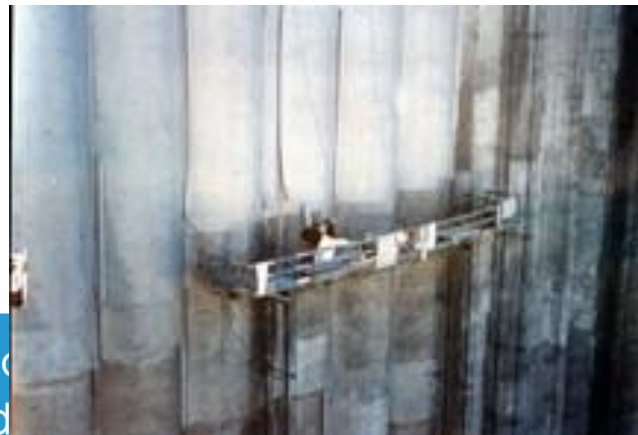
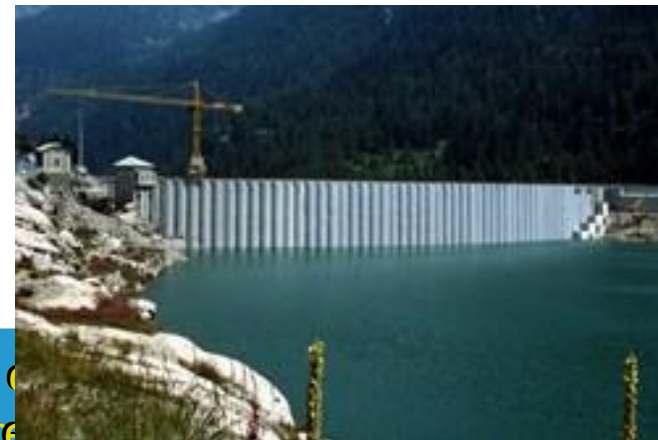
Due to the deterioration (cycles of freezing and thawing) and leakage of the face of the dam it was repaired using PVC geomembrane.

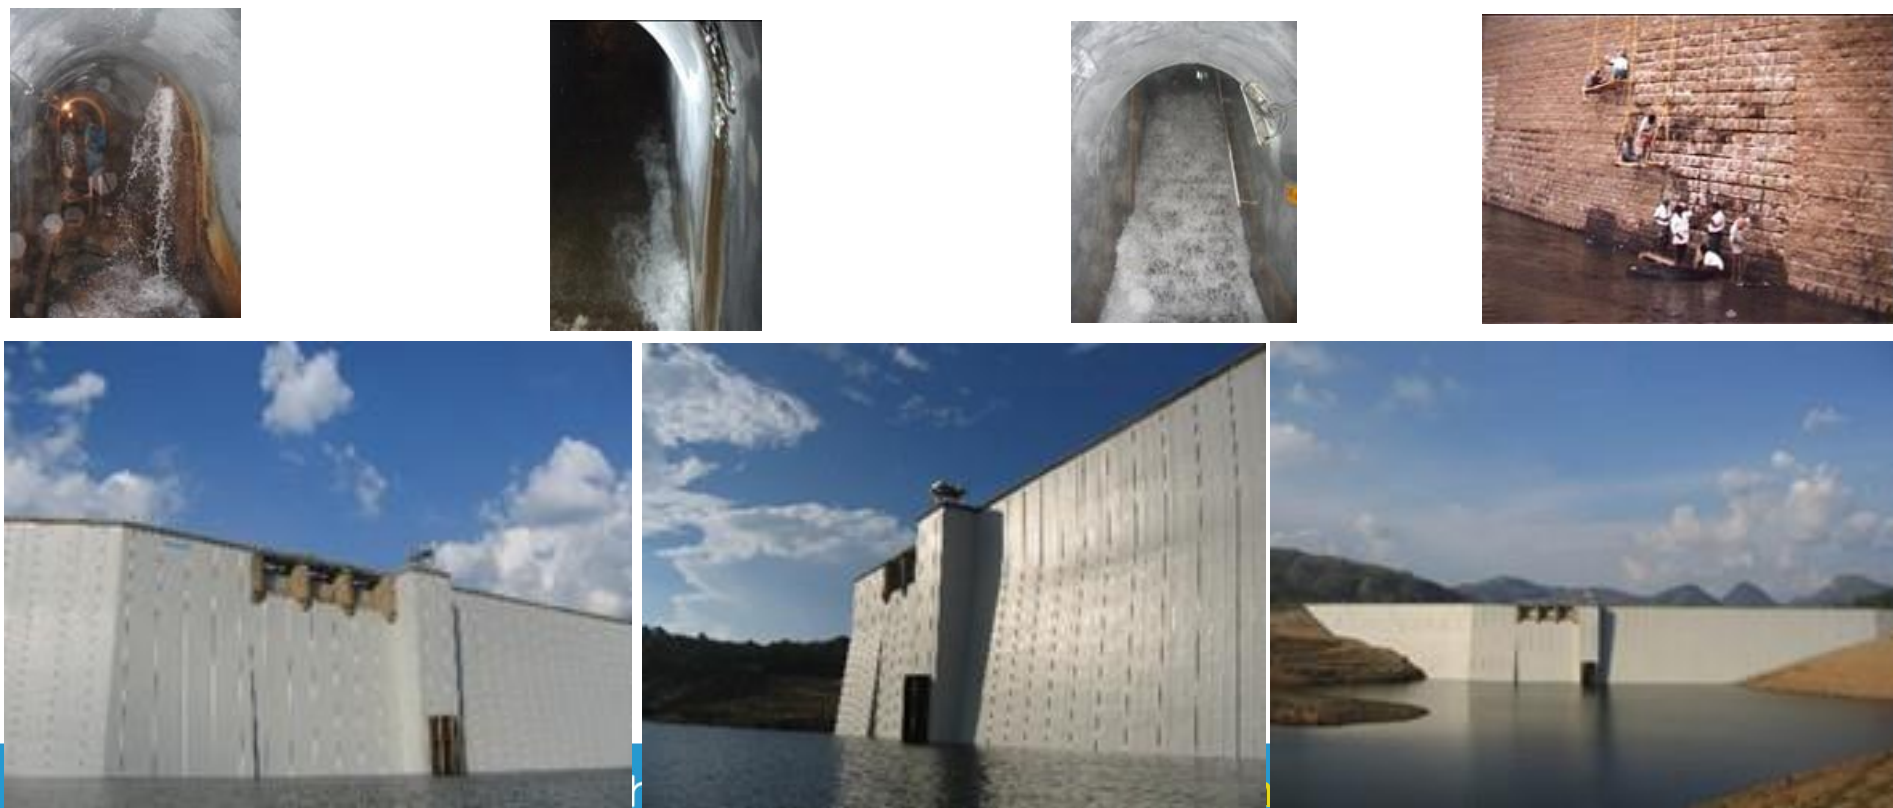
Due to the deterioration and leakage of the face of the dam it was repaired using PVC geomembrane. Leakage before repairs was 38,000 liters per minute (633 l/s) After repair (2005) 30 l/m.

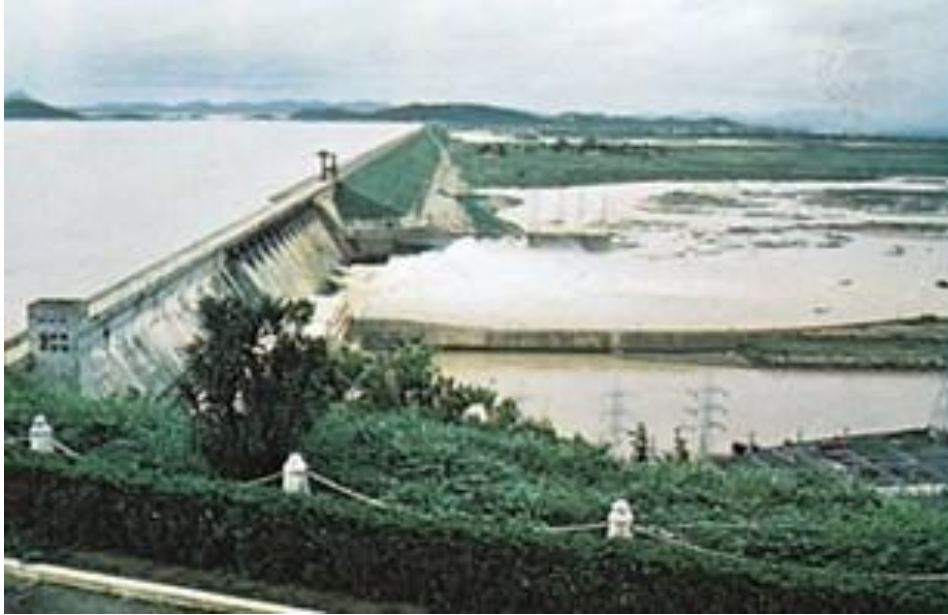
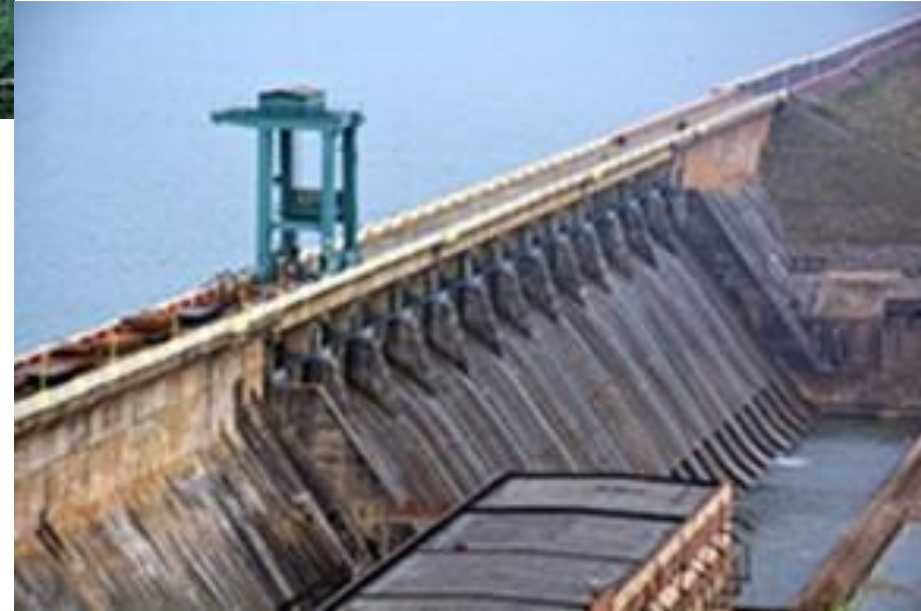
| CASE | IDENTIFICATION | COUNTRY | FINISHED | REHABILITATION/<br>REPAIR | REFERENCES |
|---|---|---|---|---|---|
| A-062 | Hirakud Dam | India | 1957 | 1975 | [22; 133; 134] |

Cracking in various locations of both the concrete spillway dams (due to ASR - Alkali Silica Reaction) have caused serious concern. The major distress and deficiencies observed in this project are:

As the reservoir water level was operated normally, under water repairs to cracks in the upstream face of spillway was required.

The purpose of epoxy injection into the crack is to provide structural improvement of the concrete spillway by filling the internal cracks with an epoxy adhesive material under pressure and ensuring highest possible bonding.

The entire under water treatment procedure was scanned and monitored through TV which gives, much more confidence and confirms the various treatment activities taken up under water. Further, the examination of extracted drill core from the under water treated surface and drilled-core test confirms satisfactory efficacy of the grouting and proper sealing of the cracks.

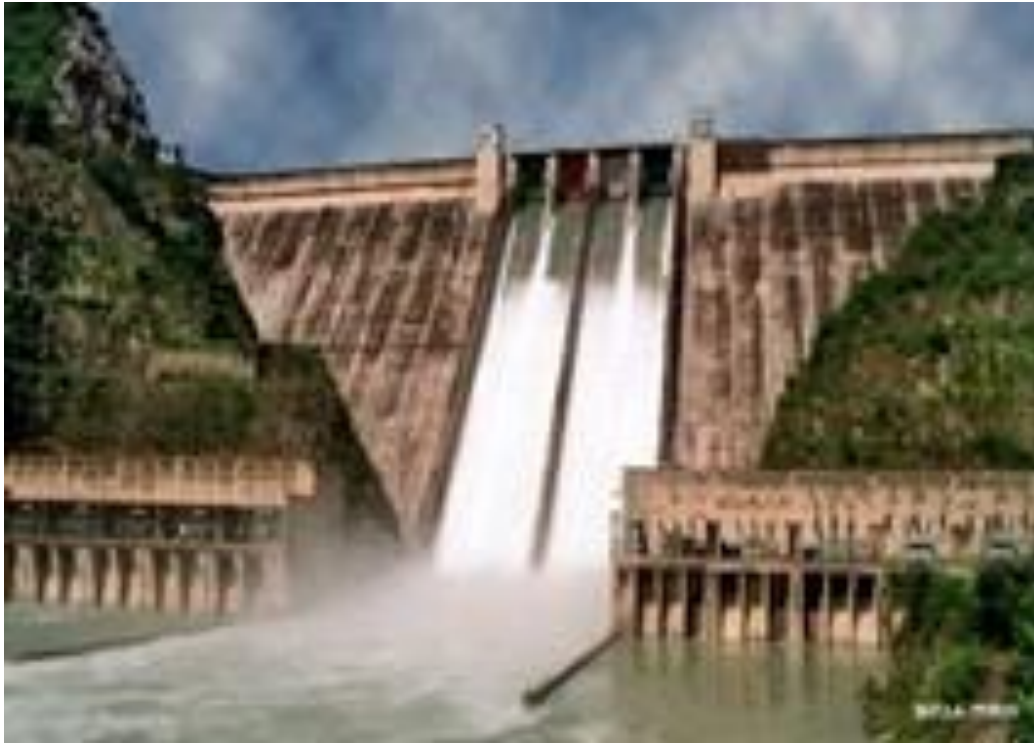
When divers inspected the stilling basin, they found erosion damage, which was attributed to gravel and boulders in the stilling basin during flood discharge. The damage varied in depth from 50 to 700 mm. Because the two power plants had to remain in operation, the damage was initially repaired with conventional underwater concrete methods. A subsequent inspection revealed that the repair had failed because of inadequate bonding of the new and old concrete. Therefore, a new method of repair that would allow for the necessary bonding while keeping the power plants operating was needed.

Concrete repair consisted of cleaning the concrete surface with an air/water jet, removing deteriorated concrete manually or pneumatically, and repairing the eroded concrete. The repair method depended upon the depth of erosion. Deterioration less than 50 mm was replaced with epoxy concrete to designated height. Areas of deterioration in excess of 50 mm were coated with epoxy before the new concrete was placed. If the depth of erosion exceeded 200 mm, epoxy-grouted dowels were installed on 0.6-m centers to anchor the new concrete, and joints were treated with epoxy paint.

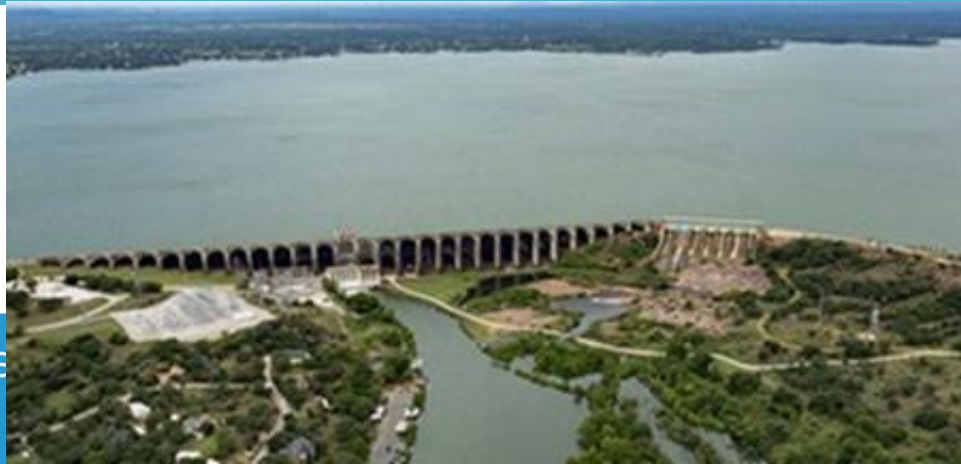
When the lake was impounded, the area between the original and later construction began leaking because of inadequate bond between the older and newer concrete, a result of the interruption in construction.

Although the dam was safe, there was required wanted to stop the leaks to conserve water and improve dam appearance. The repair method specified a water-activated foam, which would remain flexible and keep the voids filled as the dam expanded and contracted.

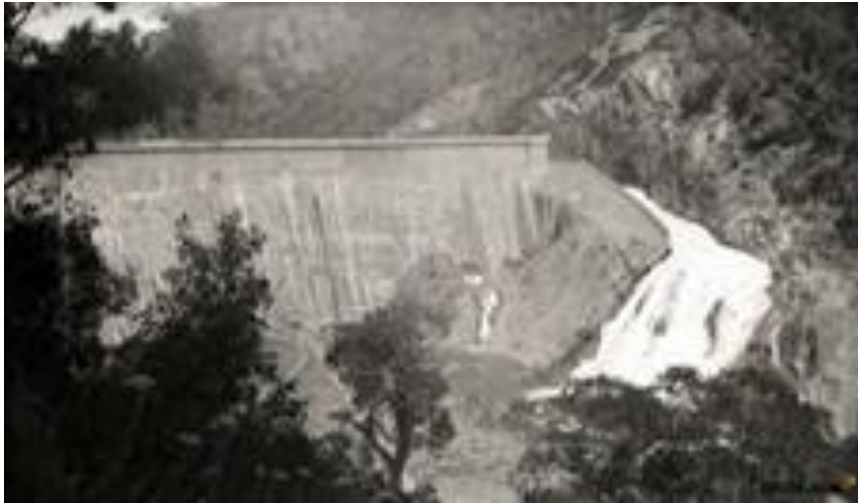
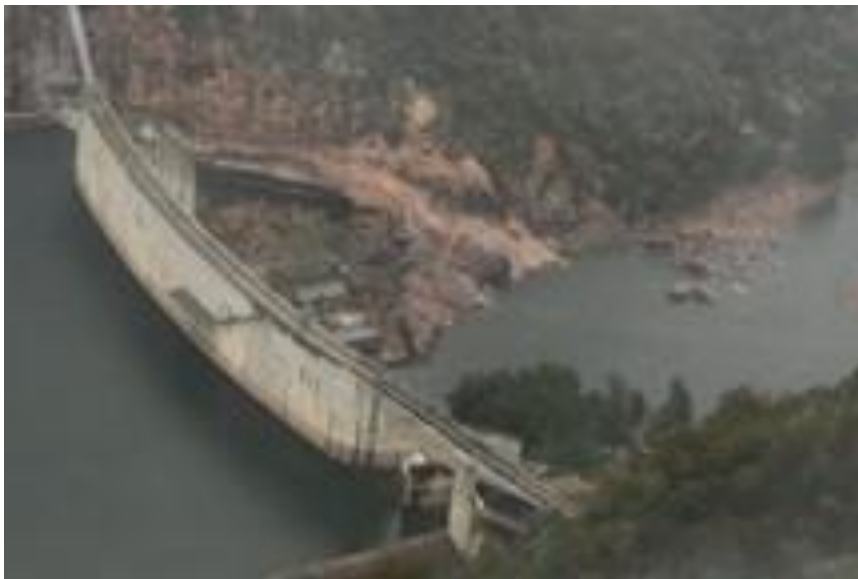
In 1990, work began on a project to increase the height of the dam by 12,2m. An open reinforced-concrete chamber was constructed at the existing crest level of the dam, and the dam was stabilized with posttensioned ground anchor cables. During high flood levels, the chamber fills with water, thus providing additional stability. Two rows of posttensioned ground anchors provide a stabilizing force for the dam.

To provide corrosion protection, strands were encapsulated in grease-filled polyethylene tubes above the anchorage zone, and cables in the anchorage zone and the free length of cable were installed in a single-stage grouting operation. Cable load is monitored, and the anchors can be restressed if necessary.

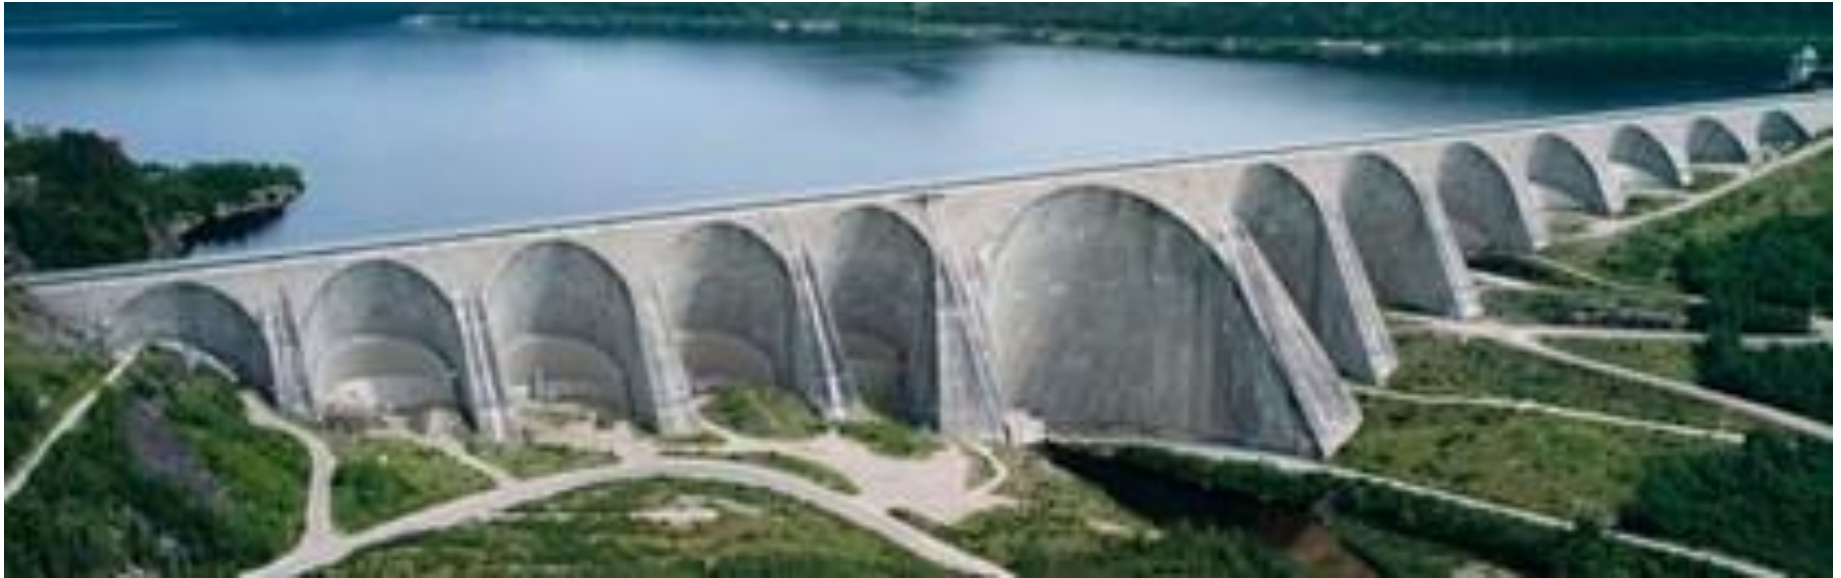
During twenty years, leakage marks have appeared on the downstream buttresses, and also some degradation of the concrete due to freeze-thaw cycles along the vertical joints was observed. This situation led to replace the joint sealing for enhancing the watertightness and appearance of the downstream face of the dam. So a new and more effective solution was required to restore the watertightness and appearance of the joints. The solution chosen in 2008, was to use a flexible waterproofing sheet geomembrane system to stop infiltration and freeze-thaw action affecting the buttresses.

The solution developed to reduce freeze-thaw damage on the downstream buttresses of the dam consists of external waterstop over the vertical joints in the upper part of the downstream face. The waterproofing system used for the dam consists of:

- waterproofing liner, geocomposite, consisting of a 2.5-mm-thick PVC geomembrane;
- Vertical and horizontal watertight stainless steel perimeter seal anchoring the PVC geocomposite to the concrete face; The flat profiles are anchored to the face of the dam via chemical anchor bolts;
- A rubber gasket was used to ensure even and adequate compression;
- An epoxy resin was applied to the face of the dam along the perimeter seal;
- Horizontal stainless steel flat profile for the top and bottom perimeter seal; The profile was bolted to the concrete of the crest wall with mechanical anchors;
- Two strips of geonet are placed under the geocomposite for ventilation;

All flat profiles, nuts, washers, couplers, anchor bolts and other metal items used in the perimeter anchor seal are made of stainless steel.

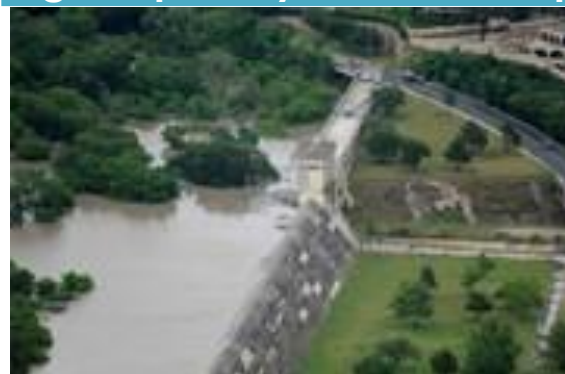
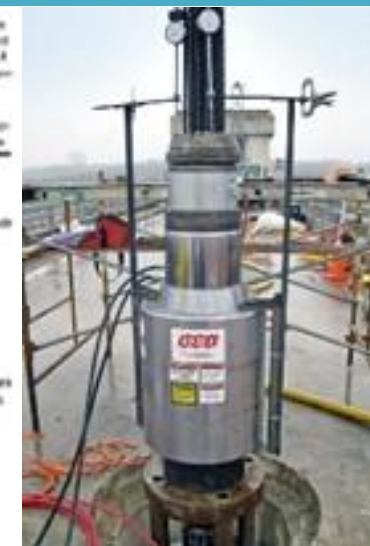
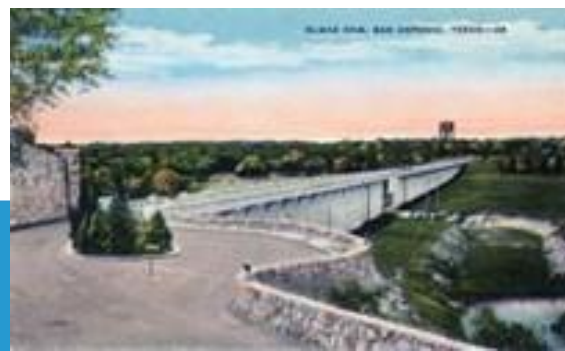
A major dam rehabilitation program had to be implemented in order to prevent damage during maximum overflow.

The alternative selected was to strengthen the two nonoverflow sections with prestressed anchors installed in 2- to 3-m- thick, hard limestone 15 m below the base of the dam and to increase the stability of the spillway with mass concrete. For construction of the 39-m- long ogee spillway crest, the topmost portion of the dam had to be removed.

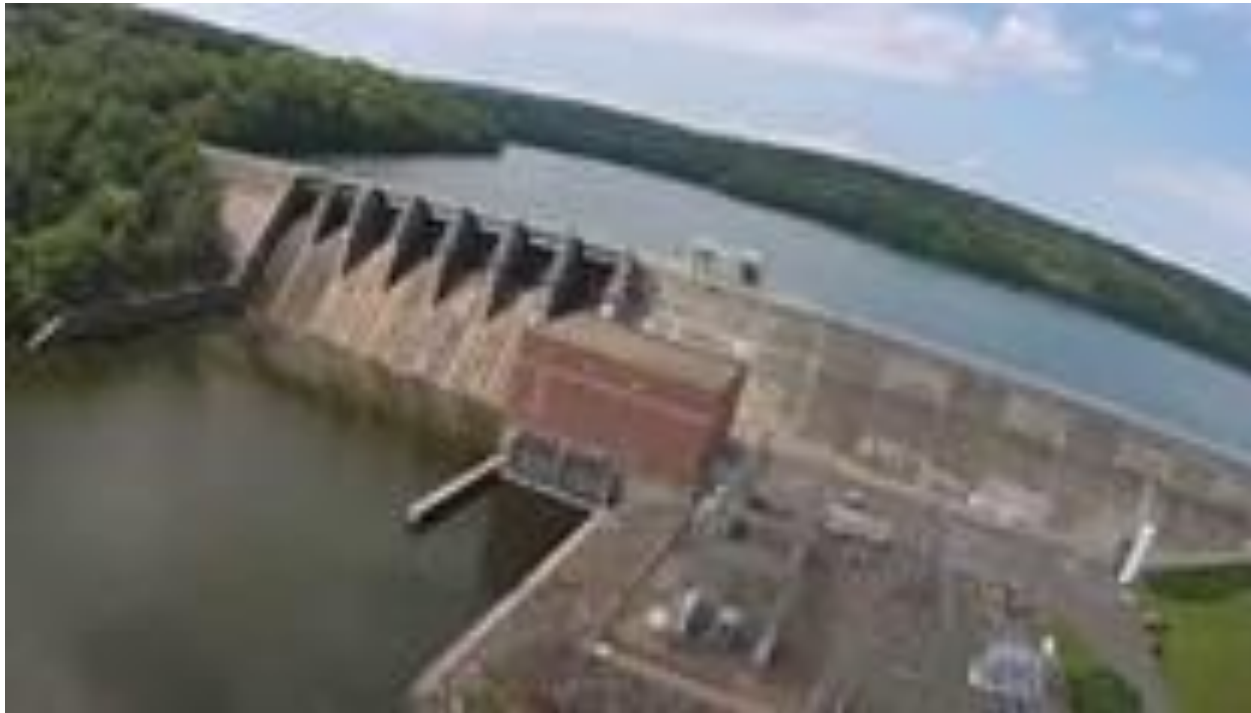
A stability reassessment in the 1980s found that the dam would be overtopped by the PMF. Therefore, high-capacity prestressed rock anchors were designed and installed to safeguard the dam against overturning.

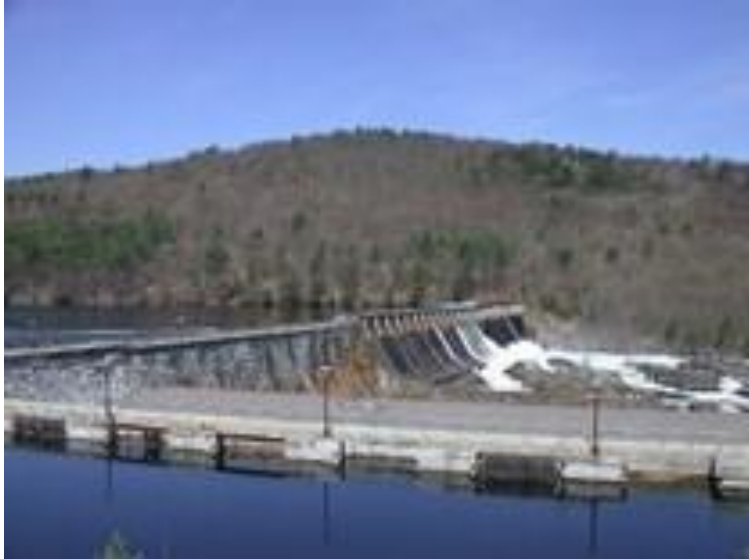
| <p><b>ASPECTS</b></p> <p>The dam was a hollow-arch concrete dam. Over time the dam, suffered concrete damage as a result of chemical reaction and cycles of freezing and thawing.</p> <p>Despite extensive maintenance the deterioration continued to occur. By the mid- 1980s, severe cracking in the dam's arches and buttresses was allowing water to penetrate the structure and cause structural damage.</p> <p>The first step in the rehabilitation was to dewater the area between a cellular cofferdam and the existing dam. Next came the demolition work on the dam. The foundation and lower buttress portions of the dam that had not been exposed to weathering were sound and usable; therefore, total concrete demolition was not required.</p> <p>The entire reinforced concrete arch roof and selected areas of the buttresses would have to be removed. Partial removal of the concrete arches and severing reinforcing steel would affect the stability of the structure and increase the need to restrict heavy vibration.</p> |

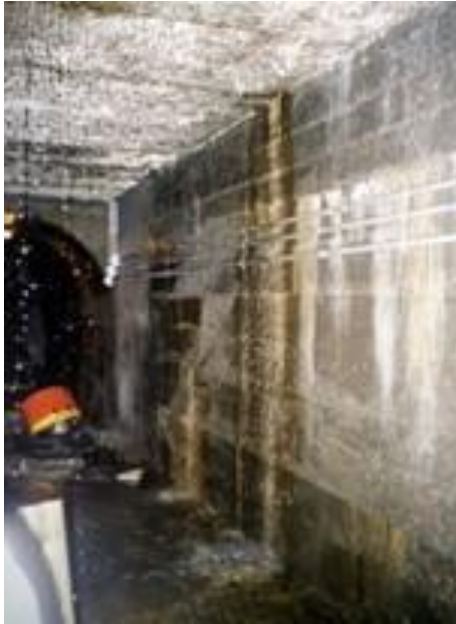
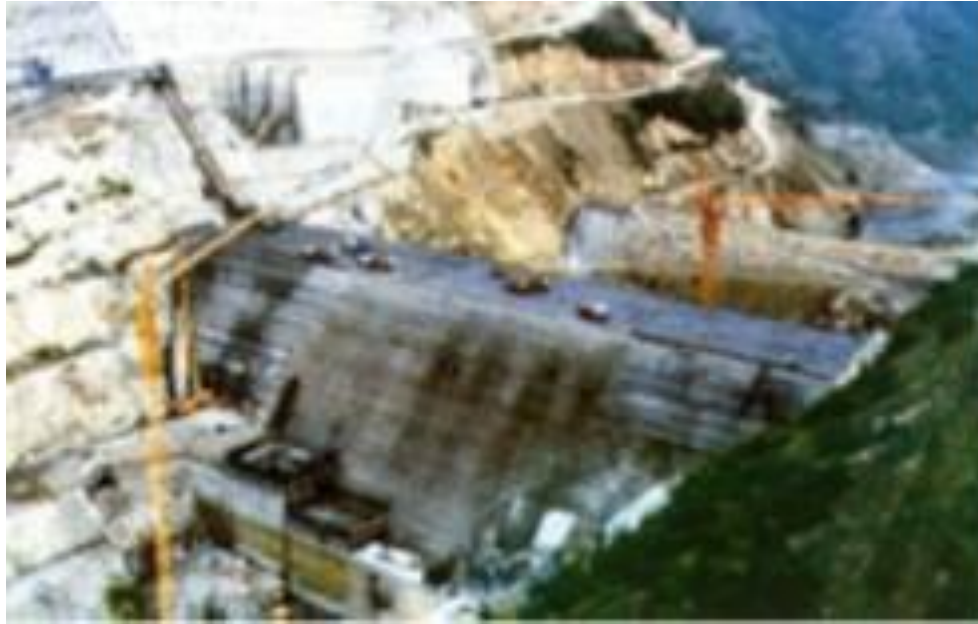
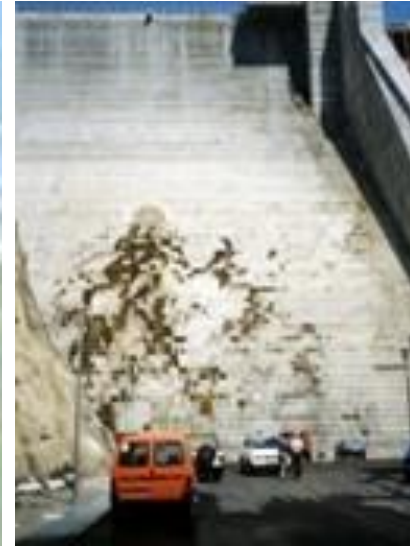
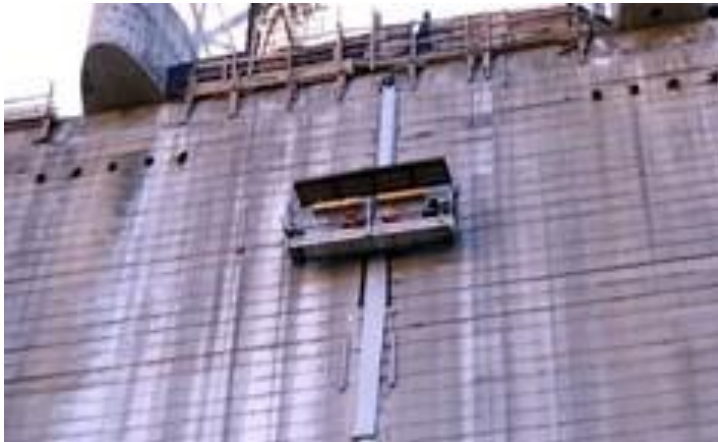
| <p><b>ASPECTS</b></p> <p>The external waterstop system has been used for the underwater repair of Platanovryssi, a RCC dam in Greece. The dam, of the high cementitious content type, was designed to be impermeable in its whole RCC mass. The vertical contraction joints were waterproofed with 12 Carpi external waterstop system during construction.</p> <p>On first filling, after mid-December 1999, seepage started increasing, and reached more than 21 l/s, dropped again and then increased to a maximum of 30,56 l/s on 10 October 2000. The cause of the leak was what appeared at first as a hairline crack in the gallery, then on the upstream and downstream face, with a maximum opening of 25 mm. The crack was approximately 20 m long.</p> <p>Repair works were scheduled for Spring 2002. Due to an unusually dry season, the owner could not afford to lose the volume of the water to empty the reservoir in order to work in dry conditions. In addition to that restriction, when Platanovryssi is emptied the pumped storage scheme of Thissavros cannot operate, with serious implications to the production system.</p> |

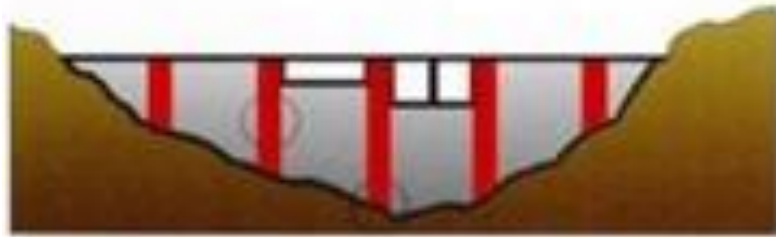
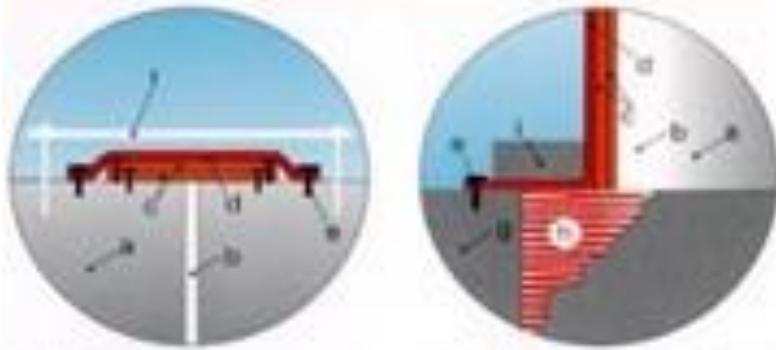
- a. RCC lifts
- b. Vertical induced joint
- c. Anti-intrusion supporting membrane/plate (optional)
- d. Geocomposite waterproofing liner
- e. Watertight perimeter seal
- f. Covering plate (optional)
- g. Concrete foundation
- h. Grout
- i. Dead weight for ballast

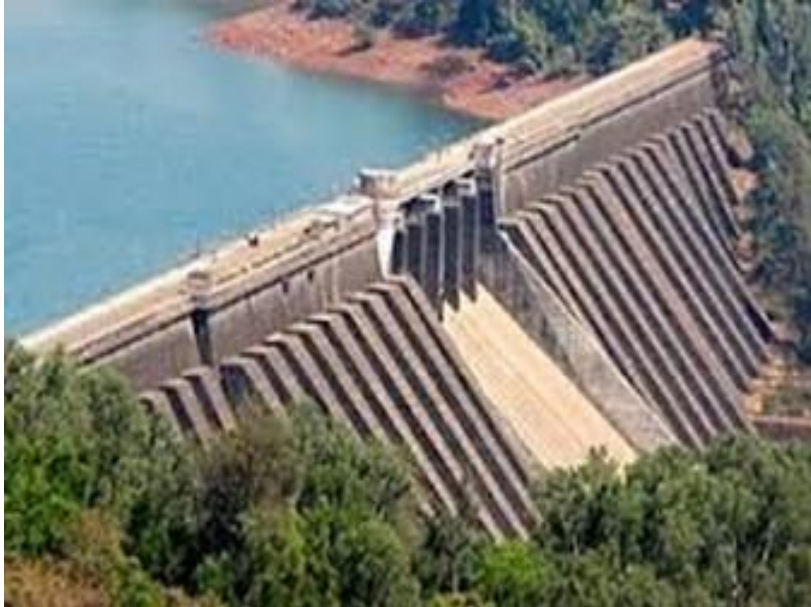
The dam has been designed for earthquake acceleration of 0.05g, constant over the entire height corresponding to maximum water level in the lake. The dam constructed in 1962 across river Koyna has experienced an earthquake of magnitude 6.5 in the Richter scale on December 11, 1967. By having measurements in the gallery located in the dam the leakage through the body of the dam and foundation was monitored. This showed increasing trend after the earthquake. The Koyna dam developed some surface cracks.

Immediately after experiencing the earthquake an expert committee recommended several temporary and permanent measures for strengthening of the dam. These measures were:

- a) Grouting of the cracks by epoxy resin, polyester grouting and sealing of crack on the upstream by grouting and guniting, thus reestablish the monolithicity of the dam as far as the epoxy grout can penetrate from the face and at the same time prevent the ingress of water into the body of the dam;
- b) Strengthening of 7 high monoliths by pre-stressed cables was carried out because it was not possible to assert that:
  - (i) the crack did not extend beyond the grouted face;
  - (ii) the crack did not continue from upstream to downstream face;
  - (iii) the resin grout has bonded the whole width of the dam.

It was therefore decided that cracked and deep monoliths should be stitched across crack by pre-stressed cables so that the bodies above and below the crack act together in unison under dynamic forces.

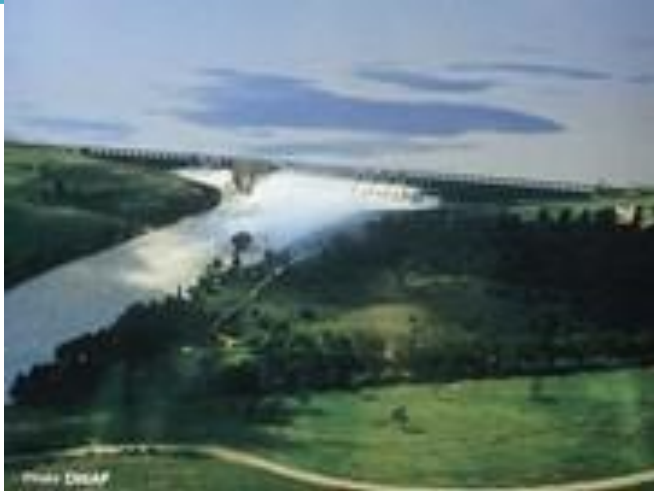
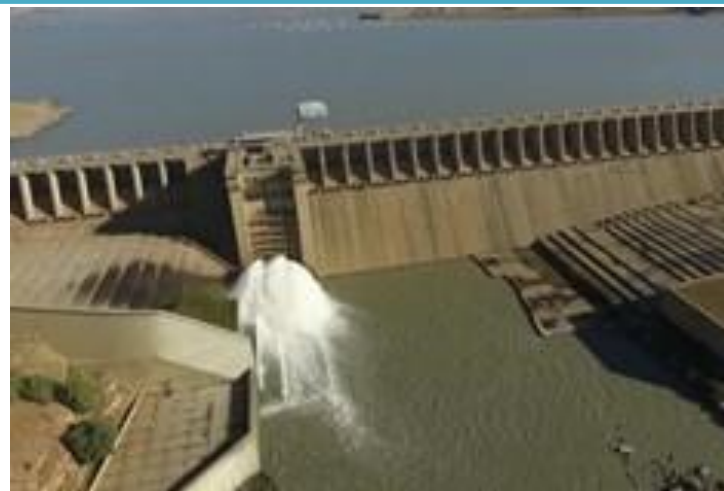
In order to meet the increasing demand for water from the dam it was raised in the early 1950's. The concrete spillway section and the dam were raised with 3 m. Stability analyses conducted in 1975 however indicated that the structure did not comply with the dam safety standards of the time and the need for rehabilitation work was identified, specifically in so far the spillway capacity and the stability of the concrete gravity sections were concerned. The dam wall was stabilized using pre-stressed cables and by increasing the cross sectional area of the concrete sections of the wall.

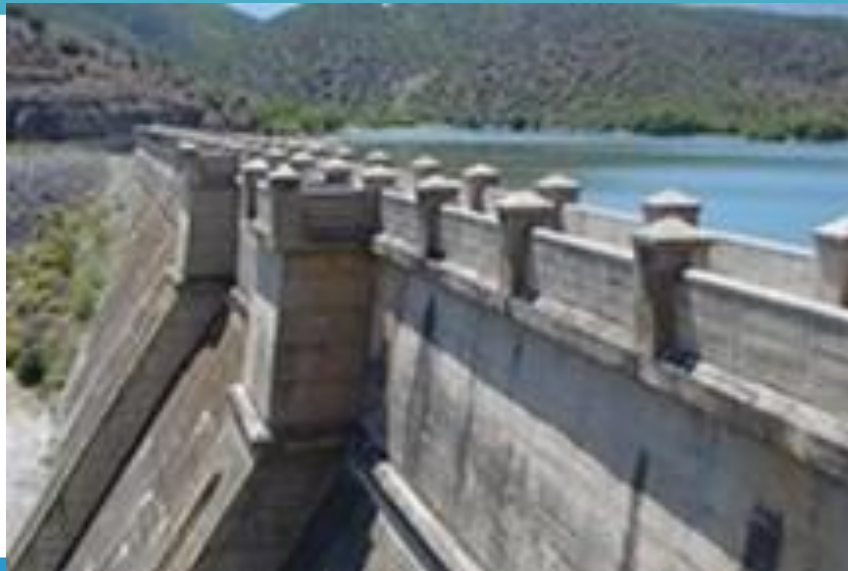
During one of compulsory dam safety evaluations of the dams in the late 1980's, Calitzdorp dam was one of those that did not satisfy dam safety requirements (the drainage system of the concrete structure was not functional and the spillway capacity was not sufficient). A decision was made to proceed with the remedial work based on the results of the prioritization methodology. The remedial work was done in the early 1990's and included improving the spillway capacity as well as the internal drainage system to decrease the influence of uplift.

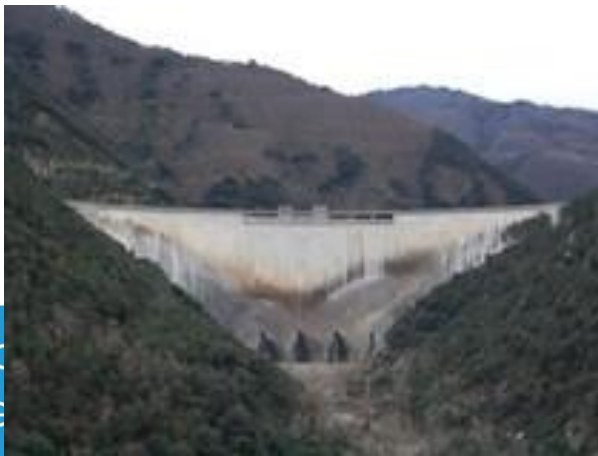
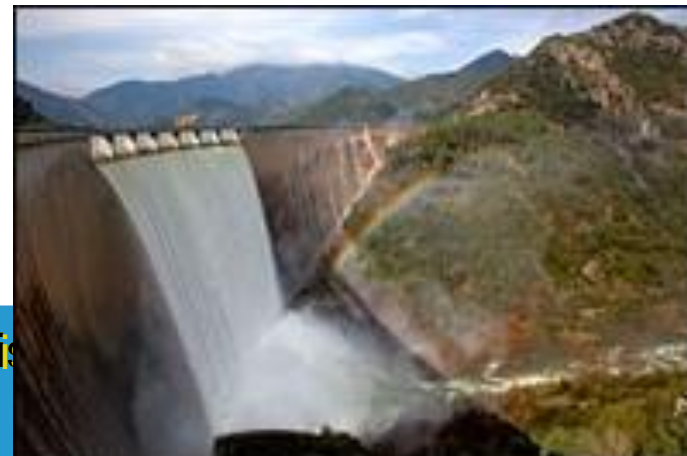
The dam was provided with a comprehensive system of monitoring and has been the subject of frequent studies of its behavior. From these studies was found that was necessary to reinforce the structure reinjecting their vertical joints. The injection was performed with two component resins.

Renovation of the bottom outlets of the dam, in addition to having to overcome the difficulties imposed by its particular geometry was also planned in such a way that modernizes some outlets designed under criteria that today would not be entirely acceptable. Difficult access to the outlets, both upstream with almost a 90 m column of water, and downstream with a height of 30 m above the stilling basin, required special methods and structures to be used for sealing the conduit, for dismantling the existing hydro-mechanical systems and for the assembly the new ones.

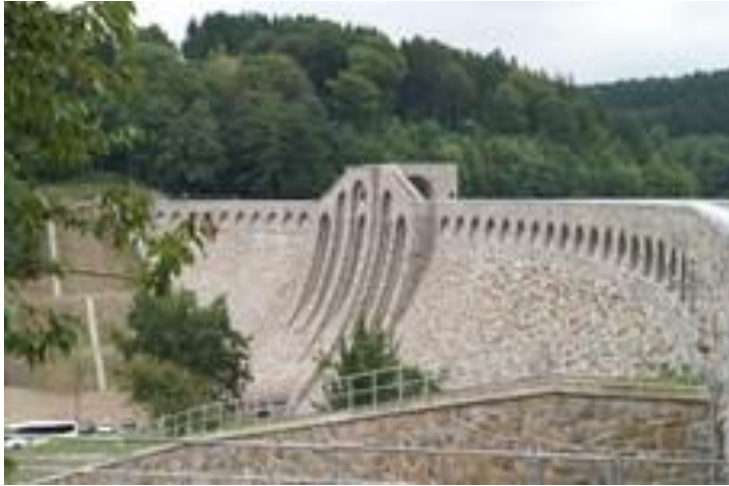
The destined works at the upstream side of the dam required draining the reservoir entirely. In order to secure continuous water supply by nearby dams, an auxiliary raw water extraction system involving the upstream dam and ducts was implemented in advance. After the 2002 event, intense rehabilitation and repair works have been conducted with a view to bringing the dam to the recommended standards. The main works at the dam have been:

- building of a new upper dam,
- construction of a 3,3 km long tunnel from above the pre-dam around the whole reservoir as an additional spillway and a facility to improve water quality and for securing adequate drinking water supply for the city of Dresden during the rehabilitation of the main dam (empty reservoir);
- increase of the spillway capacity to cope with the new design standard;
- construction of a new inspection gallery into the dam;
- refurbishment of the dam (sealing and monitoring instrumentation),
- construction of new hydraulic elements (outlets, intake system, stilling basin).
