Structural analysis and rehabilitation  
of concrete dams and spillways

# **HISTORIC CASES ON CONCRETE DAMS REHABILITATION**

Third International  
Dam World Conference

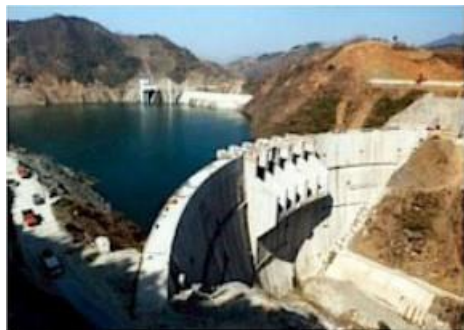
On 8 August 2002, a horizontal crack was found on the upstream face of the dam. Water pressure tests and bored dam concrete cores indicated that the crack was along the surface between the eighth and the ninth placing layer. The crack had developed from the dam upstream face to the downstream face, and had a total cracking area of nearly 1000m<sup>2</sup>, with a width less than 0.3mm. After careful observation, indoor tests and field experiments - measures including chemical grouting into the crack surface, sealing the crack boundary and installing anchor steel piles through the crack - were carried out twice for the arch dam.

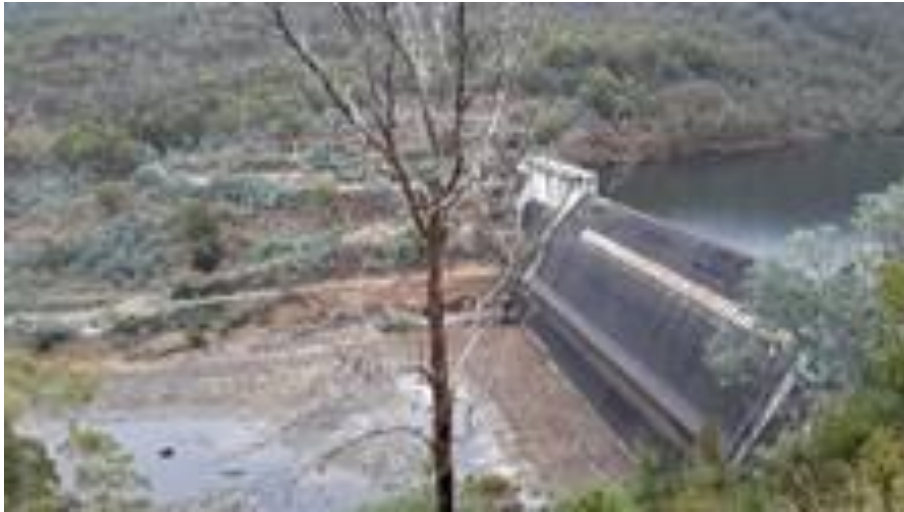
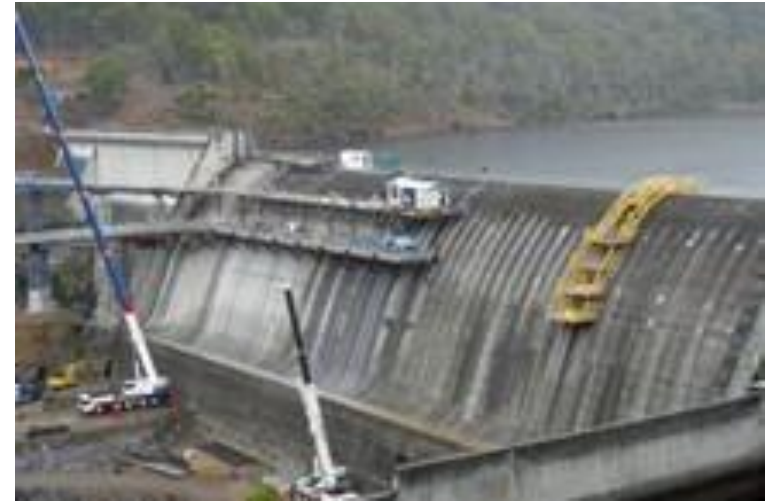
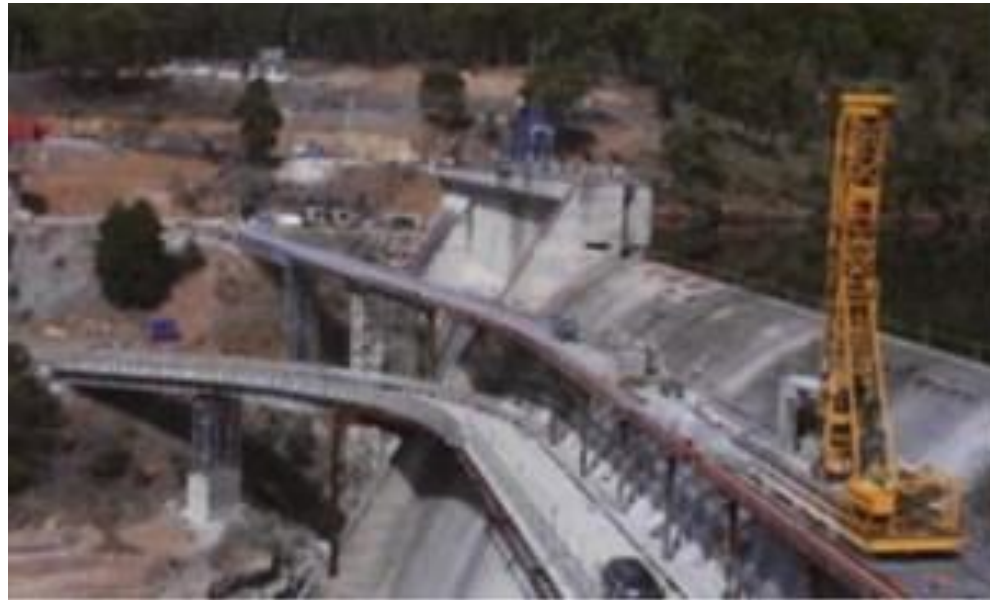
| CASE | IDENTIFICATION | COUNTRY | FINISHED | REHABILITATION/<br>REPAIR | REFERENCES |
|---|---|---|---|---|---|
| A-078 | Catagunya Dam | Australia | 1962 | 2010 | [154] |

During construction of the dam in the early 1960s, 412 post-tensioned anchors were installed but the integrity of the original anchors can no longer be assured. The stability of the dam has been restored over the past two years using 92 modern, large diameter and corrosion protected, post-tensioned anchors that can be monitored for deterioration. These are the most highly stressed anchors applied to a dam at that time.

- Installing more than half the anchors within an operating spillway, utilizing a limited construction window over the summer months;
- Providing access for drilling equipment and installation of the anchors well below the spillway crest on a 54° degree slope, 25m above the riverbed, and demobilizing these platforms sufficiently to allow floods to pass during the winter months;
- Replacing severed surface reinforcement with 9m long carbon fibre rods.

In order to gain access to the spillway of Catagunya dam for installation of the temporary access platform brackets on the spillway and the carbon fiber tensile reinforcing on the spillway face, a purpose designed and built travelling gantry was suspended from the spillway crest. This gantry had five working deck levels, with four of these providing access to the full length of the 9m long carbon fiber rods which were to be installed. Two 200m long temporary platforms were constructed to access the spillway. The upper platform was designed to provide access for the drilling, installation, and stressing equipment, as well as to provide safe and efficient egress in times of flood. The lower platform was used to give direct access to the anchor hole locations for installation of anchorage assemblies.

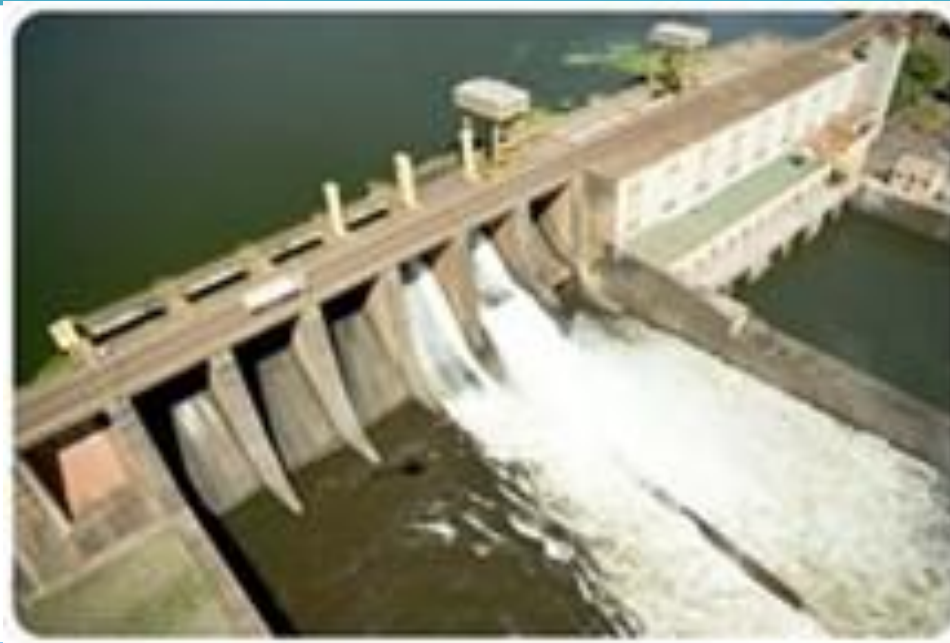
The shielding of the sluiceway was damaged and there was erosion in concrete slab of spillway. A cofferdam was constructed and the shielding was repaired and the eroded concrete treated with special concrete resin-based. Recently the equipment for the supervision and control of the power house and locks have been updated.

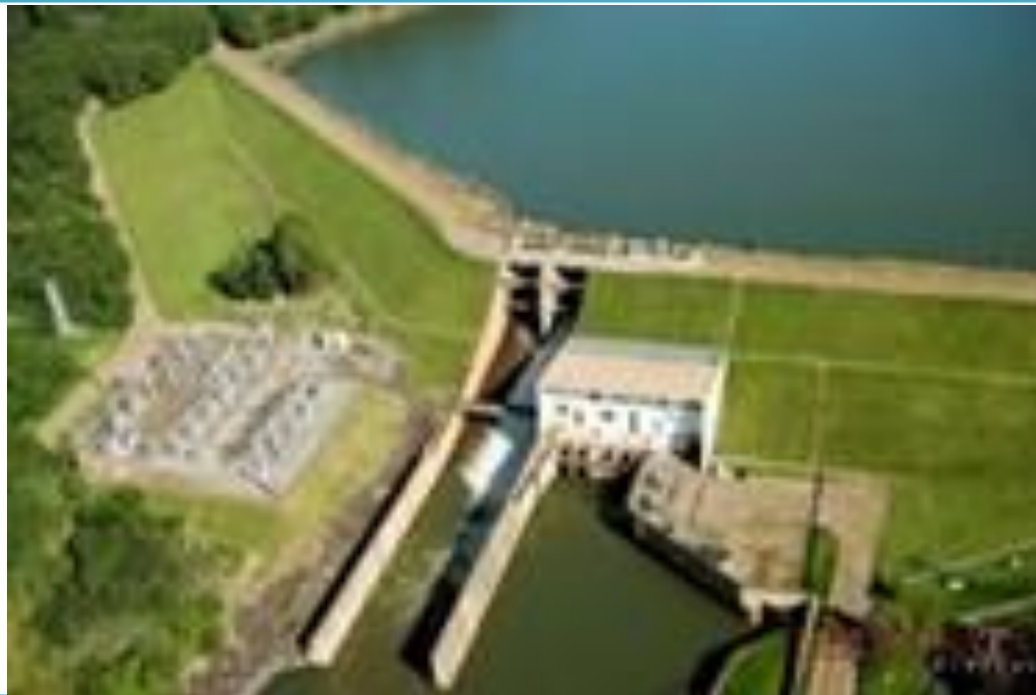
Due to the abrasive action of loose rock blocks in the basin of spillway, occurred erosions in the basin slab, exposing the reinforcement bars. Adopting a small cofferdam the concrete slab surface was repaired. Recently the equipment for the supervision and control of the power house and locks have been updated.

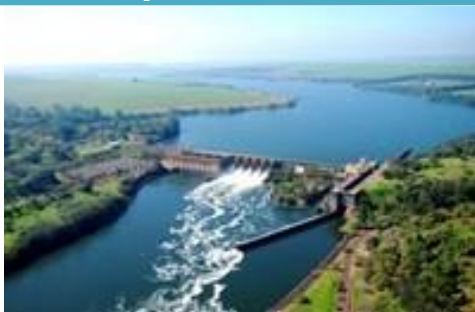
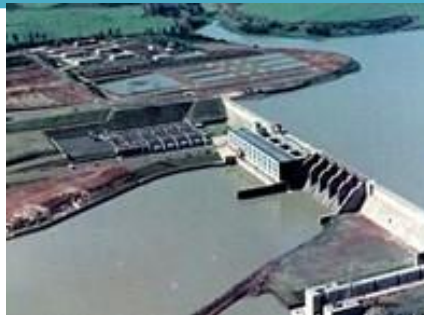
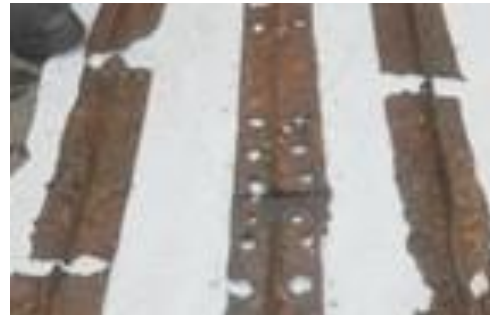
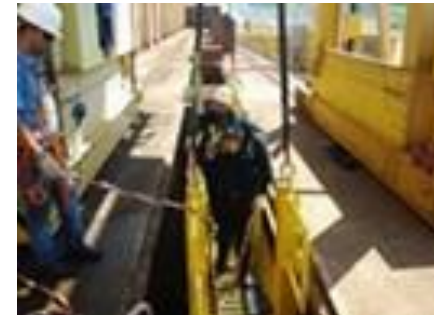
Part of the tailrace guide wall on the right bank was damaged. In several other locations were observed cracks and the structure was not in contact with the foundation. The gates had to be repaired, also.

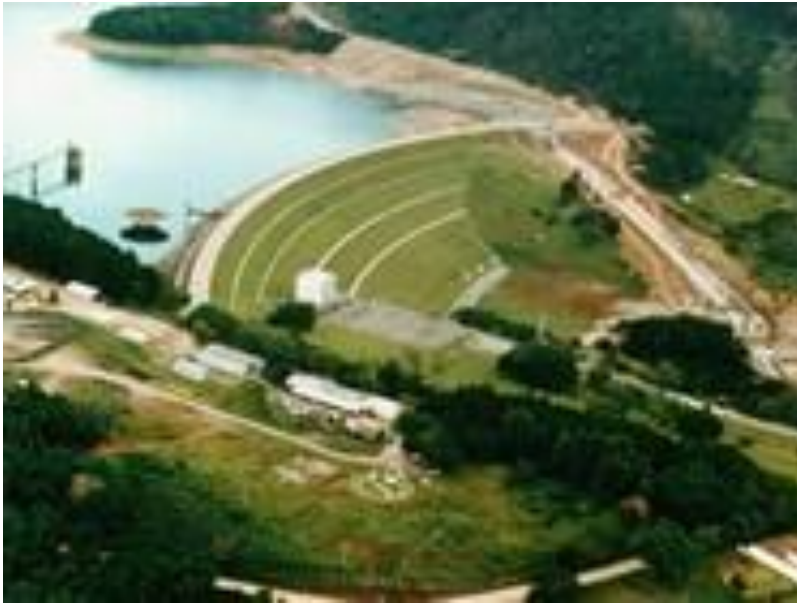
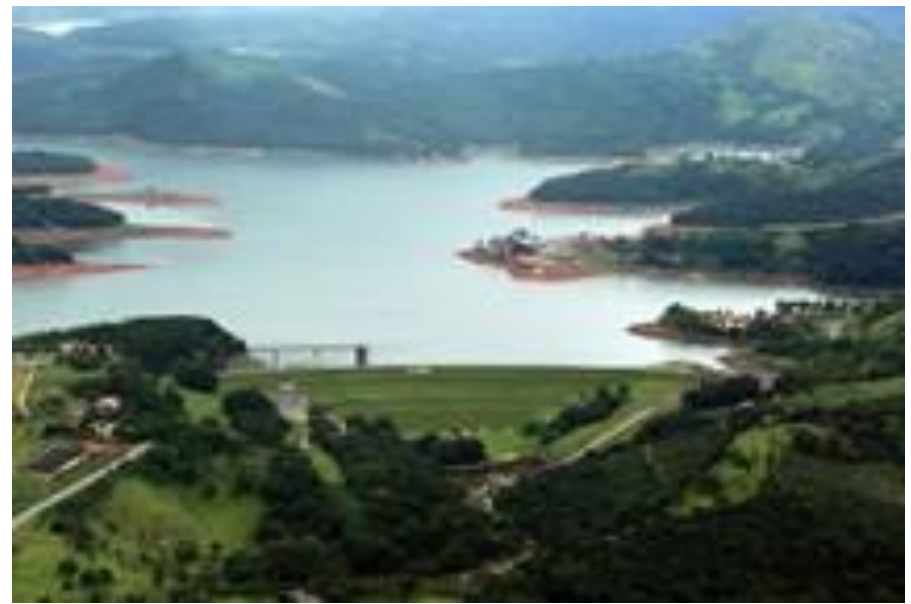
During an underwater inspections, were observed cracks in the wall that supports the rails of the trash rack. The concrete of the damaged areas was breakup and carried out the repairs with concrete.

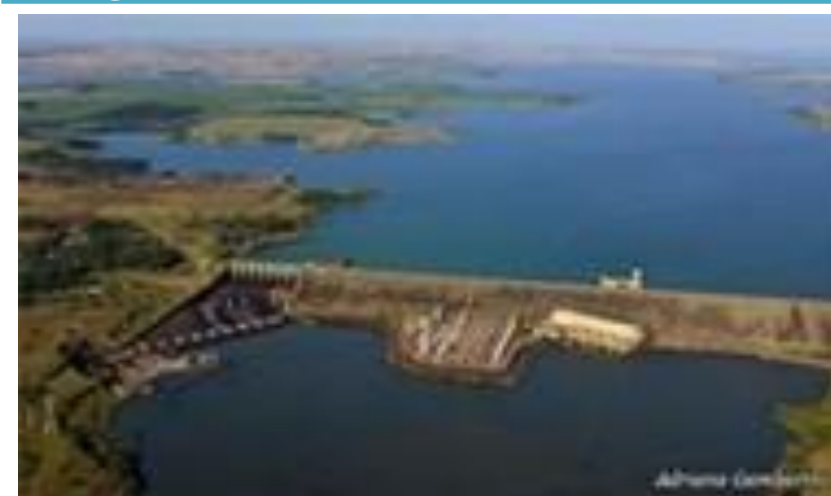
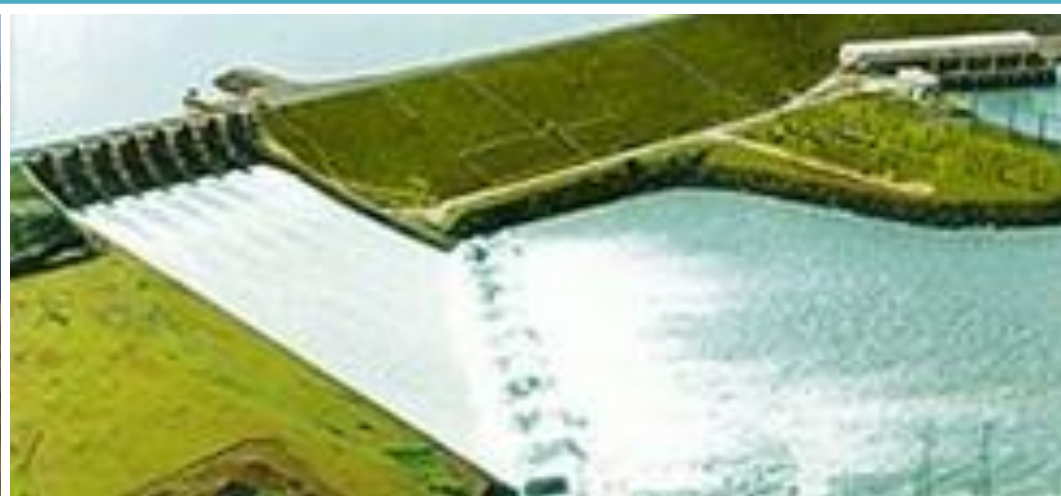
| CASE | IDENTIFICATION | COUNTRY | FINISHED | REHABILITATION/<br>REPAIR | REFERENCES |
|---|---|---|---|---|---|
| A-083 | Capivara Dam | Brazil | 1976 | 1984 | [155] |

There were observed erosions and cracks on the slabs of the of the spillway basin. The erosions were situated adjacent to the contraction joints as a result of the action of the flow at high speed. The repairs were carried out with epoxy mortar.

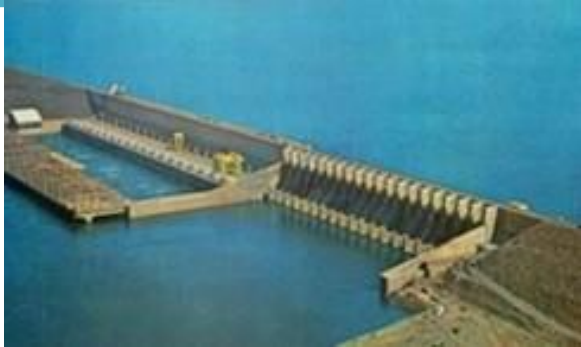
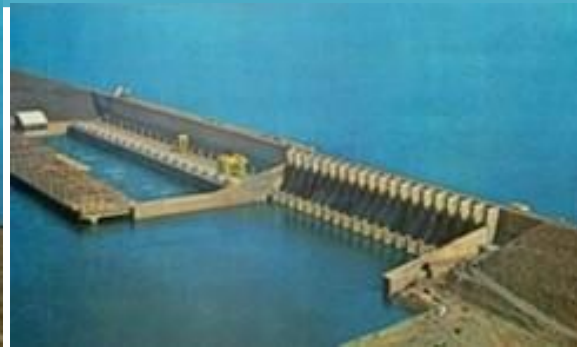
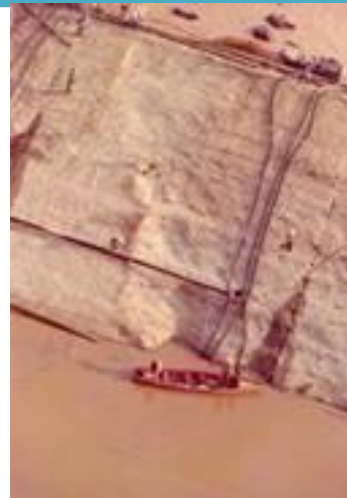
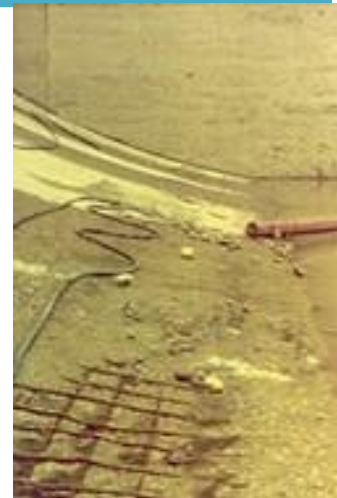
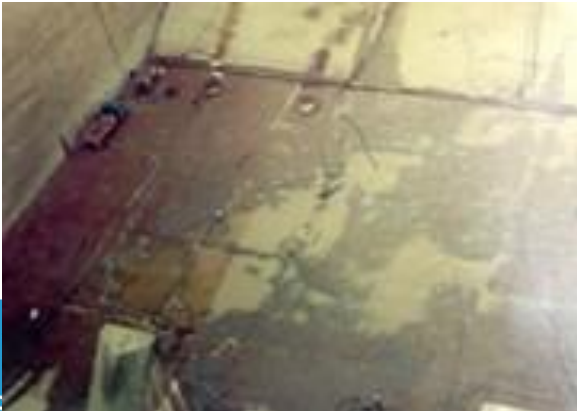
| CASE | IDENTIFICATION | COUNTRY | FINISHED | REHABILITATION/<br>REPAIR | REFERENCES |
|---|---|---|---|---|---|
| A-084 | Ilha Solteira Dam | Brazil | 1974 | 1974 | [155; 156] |

There was observed abrasion in the stilling basin due to the erosive action of rock blocks carried into the basin. Next to the deflector teeth erosion due to cavitation. The following measures were taken: underwater concrete in the critical areas of the basin before a partial reducing of the reservoir level; study on hydraulic model; repair of the eroded area with epoxy mortar and concrete.

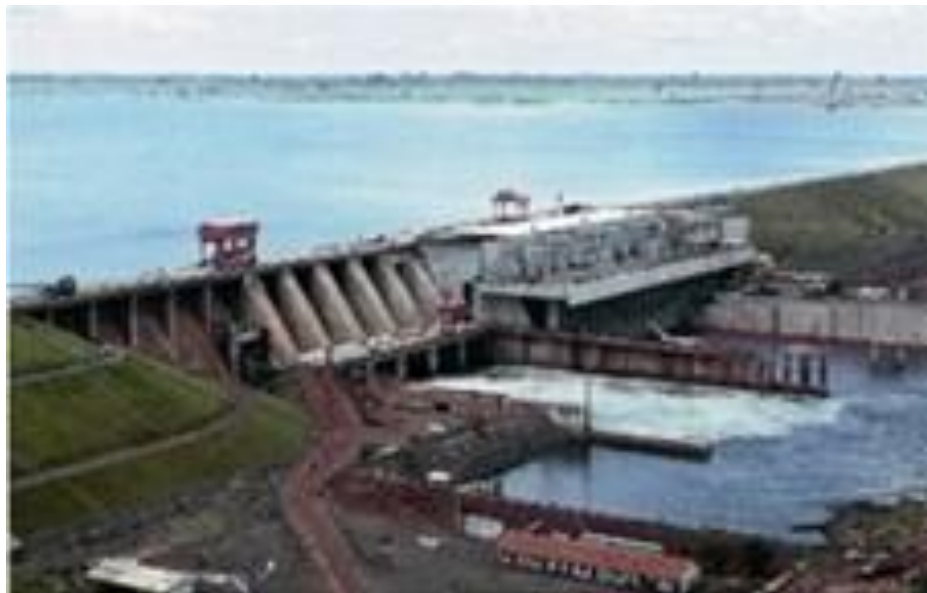
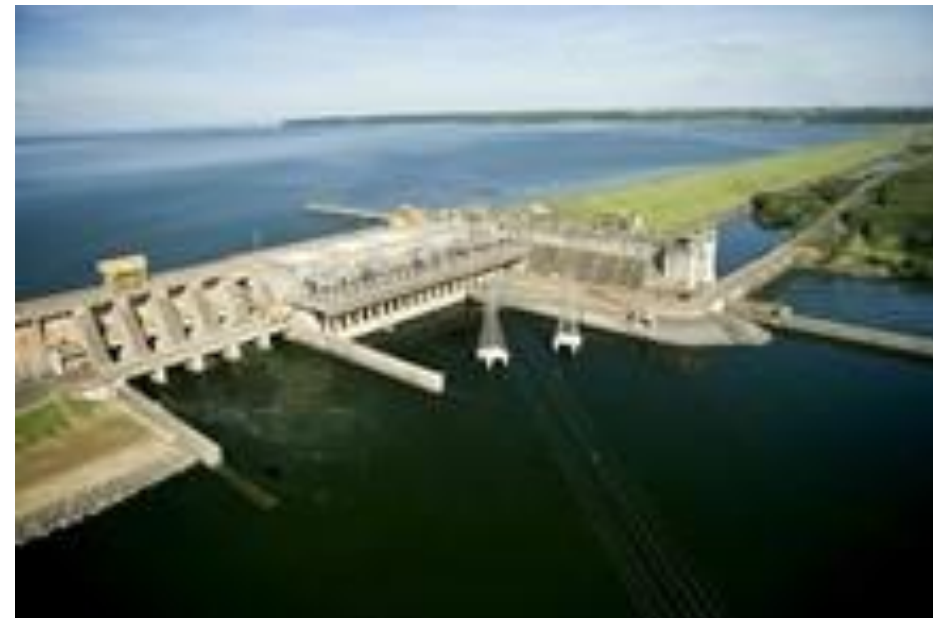
| CASE | IDENTIFICATION | COUNTRY | FINISHED | REHABILITATION/<br>REPAIR | REFERENCES |
|---|---|---|---|---|---|
| <b>A-085</b> | <b>Promissão Dam</b> | <b>Brazil</b> | <b>1975</b> | <b>1980</b> | <b>[155]</b> |

Erosion on the spillway basin due to rock blocks movement from the downstream cofferdam.

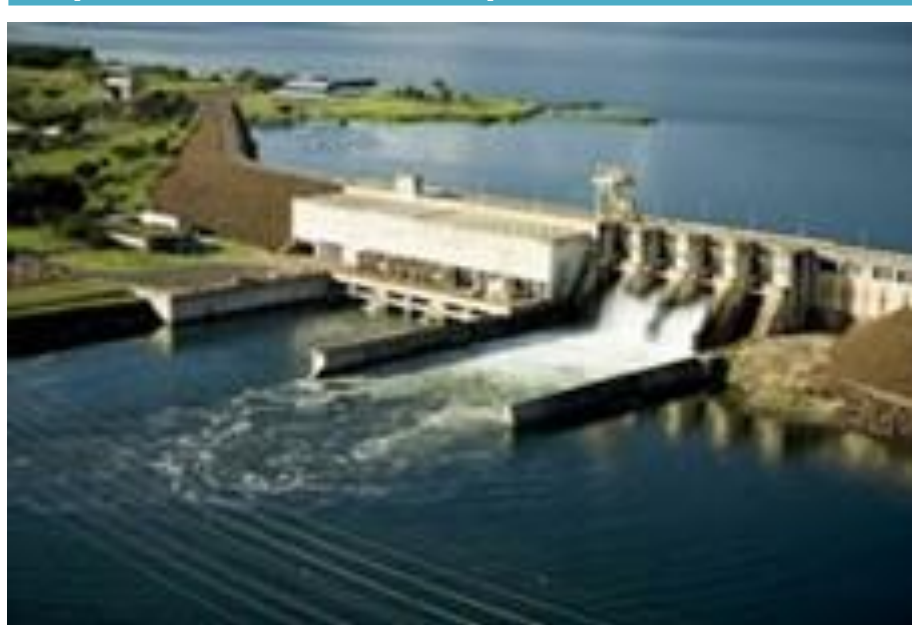
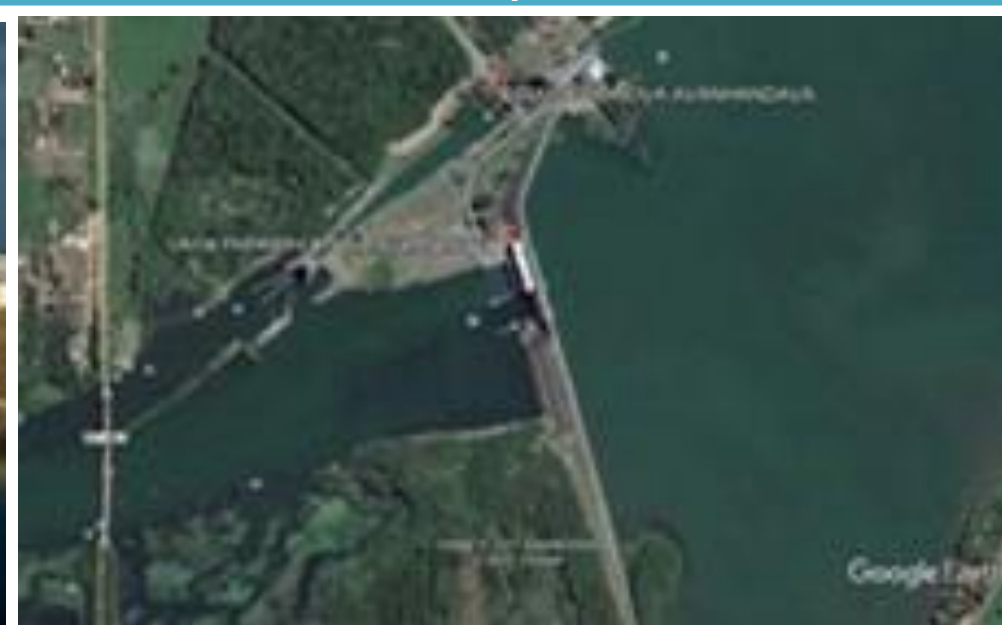
| CASE | IDENTIFICATION | COUNTRY | FINISHED | REHABILITATION<br>/ REPAIR | REFERENCES |
|---|---|---|---|---|---|
| <b>A-086</b> | <b>Nova Avanhandava Dam</b> | <b>Brazil</b> | <b>1982</b> | <b>1984/2012</b> | <b>[155]</b> |

Flood drainage galleries of the concrete structures due to the damage of fixing the seal rubbers at the base of the stop-logs of the draft tube, downstream of the powerhouse. Removal of stop-logs, replacement of the gasket, replacement of stop-logs. Replacement of the supervision and control of the command of the power house.

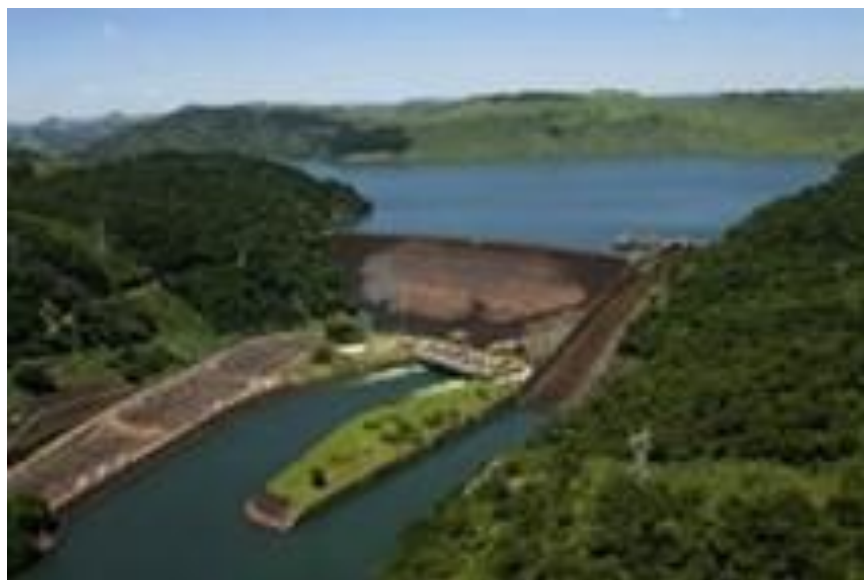
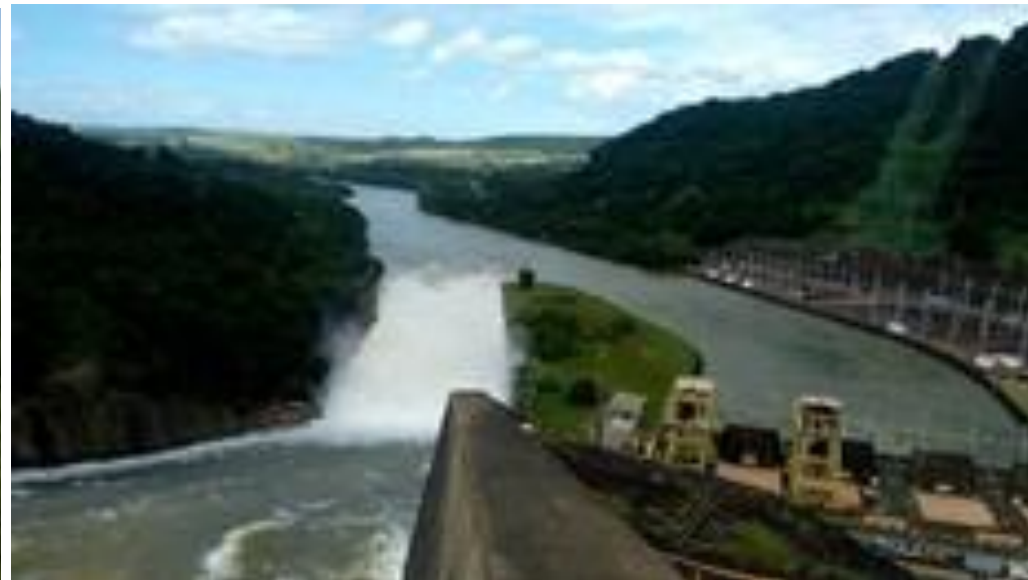
| CASE | IDENTIFICATION | COUNTRY | FINISHED | REHABILITATION/<br>REPAIR | REFERENCES |
|---|---|---|---|---|---|
| A-087 | Chavantes Dam | Brazil | 1970 | 1984 | [155] |

Erosions on the slabs of spillway trough in the vicinity of the expansion joints. Repair eroded sites using mortar and concrete with epoxy resin.

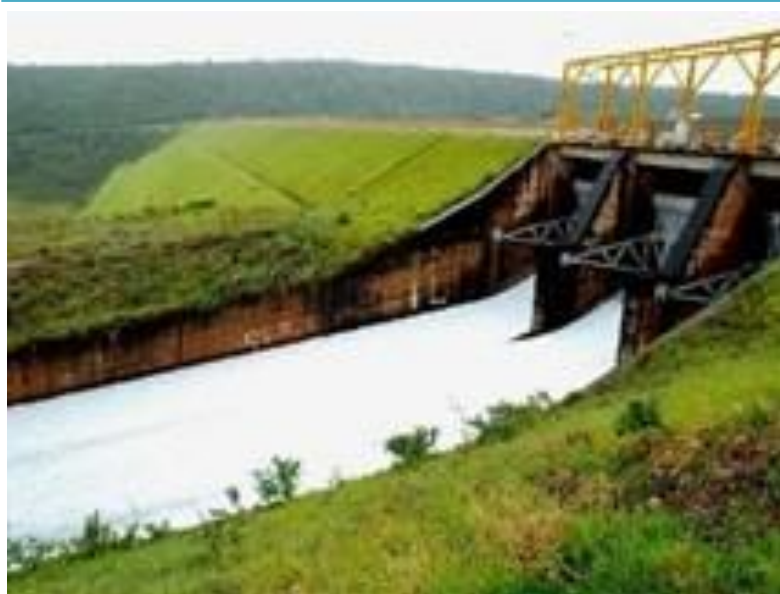
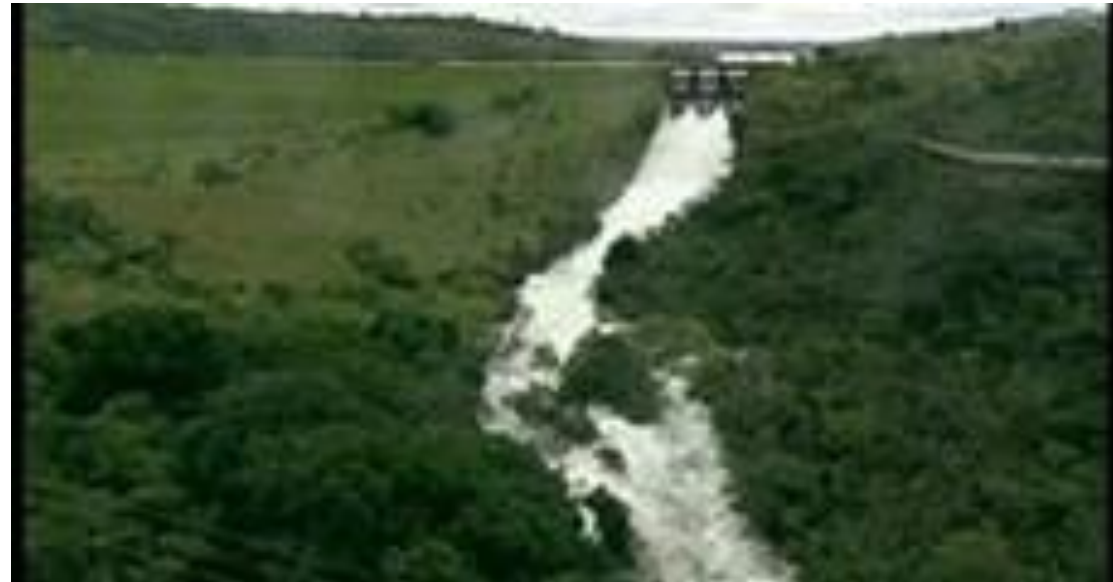
| CASE | IDENTIFICATION | COUNTRY | FINISHED | REHABILITATION/<br>REPAIR | REFERENCES |
|---|---|---|---|---|---|
| A-088 | Paranoá Dam | Brazil | 1960 | ???? | [155] |

Concrete erosion exposing the reinforcement in some places. The repair was performed with epoxy mortar.

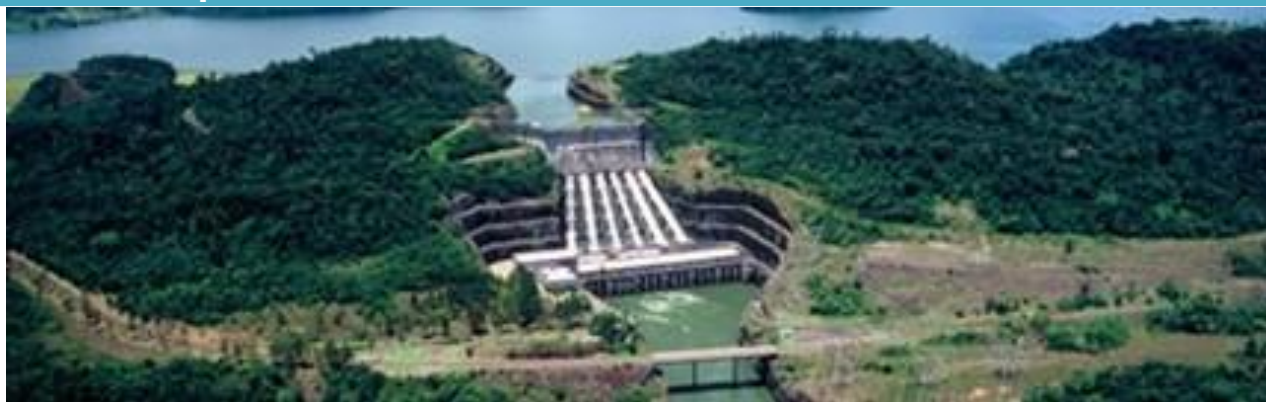
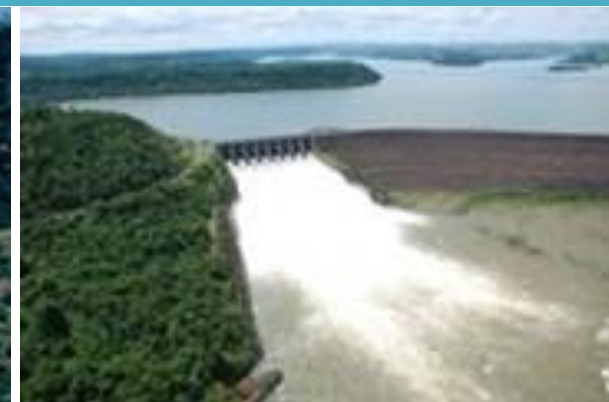
| CASE | IDENTIFICATION | COUNTRY | FINISHED | REHABILITATION<br>/ REPAIR | REFERENCES |
|---|---|---|---|---|---|
| A-089 | Salto Santiago Dam- PR State | Brazil | 1980 | ???? | [155; 157] |

Leakage through some contraction joints between blocks due abnormalities in concrete, with the sealing devices. The infiltration observed flows were of the order of 50 l/min. Erosions in the second stage concrete pillar-and the creager surface due to the heterogeneity of mixture and inadequate pouring. Repairs performed by grouting and concrete placement.

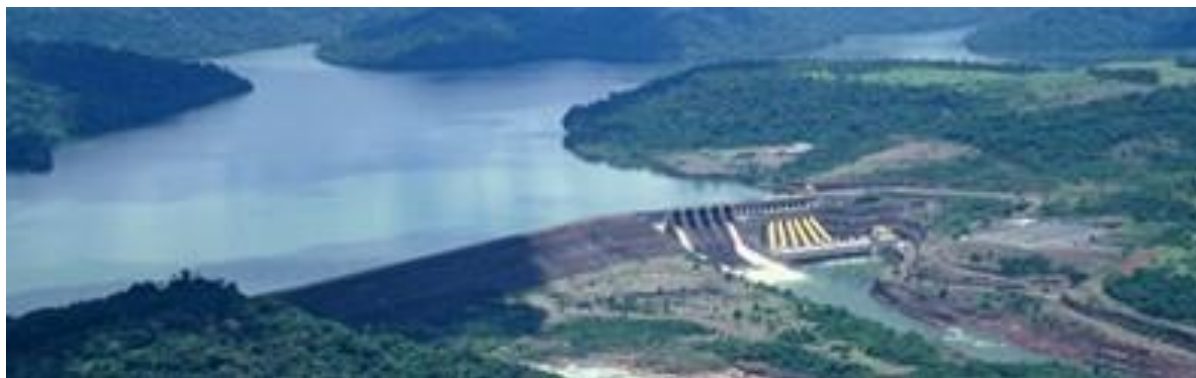
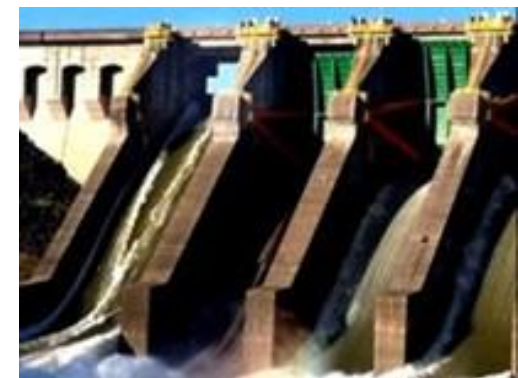
| CASE | IDENTIFICATION | COUNTRY | FINISHED | REHABILITATION/<br>REPAIR | REFERENCES |
|---|---|---|---|---|---|
| A-090 | Salto Osório Dam | Brazil | 1975 | 1973/2017 | [155] |

Erosion by abrasion, during the diversion of the river, downstream of the structures, caused by material being washed from the foot of the rock fill dam. The spillway erosion were verified in the concrete trough at certain points, which induced the erosion. The damaged concrete was repaired, with the appropriate concrete replacement to finish of hydraulic erosion were verified in the surfaces of the suction tube, downstream of the reinforcement in all units of the powerhouse. The damaged areas were treated with replacement of concrete eroded by conventional concrete and high strength mortar. In October 2017 occurred a pullout of a gate of the Spillways, which was repaired after lowering the reservoir level

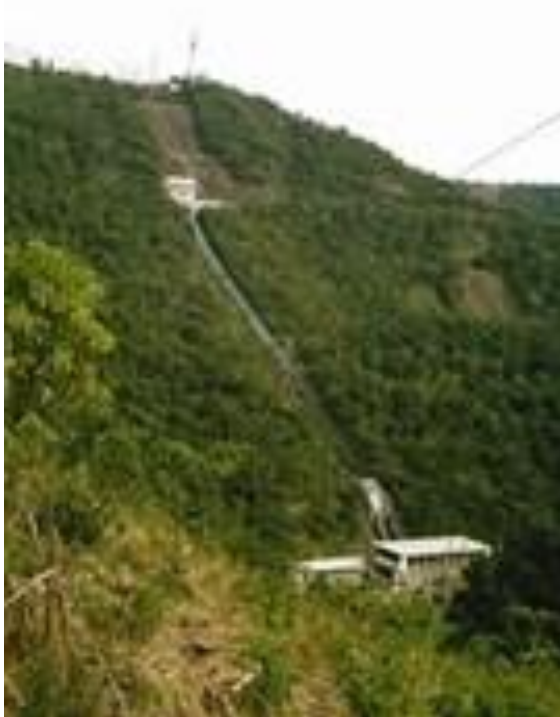
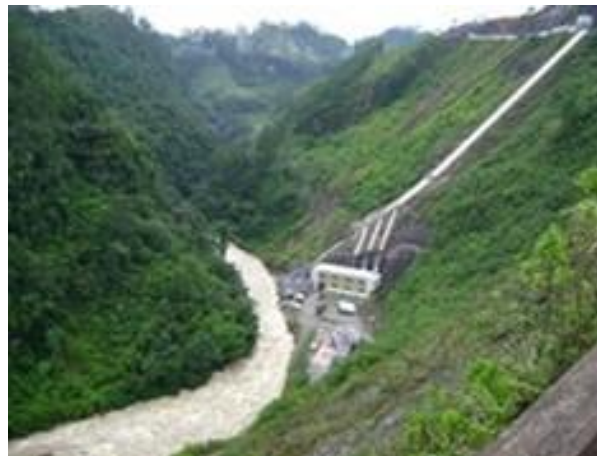
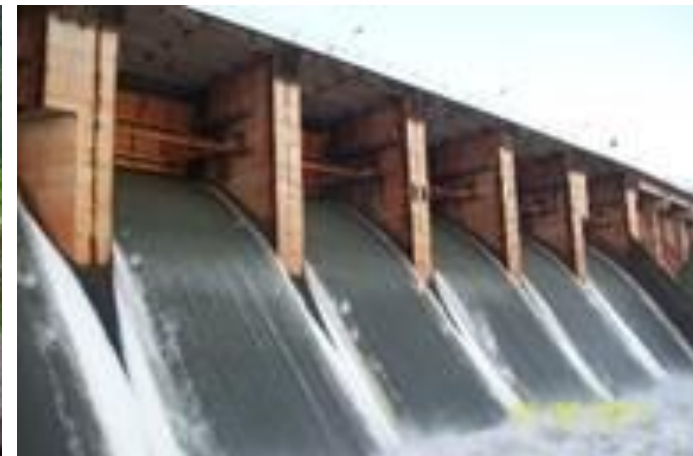
| CASE | IDENTIFICATION | COUNTRY | FINISHED | REHABILITATION/<br>REPAIR | REFERENCES |
|---|---|---|---|---|---|
| A-091 | Passo Fundo Dam | Brazil | ???? | ???? | [155] |

Partial obstruction of the drainage holes in the rock mass of the foundation of the spillway.  
Periodic cleaning of the holes and the drainage gallery.

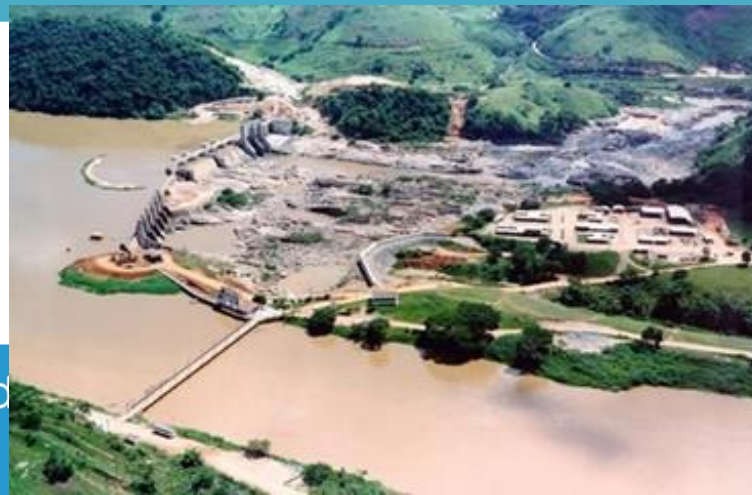
| CASE | IDENTIFICATION | COUNTRY | FINISHED | REHABILITATION/<br>REPAIR | REFERENCES |
|---|---|---|---|---|---|
| A-092 | Ilha dos Pombos Dam | Brazil | 1924 | 1985 | [155; 158] |

Since the early years of its operation, the concrete structures presented issues related to various causes that induced damage to the structures, causing a widespread cracking, mainly attributed to the expansion reactions in concrete, involving aggregates and alkalis (AAR).

- Grout injections, with what would be reduced the leakage;
- recompose the segregated concrete, damaged and loose;
- implementation of a waterproof coating on the surfaces that will be in contact with water or moisture.

The waterproof coating was executed with reinforced concrete with thickness varying between 5 cm and 10 cm

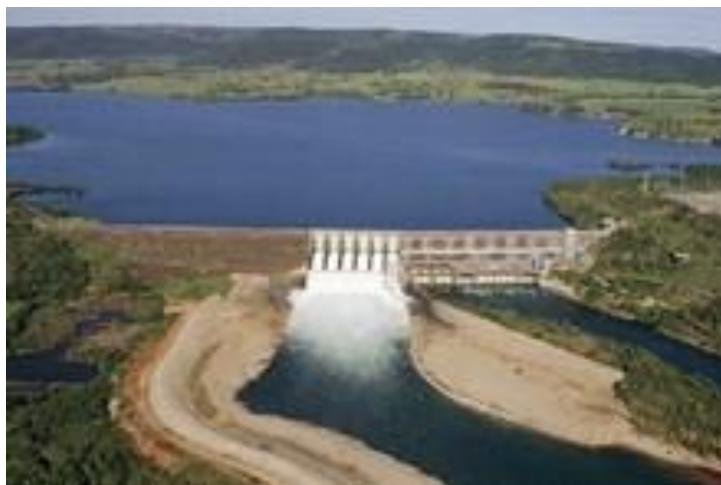
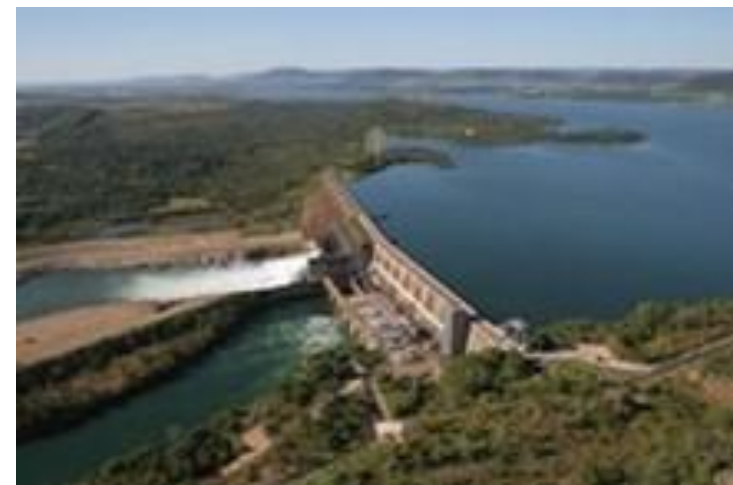
The dam was designed with a spillway (sky jump) without dissipation basin excavation with maximum capacity of 14100 m<sup>3</sup>/s. The discharge operation of spillway had excavated a bigger basin than anticipated, coming close to the concrete wall that separates the anchored tailrace of the spillway. There was also damage to the earth-rock fill dam built in extension to the wall. Replacement of part of the earth-rock dam by reinforced concrete wall; controlled operation of the spillway gates to prevent the increase of erosion of the basin along the anchored wall.

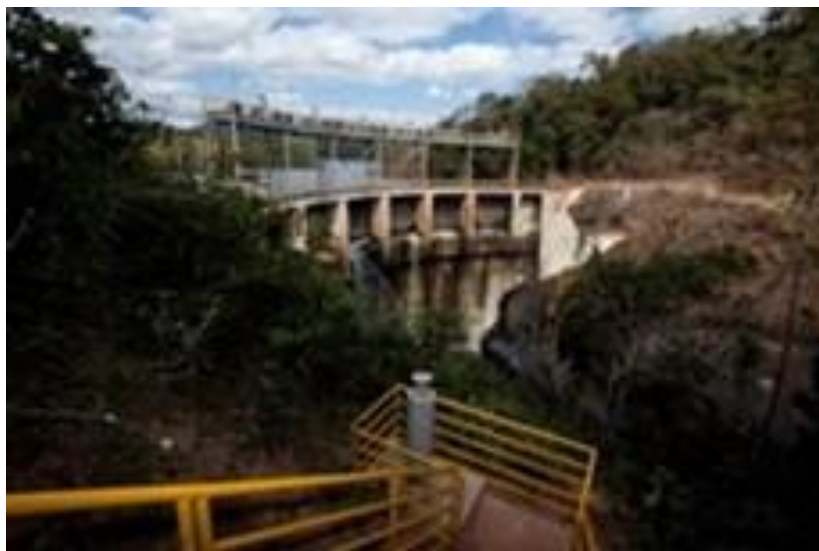
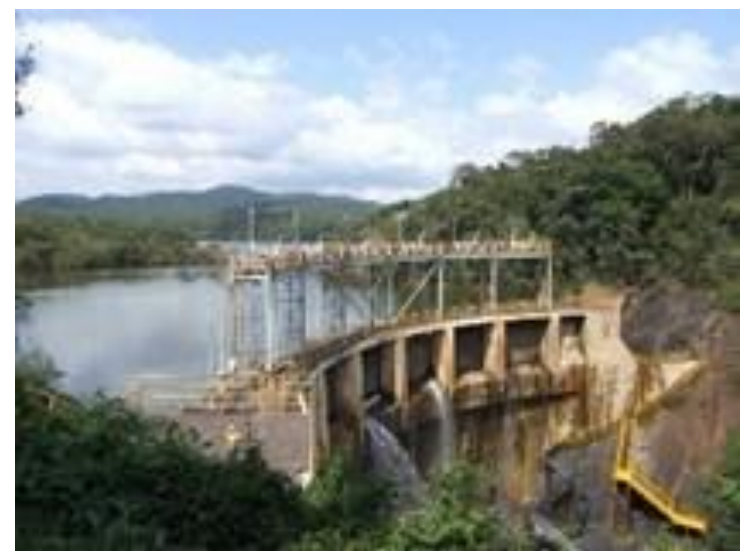
| CASE | IDENTIFICATION | COUNTRY | FINISHED | REHABILITATION/<br>REPAIR | REFERENCES |
|---|---|---|---|---|---|
| A-095 | Peti | Brazil | 1946 | ???? | [155] |

The dam showed cracks (due to the reactivity of the aggregate/cement/water and to temperature changes) that allow percolation of water at various locations. The repairs were performed with the application of a special asphalt layer (components, epoxy) in the wall of upstream and on the platform of the crest. In the downstream wall was applied a layer (painting) of cement with waterproofing additive. The cracks were treated before application of protective layers. The fissures and cracks remain leakproof.

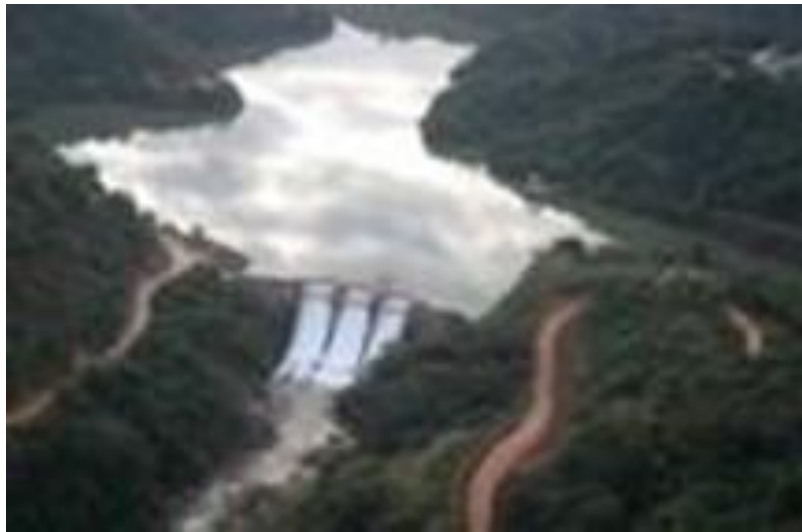
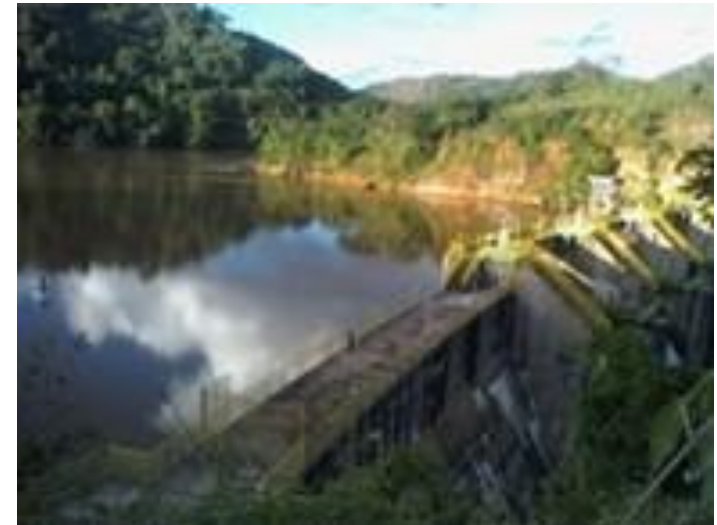
| CASE | IDENTIFICATION | COUNTRY | FINISHED | REHABILITATION / REPAIR | REFERENCES |
|---|---|---|---|---|---|
| A-096 | Salto Grande Dam -MG State | Brazil | 1956 | ???? | [155] |

Due to the siltation of the Santo Antonio River reservoir, to the doorstep of the spillway, the spillway gates operation removes part of silted material. This fact made the surface strand suffered an abrasion process which culminated in the loss of some dissipators teeth (at 30 cm) and with the threat of loss of the geometry of the spillway. The repair was done overlaying the whole surface with high abrasion resistance concrete

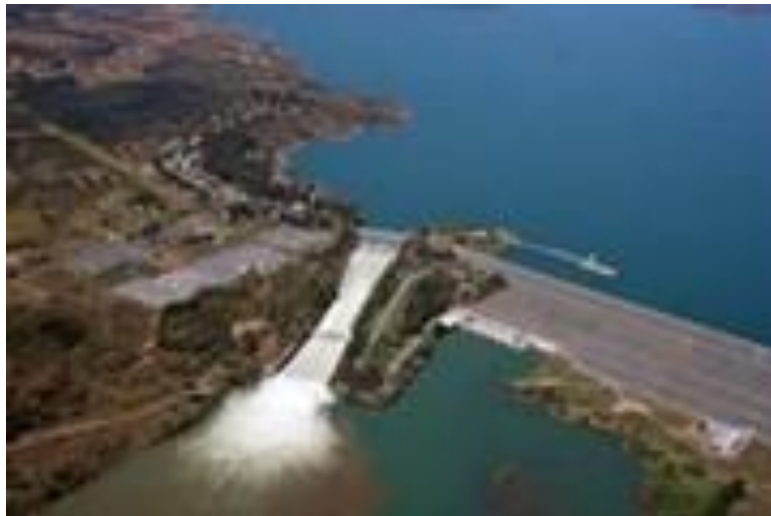
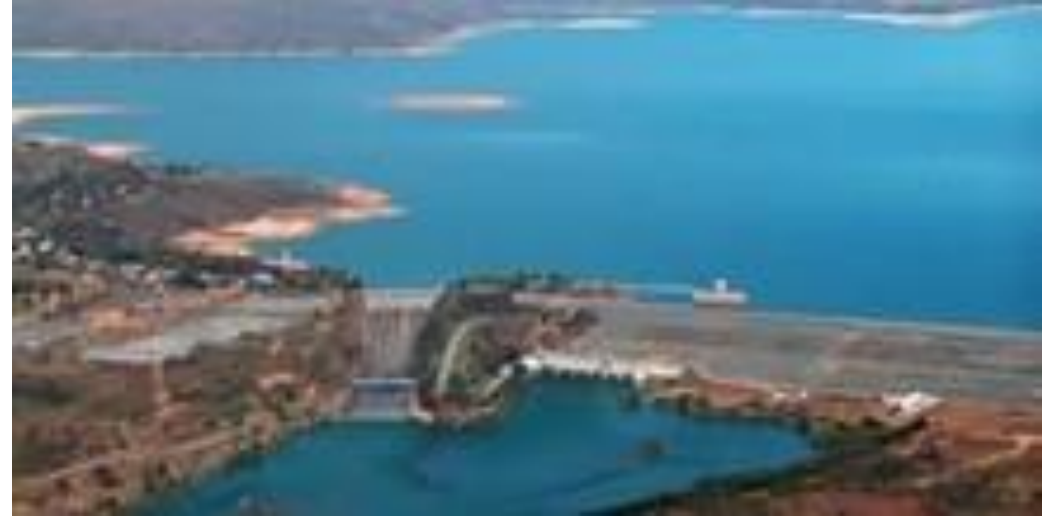
| CASE | IDENTIFICATION | COUNTRY | FINISHED | REHABILITATION/<br>REPAIR | REFERENCES |
|---|---|---|---|---|---|
| <b>A-097</b> | <b>Tres Marias Dam</b> | <b>Brazil</b> | <b>1961</b> | <b>1984</b> | <b>[155]</b> |

Lateral overtopping of spillway chanel, before the formation of the jet, for discharges between 800 and 2,000 m<sup>3</sup>/s m3/s, causing erosions on the ground side walls due to external violent turbulence of the waters inside the gutter. Modifications of the spillway profile and concrete repair of the basin were performed. These modifications allow the flows up to 1.300 m<sup>3</sup>/s.

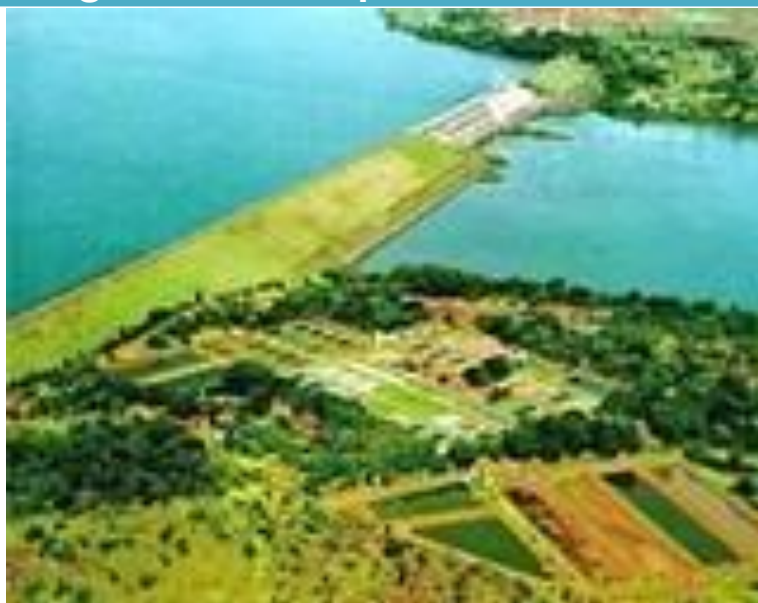
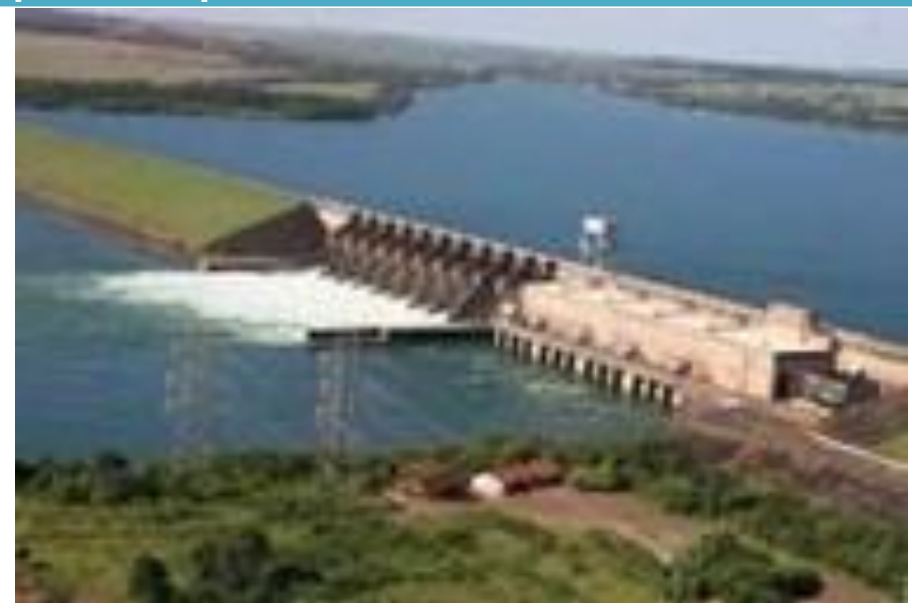
| CASE | IDENTIFICATION | COUNTRY | FINISHED | REHABILITATION/<br>REPAIR | REFERENCES |
|---|---|---|---|---|---|
| A-098 | Volta Grande Dam | Brazil | 1974 | ???? | [155] |

During the diversion through the sliceways, was carried into the spillway stilling basin part of the rocky material dissipation of the spillway channel. This cause a destructive process of erosion by abrasion and impact. The process has accelerated with the operation of the spillway. As a result, the concrete surface of the basin and dissipators teeth virtually disfigured with exposed reinforcements. The repair was performed with concrete.

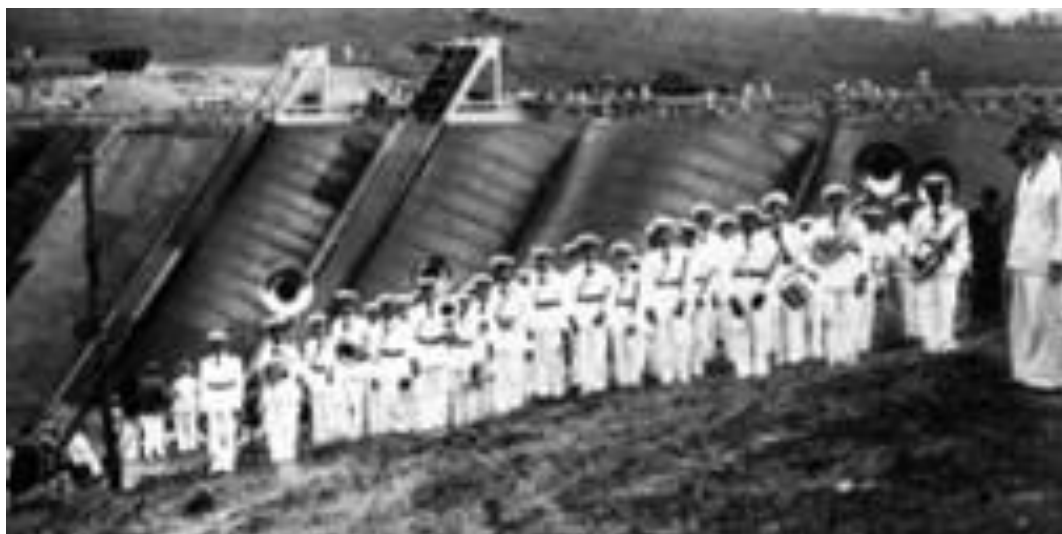
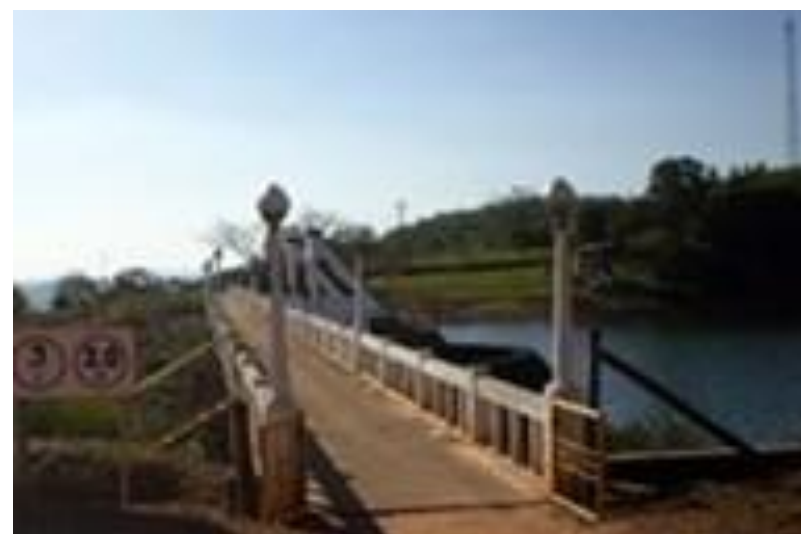
| CASE | IDENTIFICATION | COUNTRY | FINISHED | REHABILITATION/<br>REPAIR | REFERENCES |
|---|---|---|---|---|---|
| A-99 | Xicão Dam | Brazil | 1942 | ???? | [155] |

The dam is a reinforced concrete structure with multiple vaults and buttresses, with a maximum height of 20 m and length of 115m. There were observed leaks by construction joints of concrete of the dam and the contact concrete/rock. The leaks were ferruginous spots in concrete, with evidence of corrosion of the reinforcement. Emptying the reservoir and treatment of construction joints. Performed the repair at the contact with the Foundation, reducing the leaks in the concrete dam and foundation contact.
