Structural analysis and rehabilitation  
of concrete dams and spillways

# **HISTORIC CASES ON CONCRETE DAMS REHABILITATION**

Third International  
Dam World Conference

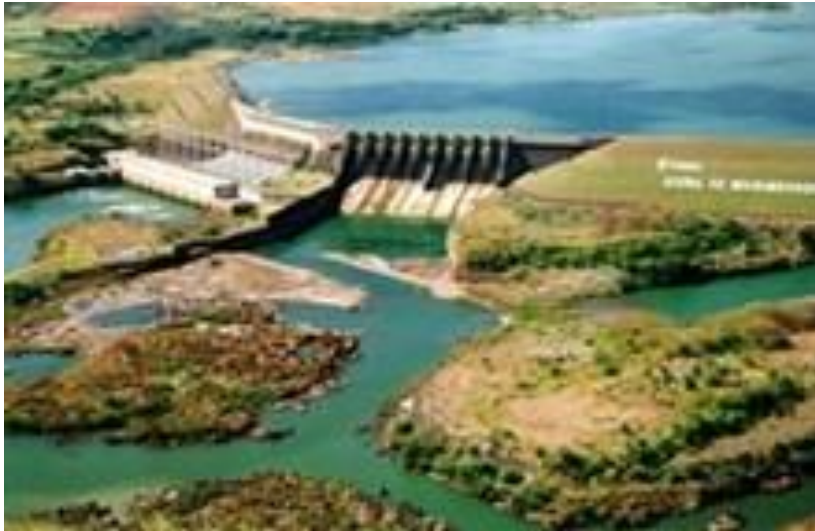
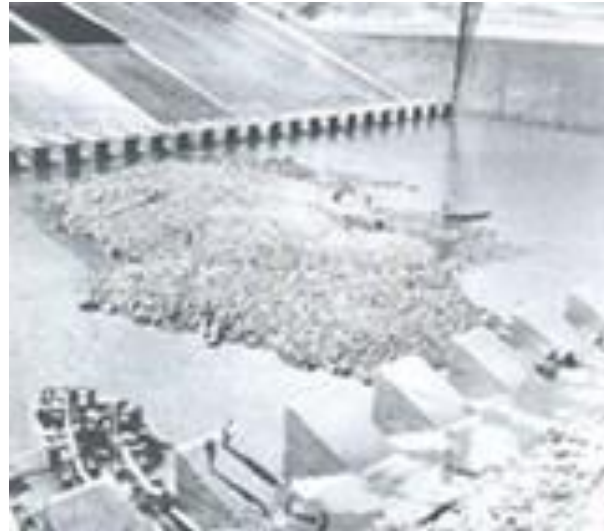
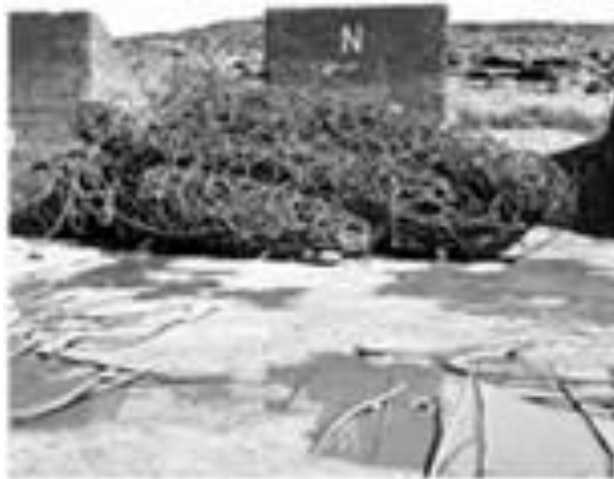
| CASE | IDENTIFICATION | COUNTRY | FINISHED | REHABILITATION/<br>REPAIR | REFERENCES |
|---|---|---|---|---|---|
| A-100 | Marimbondo Dam | Brazil | 1975 | 1982 | [155; 159] |

In May 1975, after the river closure, erosion of the spillway chute and dissipation basin there were observed. There was a great amount of solid material deposited inside the stilling basin (around 3800 m<sup>3</sup>).

The stilling basin was dewatered In 1980, for the recovery of the eroded concrete. The horizontal bottom slab was with widespread erosion observing surface damage, reinforcement and erosions. Spillway chute presented with gradual abrasion with no major wear compared to those seen in 1975 and 1978.

The rock downstream of the dissipation basin featured irregular due to erosion of the current return flows and the effect of the cracks of the rock. In 1980 and 1982 the stilling basin was dewatered for concrete repairs.

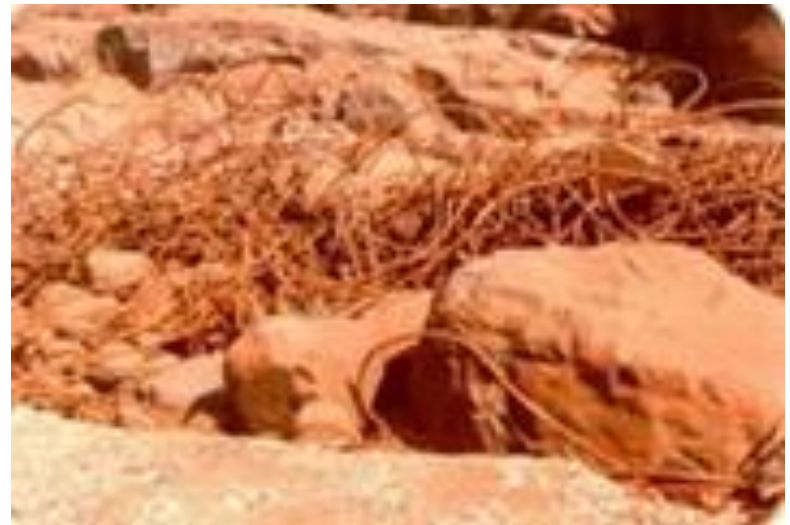
Foto T - Detalhe das ferragens ancoradas da base de dissipação

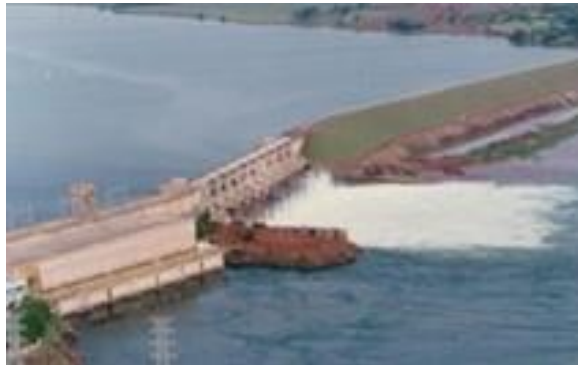
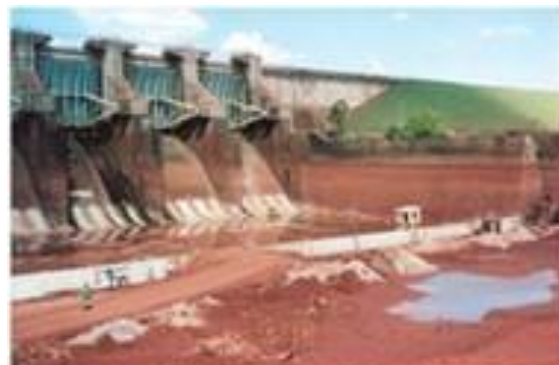
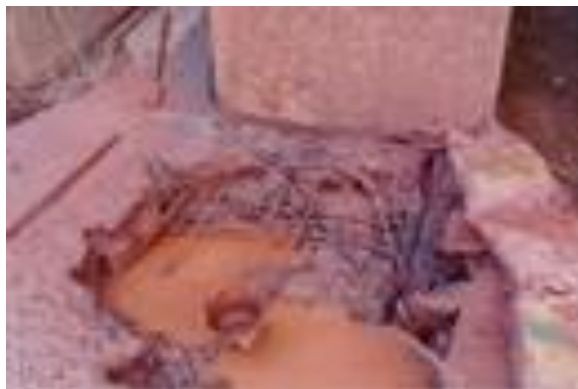
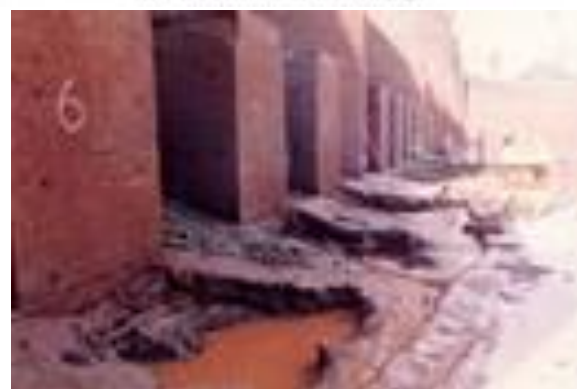
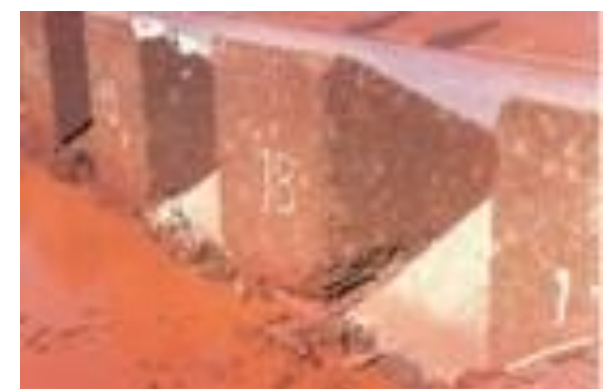
| CASE | IDENTIFICATION | COUNTRY | FINISHED | REHABILITATION/<br>REPAIR | REFERENCES |
|---|---|---|---|---|---|
| A-101 | Porto Colombia Dam | Brazil | 1974 | ???? | [155] |

Erosion on surface of the blocks and slab of the spillway with the reinforcement exposed. The repair was performed with concrete and epoxy mortar.

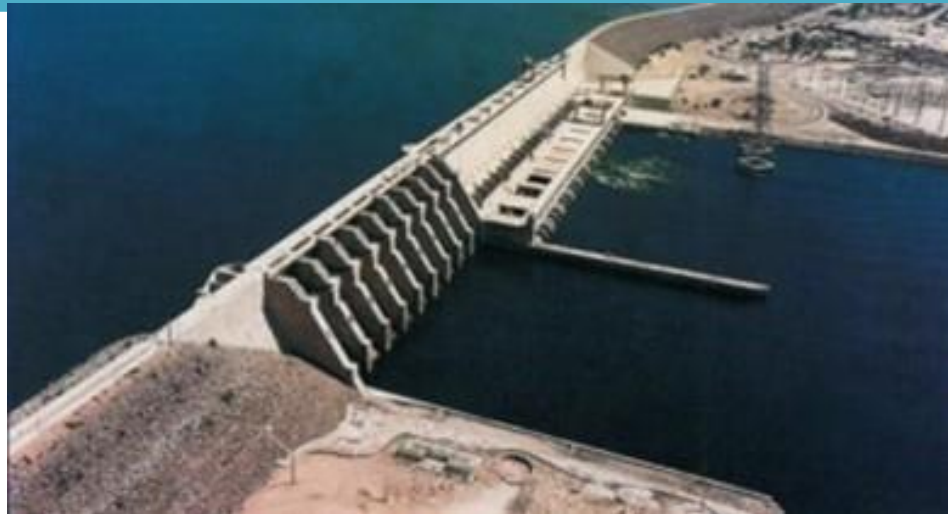
| CASE | IDENTIFICATION | COUNTRY | FINISHED | REHABILITATION/<br>REPAIR | REFERENCES |
|---|---|---|---|---|---|
| A-102 | Moxotó Dam | Brazil | 1975 | 1983-1990 | [155; 160; 161; 162] |

In 1983, in order to minimize the effects of the AAR in the concrete involving the generating units, it was decided to realign all the equipment. With the evolution of the observed expansion through instrumentation data and simulation of mathematical model, it was shown that the opening together would provide the traction tension reduction on the elements of the turbine. The solution adopted was the opening of three expansion joints between the blocks using the technique of steel wires impregnated with abrasive, for a gap of 30 mm.

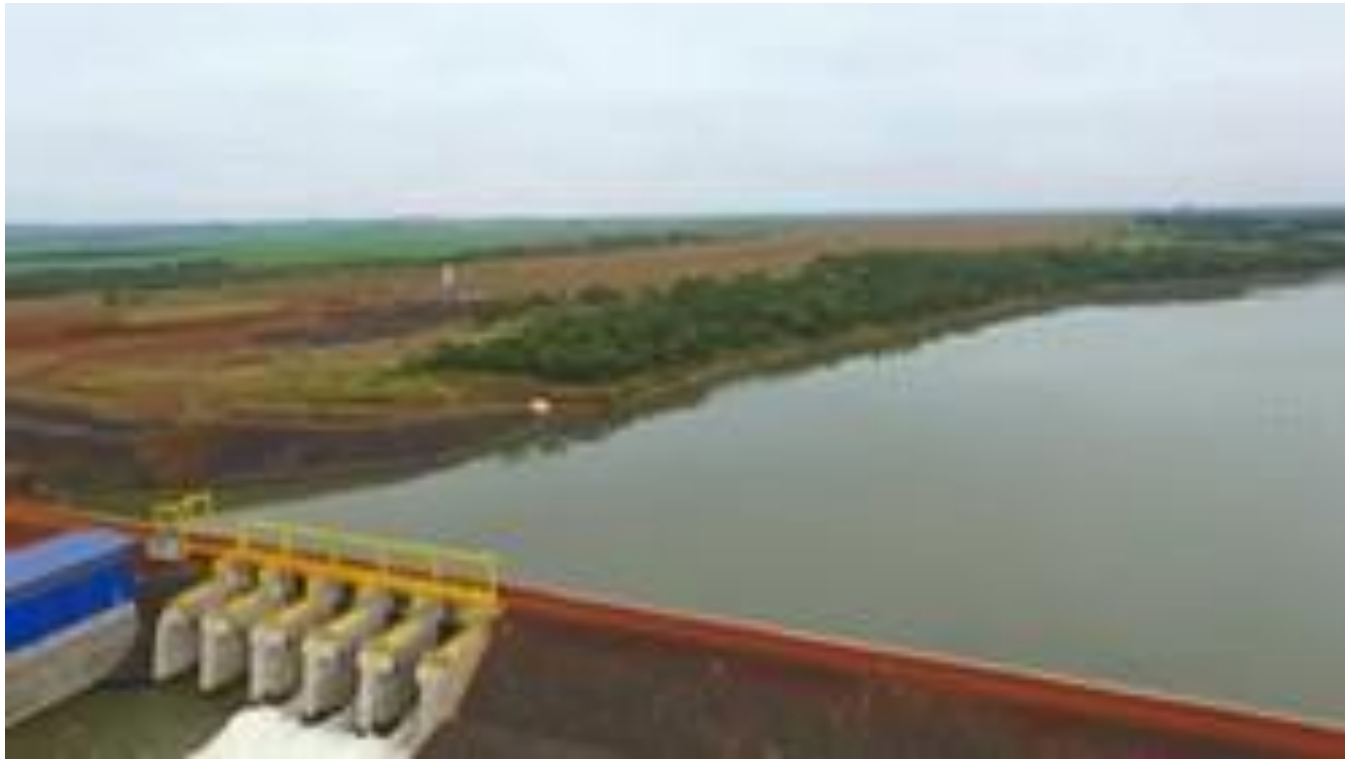
| CASE | IDENTIFICATION | COUNTRY | FINISHED | REHABILITATION/<br>REPAIR | REFERENCES |
|---|---|---|---|---|---|
| A-103 | Ype Dam | Brazil | 2017 | 2017 | <a href="http://www.emaisgoias.com.br">www.emaisgoias.com.br</a> |

One of the spillway gates of the Rio Verde dam broke. The repair is undergoing

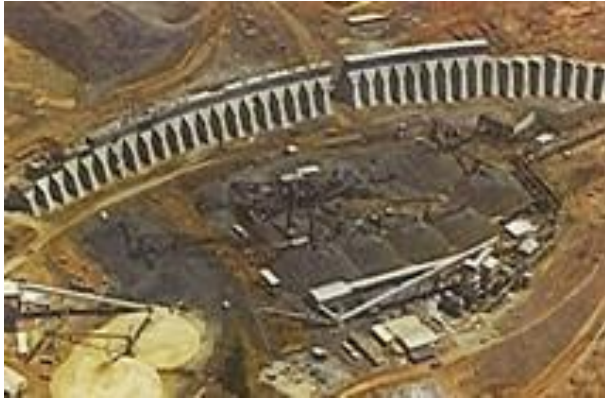
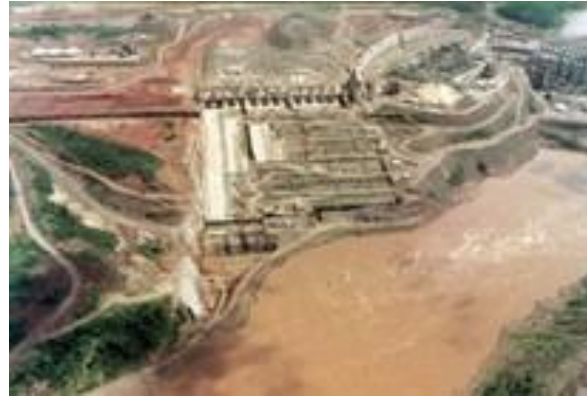
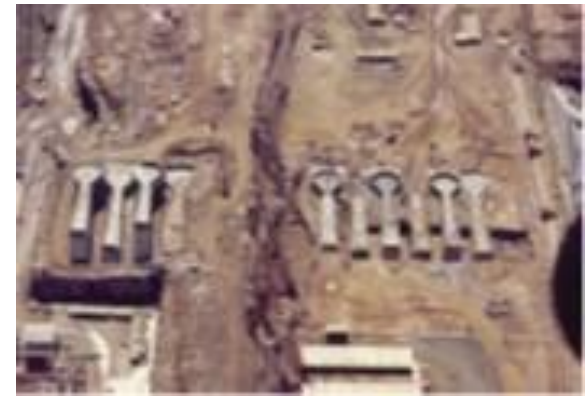
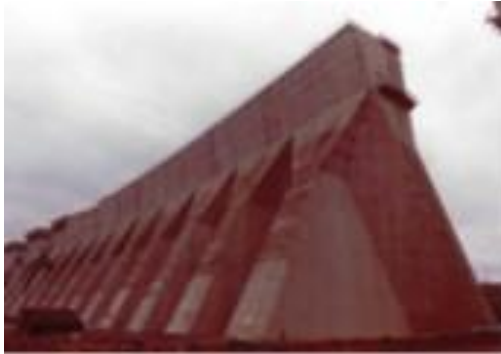
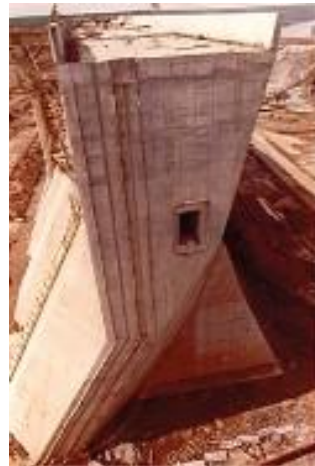
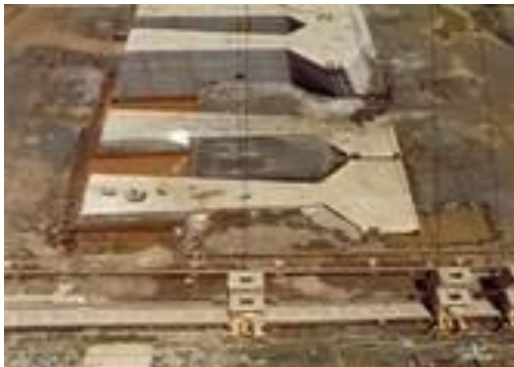
During the construction of the Right Lateral Dam, some blocks, which are under the cableway cranes, were poured slowly, and at the other side of the cranes, they were poured in a faster sequence (5 or 6 layers per month). The blocks poured in a faster sequence exhibited some cracking. Some professionals discussed thermal cracks when first analyzing this dam. However, an additional analysis using a finite element system and based on some laboratory tests on geometrical models indicated the occurrence of a large shear tension in the same zone as the real structure. In addition to these analyses, the strain meter spider installed displayed compressive stresses, not tensile stresses.

Virtually all cracks were verticals or sub-verticals, and began in the foundation. The cracks if characterized from micro-cracks of small depth and extension, even some cracks were between 10 and 20 m in length. The opening media of these cracks were around of 0,3 and 0,9 mm, and some cross the entire buttress, but none achieved the complete separation of the foothills and the head of the blocks. The cracks were injected with resins and special equipment.

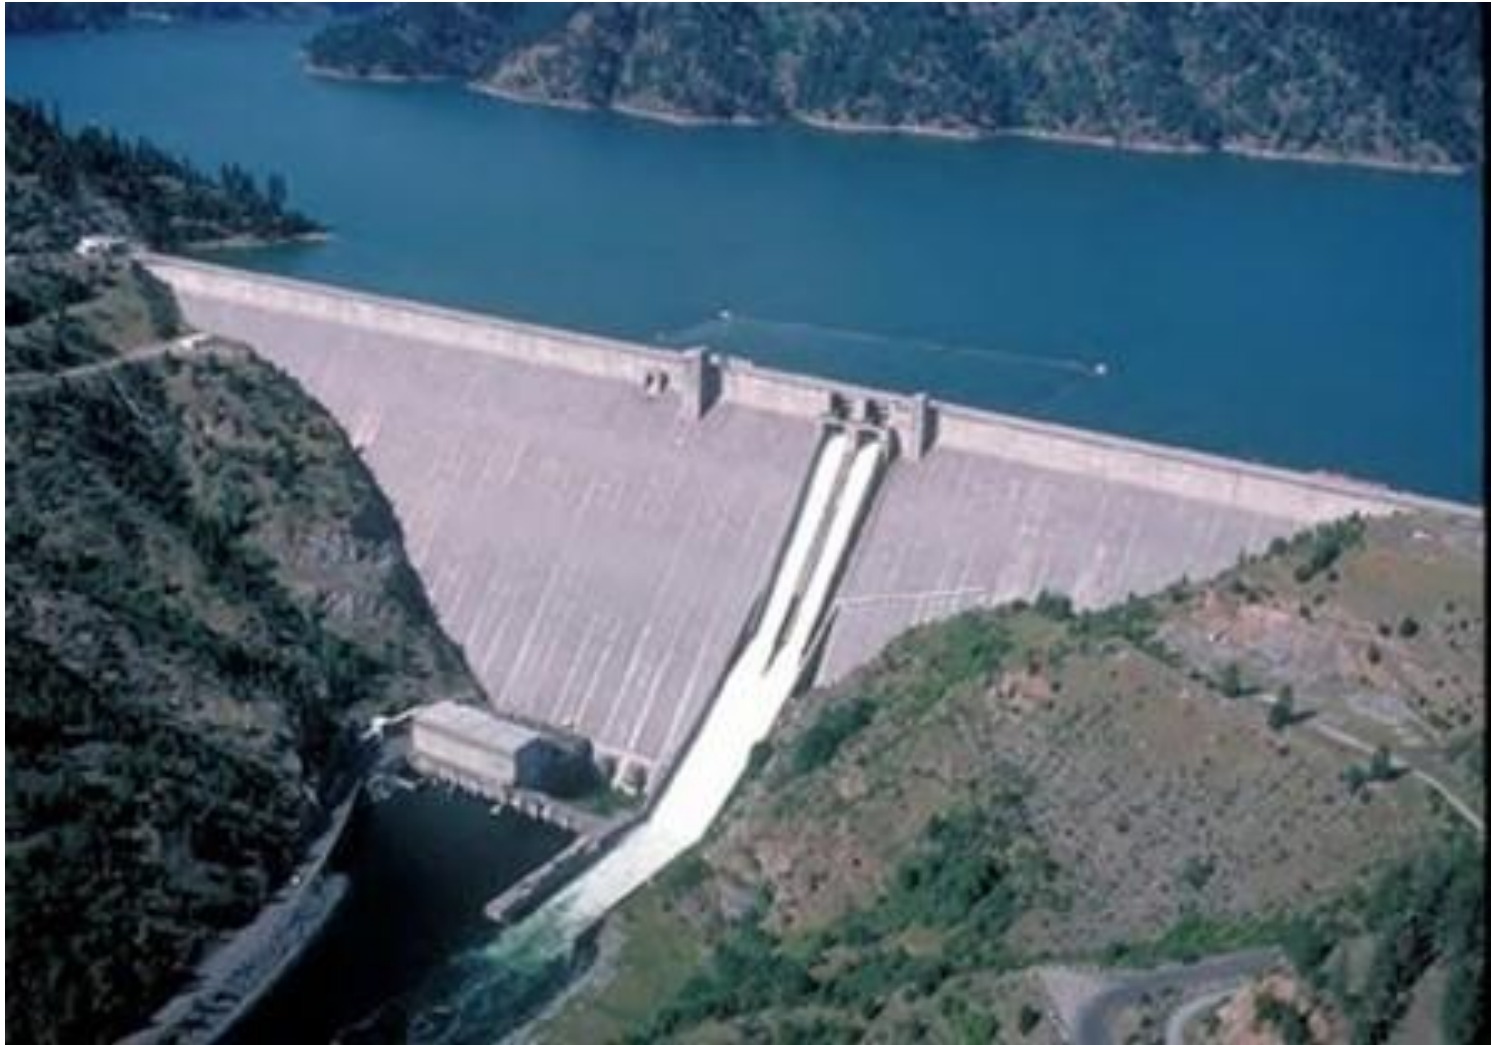
| ASPECTS |
|---|
| <p>Before the reservoir was filled, cracks on the upstream face of several monoliths were measured and mapped to pinpoint their exact location and length. At that time, the cracks were not regarded as being significant. After reservoir filling, eight of the cracks that were mapped penetrated the interior of the structure, causing an inflow of water into several galleries. These cracks were drilled to release hydrostatic pressure. After the drilling was completed, flows decreased, and over time most of the cracks healed as a result of calcification. The permanent solution selected was to seal the crack with an epoxy material designed to be placed underwater.</p> <p>In the late 1980's, erosion resulting from the grinding action of riprap and trapped debris caused a loss of almost 1220 m<sup>3</sup> of concrete in the stilling basin, and the outlet conduit suffered cavitation damage when excessively high flows washed out large pieces of aggregate and matrix from the face of the outlet. Both the stilling basin and the outlet conduit were repaired with polymer-impregnated concrete in the first major field application of this repair material.</p> |
